**EVALUATION OF THE RECTANGULAR RAPID FLASH BEACON AT A  
PINELLAS TRAIL CROSSING IN ST. PETERSBURG, FLORIDA**

**FDOT Contract BA784  
Final Report**

**University of North Carolina  
Highway Safety Research Center**

**October 2009**

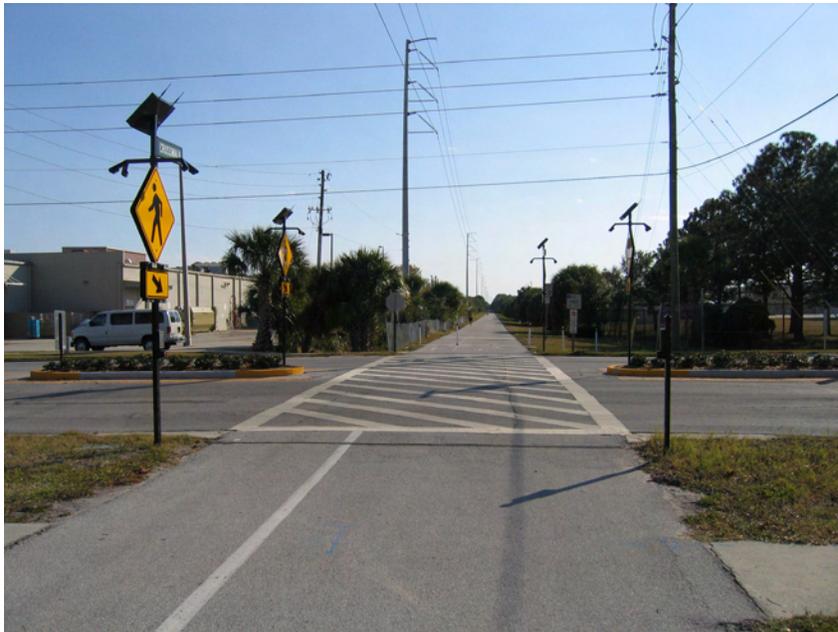
This report is an evaluation of the installation of the rectangular rapid flash beacon (RRFB) where the Pinellas Trail crosses 22<sup>nd</sup> Avenue N, a busy four-lane, urban street in St. Petersburg, Florida. The unit has two rectangular yellow LED indicators which flash rapidly in a wig-wag sequence. It is solar-powered, radio controlled, and activated by trail users. The RRFB had been previously evaluated at 19 uncontrolled pedestrian crosswalks in St. Petersburg, and the system wide average motorist yielding compliance rate improved from less than 1% to 82%. For the current study, it was felt that the RRFB would make the trail crossing safer by increasing the yielding of motorists to trail users. The RRFB system was installed on August 2, 2008 and included beacons and signs on the edge of the roadway and in the median, as well as a push button to activate.

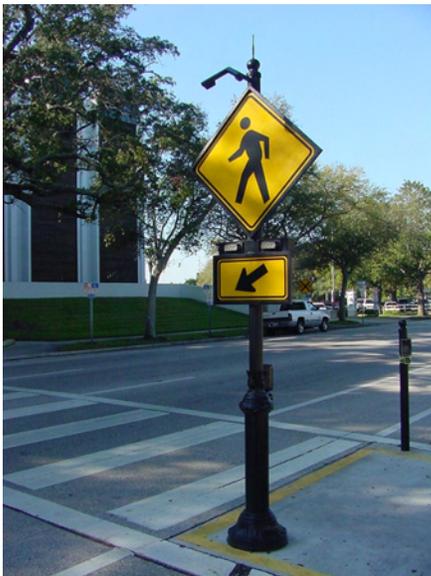
**Figure 1. RRFB at an uncontrolled crosswalk.**

One countermeasure used at 19 of the St. Petersburg uncontrolled crosswalks is the rectangular rapid flash beacon (RRFB). The unit has two rectangular yellow LED indicators which flash rapidly in a wig-wag sequence. It is solar-powered, radio controlled, and activated by pedestrians (Figure 1). An evaluation of 18 of these 19 locations had been previously performed, and the system wide average motorist yielding compliance rate improved from less than 1% to 82% (Shurbutt, Van Houten, and Turner, 2008). For the current study, it was decided that the RRFB should be installed and evaluated at a location where the Pinellas Trail, a multi-use facility, crosses 22<sup>nd</sup> Avenue N, a busy four-lane, urban street with 15,000 vehicles per day, and posted speed limit of 40 mph. Depending on season, the Pinellas Trail has approximately 1,300-2,000 trail users per day. It was felt that this would make the trail crossing safer by increasing the yielding of motorists to trail users.

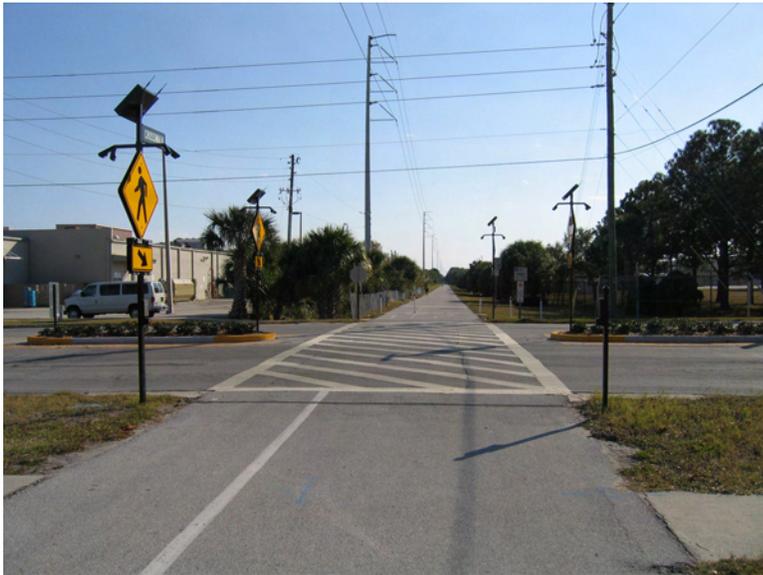
**Figure 2. RRFB at the Pinellas Trail crossing.**

The decision had been made by the Neighborhood Transportation section to install a safety treatment at a street crossing with the Pinellas Trail. A consultant examined candidate locations and recommended that a RRFB be installed at 22<sup>nd</sup> Avenue North and the trail. This was the device previously evaluated at uncontrolled pedestrian crosswalks in St. Petersburg and described in the introduction and literature review. The RRFB system was installed on August 2, 2008 (Figures 2 and 3) and included beacons and signs on the edge of the roadway and in the median, as well as a push button to activate. The vendor was Stop Experts, Inc., and the cost of the system was \$26,050.

The treatment of primary interest in this experiment was two (2) rectangular LED flashing beacons. The LED flashers on the front and back were each six (6) inches wide, 2.5 inches high, and placed nine (9) inches apart. Each unit was dual indicated (LED's on front and back). Each side of the LED beacon flashed in a wig-wag flashing sequence (left light on, then right) - the two LED's in combination flashed 190 times in the wig-wag flashing sequence during a 30 second cycle. Of the two LED's, the left LED flashed two times (in a slower type of a rapid flash) each time it was energized followed by the right LED, which flashed in a very fast rapid three (3) flash volley when energized. Four (4) signs along with beacons were installed at each crosswalk. Radio frequency transmitters linked the devices so a depression of any of the pedestrian call buttons activated the flashers on all four signs. A separate LED facing the pedestrian flashed to indicate to pedestrians that the system was operating. The system also presented an audible message instructing pedestrians that the light flashing across the street indicates that the device was operating, and instructing them to wait for cars to stop before crossing.

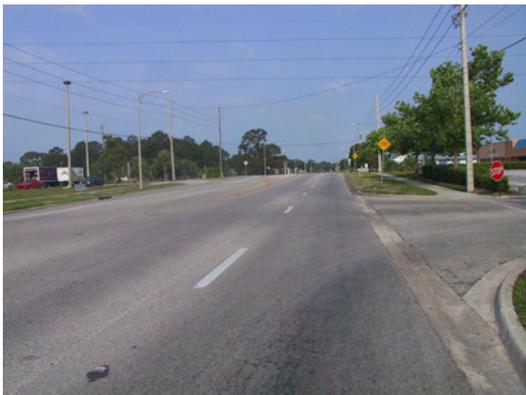
**Figure 4. View of roadway before RRFB.**

The before condition of the trail crossing (Figures 4 and 5 ) at 22<sup>nd</sup> Avenue North did not have a median of any kind, and the consultant recommended that a striped, center refuge island be installed due to the numbers of interacting trail users and motor vehicles at the crossing.

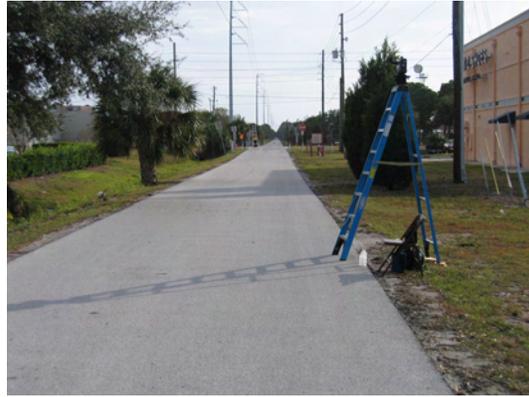
**Figure 6. Videotape data set up.**

The experimental design was to collect data of trail users before and after the installation of the RRFB. Videotape data were collected by a staff person from HSRC during several time periods before and after installation. A camera was set up on a stepladder beside the trail and several hundred feet from the actual trail crossing, and videotape was collected from both directions of travel (Figure 6). Data were collected at various times of the day on both weekdays and weekends when it was not raining.

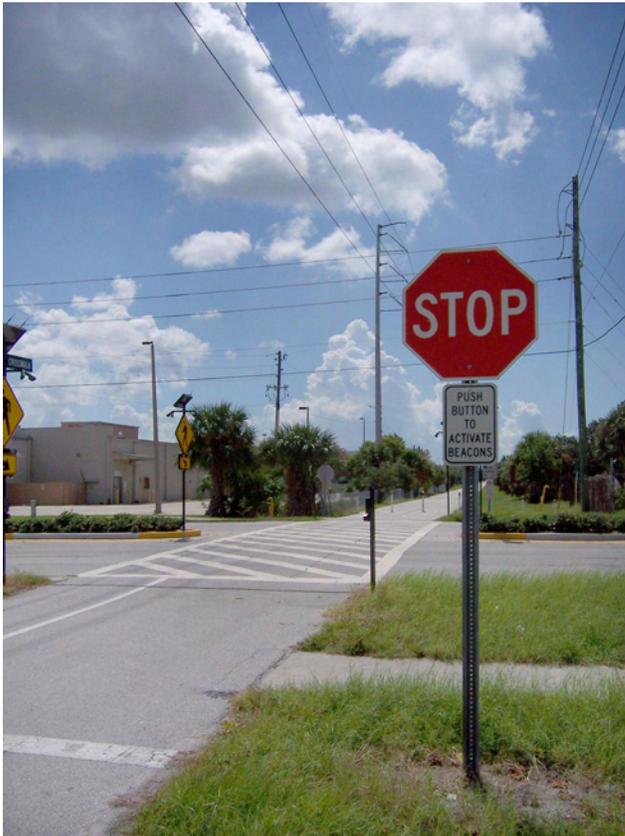
**Figure 7. Sign to remind users to push the button.**

While motorist yielding improved significantly after installation of the RRFB, an issue from the findings is why the motorist yielding was not greater. One factor is whether the button was pushed to activate the flashers. Based on the videotape analysis in the after period, it is interesting to note that 32% of the trail users pushed the button, 49% did not, and for 19% of the trail users the button had already been pushed. An examination of the on-scene observer after data indicated that many trail users were not pushing the button, and the city installed a sign to see if this would help (Figure 7.) However, not pushing the button remained a problem.

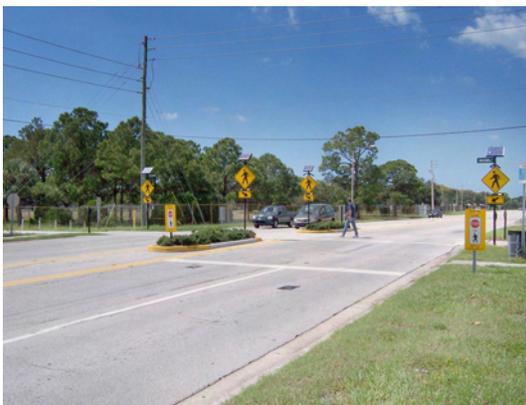
**Figure 8. Motorists yielding to trail user.**

When the button was pushed in the after period, the flashers were activated immediately. However, motor vehicles traveling along the street might be close enough to the crossing (i.e., in the dilemma zone) where stopping to yield would be difficult. These vehicles tended to pass through the crossing while the flashers were operational. Sometimes it appeared that trailing motor vehicles would simply “follow the leader,” even though it appeared they had adequate time to stop safely. In many cases it would take 5-10 seconds after the flashers were activated to get motorists to a complete stop, and this is reflected in the delay for the after period. It also appeared that motorists came to recognize that the flasher might be on after trail users had cleared the crossing, and the motorists would proceed on through the crossing without stopping if no users were present. This is a legal maneuver.
