## **On-Street Pedestrian Surveys of Pedestrian Crossing Treatments**

Transportation Research Board, Washington, D.C.

November 2003

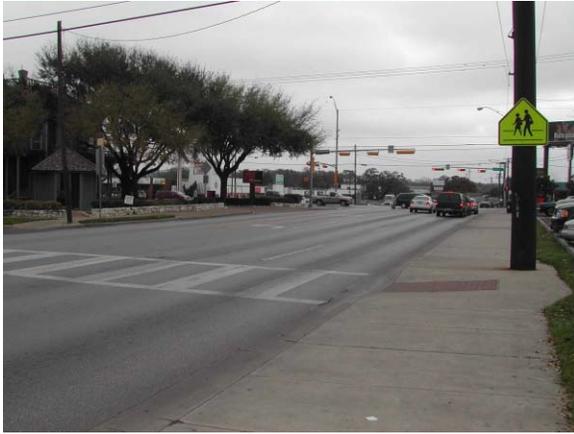
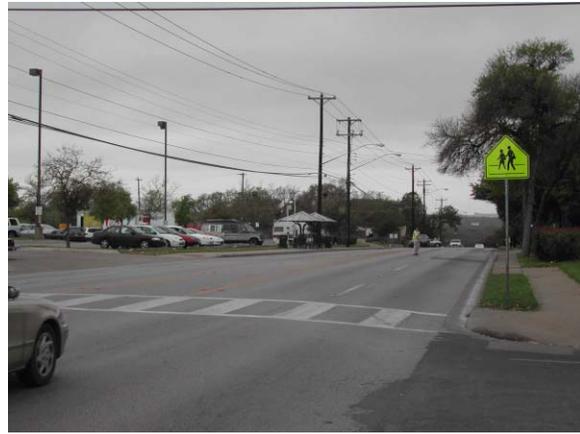
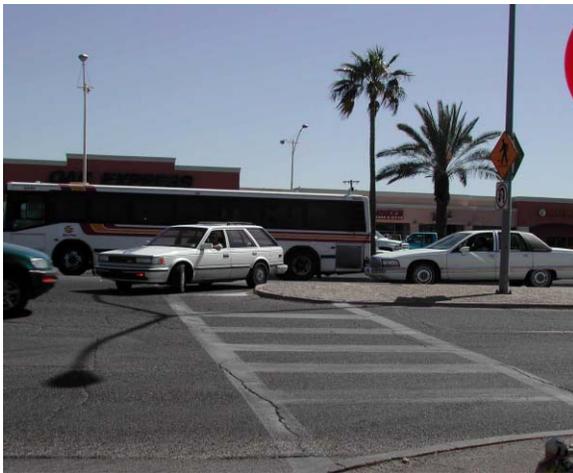
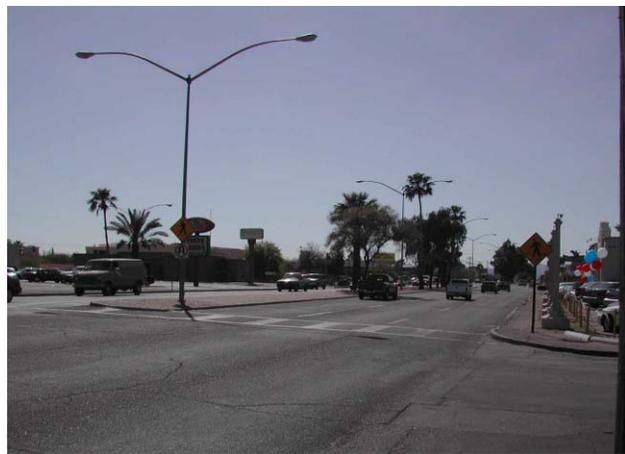
**FIGURE 1 Marked Crosswalk Treatments at Sites 1 and 2.**

Two marked crosswalk treatment sites were selected (See figure 1). They consisted of high visibility, laddle-syle pavement markings on the roadway to delineate the crossing area. Pedestrian crossing warning signs were present and faced in each direction.

Site 1 was a two-way, four lane roadway with a two-way left turn lane (TWLTL). The posted speed limit was 35 mph (56 km/hr) and the crosswalk was located about 200 ft (61 m) from a signalized intersection (see Figure 1a). There were transit stops on both sides of the street with benches and bus shelters. Figure 1b shows the location that a pedestrian would cross to the transit stop if crossing the road at the bus stop. The nearby land use consisted of a grocery store, a strip mall, an elementary school, and a medical building. The population surveyed consisted of transit-dependent individuals, disabled pedestrians, and college students.

Site 2 was a six-lane roadway with a raised median and left-turn bays in each direction (see Figure 1c). The posted speed limit was 35 mph (56 km/h) and the marked crossing was about 600 ft (183 m) from a signalized intersection. Transit stops were located on both sides of the major street, however the transit stop located on the south side is located approximately 150 feet (46 m) from the crossing in front of a strip mall, while the transit stop on the north side was about 400 feet (122 m) from the crosswalk. Site 2 was in a commercial area with nearby residential neighborhoods (see Figure 1d). The pedestrian population was primarily local residents who were utilizing the transit system.

Sites 1 and 2 had treatments that included a marked crosswalk and pedestrian crossing warning signs. The perspective of pedestrians at this type of crossing was that the crossing was unsafe. When asked if they thought the crossing treatment was safe and effective, 85 percent of the Site 2 participants and 66 percent of the Site 1 participants said no. Some of the primary reasons given for not feeling safe were:

At Site 1 specifically, it was felt that the location of the crosswalk made it ineffective because it was too far from the bus stop to encourage people to walk to the crossing. This was considered to be especially true since there was no “benefit” to using the crossing without some type of active system to warn drivers to watch for pedestrians.

One simple improvement that was mentioned at both locations was that the faded crosswalks should be repainted to improve their visibility to motorists. At Site 1, additional location specific suggestions included moving the crossing closer to the transit stop and adding a crossing guard (this was influenced by the close proximity of an elementary school).

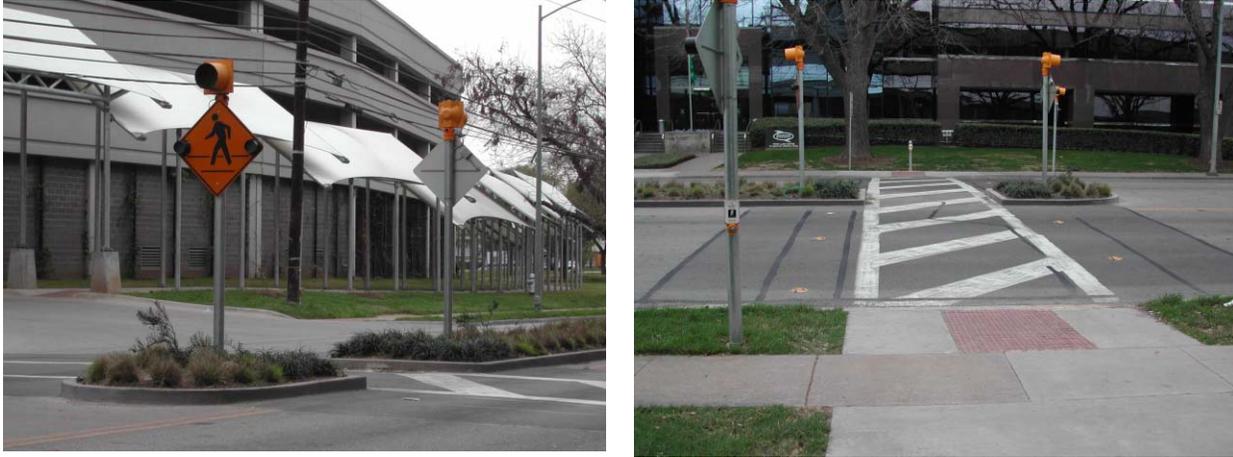
**FIGURE 2 In-Roadway Warning Lights Treatment at Site 3.**

Site 3 had pedestrian-activated in-roadway warning lights, diagonal (zebra) pavement markings, pedestrian crossing warning signs with flashing beacons, and a median refuge island (see Figure 2). This site was located between a large office complex and a parking garage and was primarily used by employees of the large office complex. The roadway at Site 3 had four-lanes with a raised median. The speed limit was 35 mph (56 km/h), and the crosswalk was located midblock.

In addition to a marked crosswalk, Site 3 had amber flashing lights on top of the pedestrian crossing warning signs and in the pavement along the crosswalk (see Figure 2). With the addition of the amber warning lights and in-pavement warning lights, pedestrian perception about safety was somewhat higher than if only a marked crosswalk existed. Nevertheless, the answers are still skewed to the negative side with over 60 percent of the participants rating the crossing as unsafe. However, even with the inclusion of so many additional features, pedestrians did not typically find the crossing to be confusing or hard to understand.

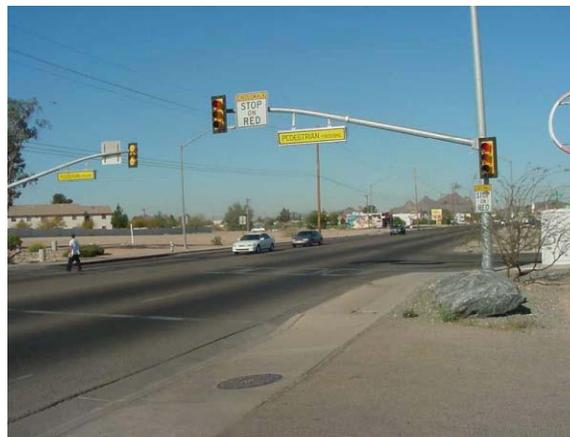
**FIGURE 3 Hawk Treatment at Site 4.**

The crosswalk treatment referred to as a “Hawk” is a pedestrian crossing signal that is activated by the pedestrian. Before activation the signal is dark. After activating the signal light progression is: flashing amber ball, solid amber ball, solid red balls, flashing red balls (wig-wag signal heads). The flashing red balls would permit stop and go vehicle operations during the flashing don’t walk interval if no pedestrians are in the crosswalk.

Site 4 was located on four-lane roadway with a two-way left turn lane and a bike lane on each side (see Figure 3). Ladder-style crosswalk markings were present at the crossing. The speed limit was 35 mph (56 km/h), and the pedestrian crossing signal was located at a transit center. As such, the majority of the pedestrian population at this site was transit dependent. With the exception of the transit center and a few small local businesses, the area was predominantly residential.

Site 4 had a Hawk pedestrian crossing treatment. With this type of a crossing treatment, the survey responses from the pedestrians have again moved towards a more positive perception of safety as the crossing treatment control has increased. At this location, 75 percent of the participants indicated that they felt safe at this crossing. Ninety-eight percent responded that the signal was not hard to understand. Although the general perception of this crossing was that the pedestrians liked the signals because they stopped the traffic, there was still the complaint that the unpredictability of the traffic was a concern (i.e. whether motorists would stop for the signal).

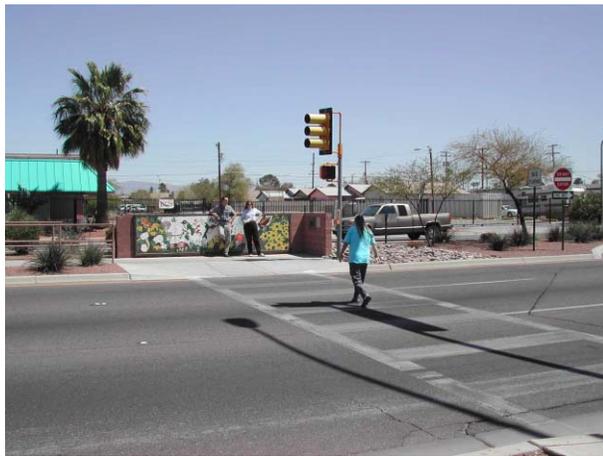
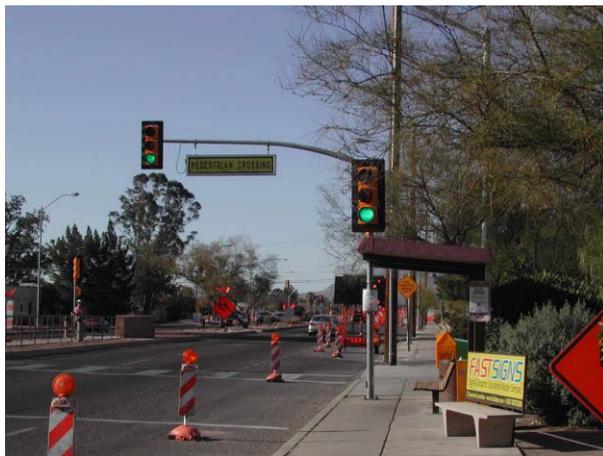
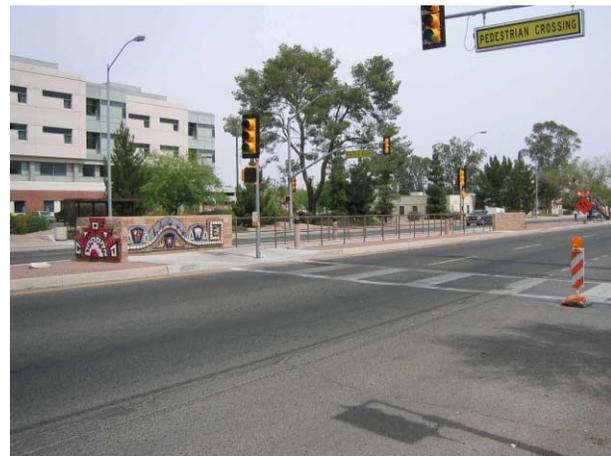
**FIGURE 4** Split Midblock Signal Crossing at Sites 5 and 6.

The Split Midblock Signal treatment uses a traffic signal configuration where a pedestrian uses a pedestrian signal button to activate the signal and cross the first half of the street, then proceed down a center refuge island approximately 100 feet (31 m) long to push a second pedestrian signal button and activate the second half of the pedestrian traffic signal. This treatment allows the stop time for each direction of traffic to be shorter than if one button activated the entire crossing. If one button activated the entire crossing then the walk indication would need to be timed to allow the pedestrian to cross both directions of traffic. The Split Midblock Signal permits the walk indication to be times uniquely for each direction.

Site 5 was a six-lane divided roadway with a raised center median (see Figure 4a). The speed limit was posted at 40 mph (64 km/h) and curbside transit shelters existed on each side of the roadway. The land use consisted of government supported housing and commercial properties (see Figure 4b). The apartment building provided housing to many disabled and older transit-dependent pedestrians who were surveyed as part of this study.

Site 6 was a six-lane divided roadway with three lanes in each direction and a raised median (see Figure 4c). The posted speed limit was 35 mph (56 km/h). A transit shelter existed on the southbound side, but the northbound transit shelter was temporarily relocated due to nearby roadway construction that was present while the on-street survey was conducted (see Figure 4d). The pedestrians surveyed consisted largely of medical center employees, as well as visitors to the medical center.

The traffic control provided at the Split Midblock Signal included a traffic signal along with a pedestrian median refuge island. In this situation, the reactions of the pedestrians at Site 6 were overwhelmingly positive with 78 percent of the pedestrians responding that the crossing is very safe. Site 5 responses were more diverse with an even spread of responses from very safe to unsafe. The researchers feel that the difference of perceptions between these two locations could be largely influenced by the type of pedestrian traffic in the area (see Table 2 for demographics). The feeling of safety is much lower for Site 5 which had an older population and more disabled pedestrians. Although Site 6 is located at the hospital, the pedestrians who were crossing the street were primarily hospital staff and visitors. The older and/or disabled people at this site are typically being dropped off prior to parking due to the long walk required between the parking lot and the hospital entrance.
