**PEDESTRIAN SAFETY
IMPACTS OF CURB
EXTENSIONS:
A CASE STUDY**

Final Report

SPR 304-321

Randal S. Johnson
Department of Civil, Construction & Environmental Engineering
Oregon State University
Corvallis, Oregon

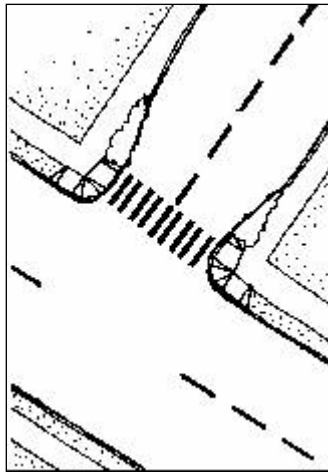
Figure 1.0: Curb extension diagram

When the intended purpose of curb extensions is for traffic calming, they typically extend into the travel lane to reduce speeds by narrowing the lanes. A series of curb extensions at intersection or mid-block locations is typically used to reduce speeds along a corridor. Bulbouts at intersections can reduce the speeds of turning vehicles and still maintain an adequate turning radius.

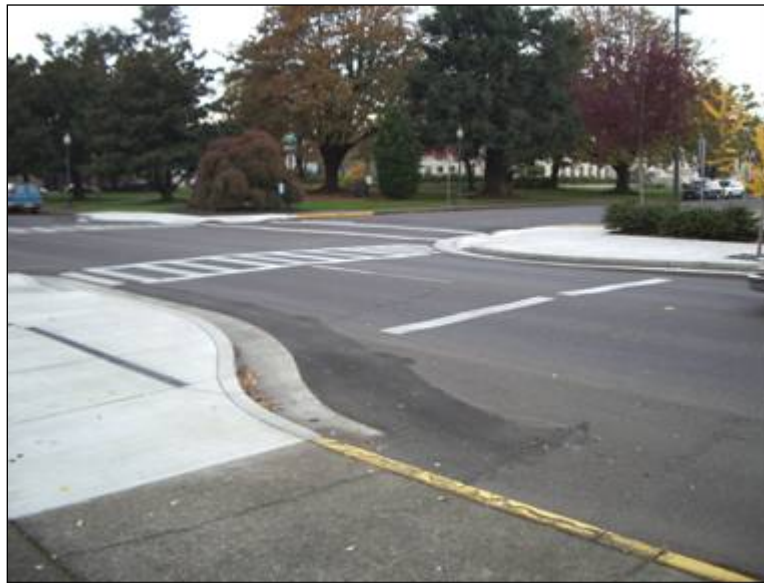
Figure 1.1: Crosswalk with continental marking and advance stop bars

The advance stop bars (Figure 1.1) are also evaluated in this study as a pedestrian safety feature. An advance stop bar is a stripe that is placed up to 20 or more feet upstream from the crosswalk.

A common pedestrian safety hazard that occurs on a one-way multi-lane street is when the motorist in the near lane yields at the edge of the crosswalk marking. This blocks the view of the pedestrian already in the crosswalk from the motorist in the far lane, often resulting in a failure to yield and an increase in the potential for a pedestrian-vehicle collision. This type of collision is known as a “multi-threat” collision (Zegeer, et al. 2001). The use of advance stop bars encourages the near lane driver to yield farther back from the crosswalk, thus maintaining a safe stopping sight distance for the motorist in the far lane.

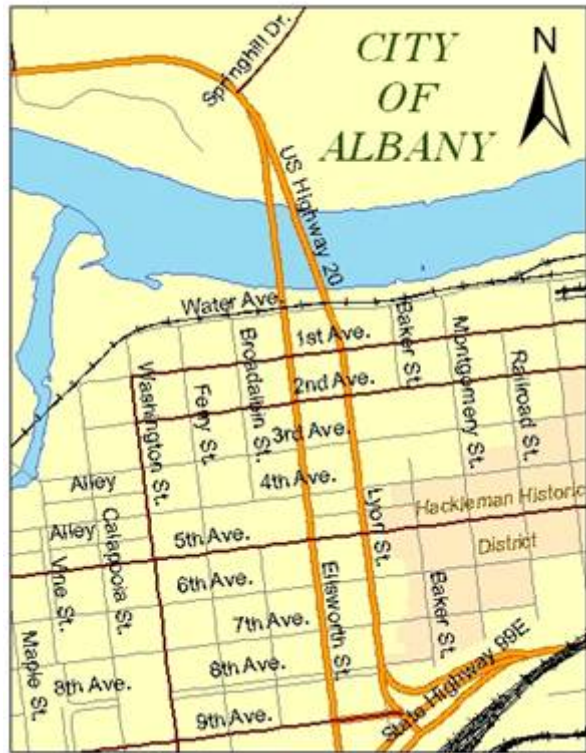
Figure 2.0: Study area: Albany, Oregon

The curb extension project includes the intersections of 4th and 5th Avenues along Ellsworth and Lyon Street. (Figure 2.0). Lyon (northbound) and Ellsworth (southbound) comprise a one-way couplet of U.S. Highway 20 through downtown Albany. Both streets have two travel lanes with on-street parking on both sides. All four intersections also have a no parking zone (yellow curb marking) of approximately 40 feet on all nearside approaches. There is no stop control along Highway 20 at these intersections, but there are stop signs on the approaches of 4th and 5th

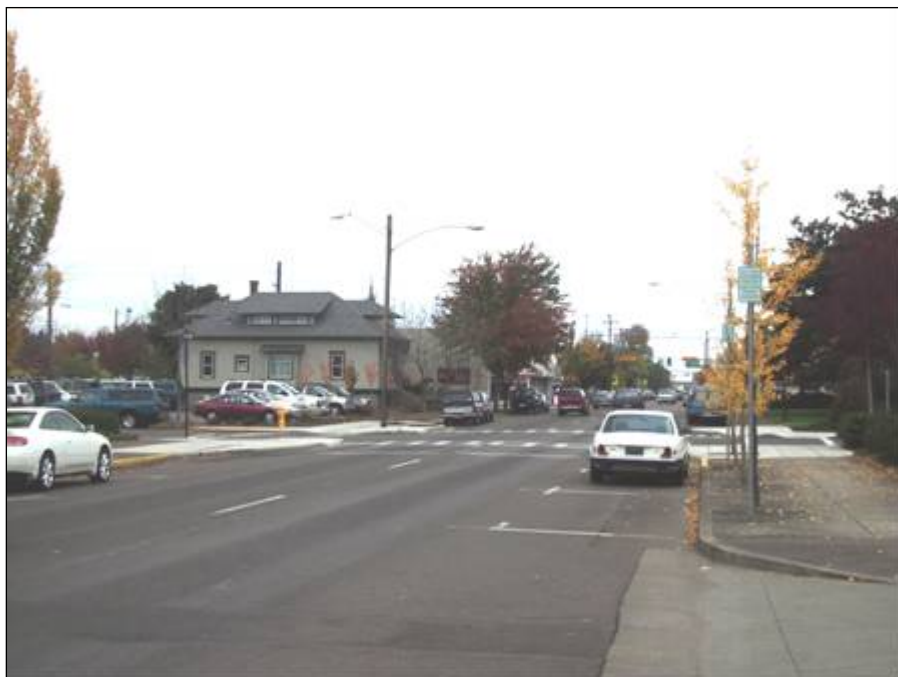
Figure 2.1: 4th Ave./Ellsworth St. facing south

The intersection of 4th Ave. and Ellsworth Street (Figure 2.1) has curb extensions on both the near and far side crosswalk on Ellsworth Street. Continental crosswalks with advance stop bars are located on the major crossings, while the minor crossings only have parallel lines. The close proximity of the government offices makes this intersection an important link to the downtown shopping area. Observations show that this link has the highest pedestrian volume in the study area, although an exact count was not determined.

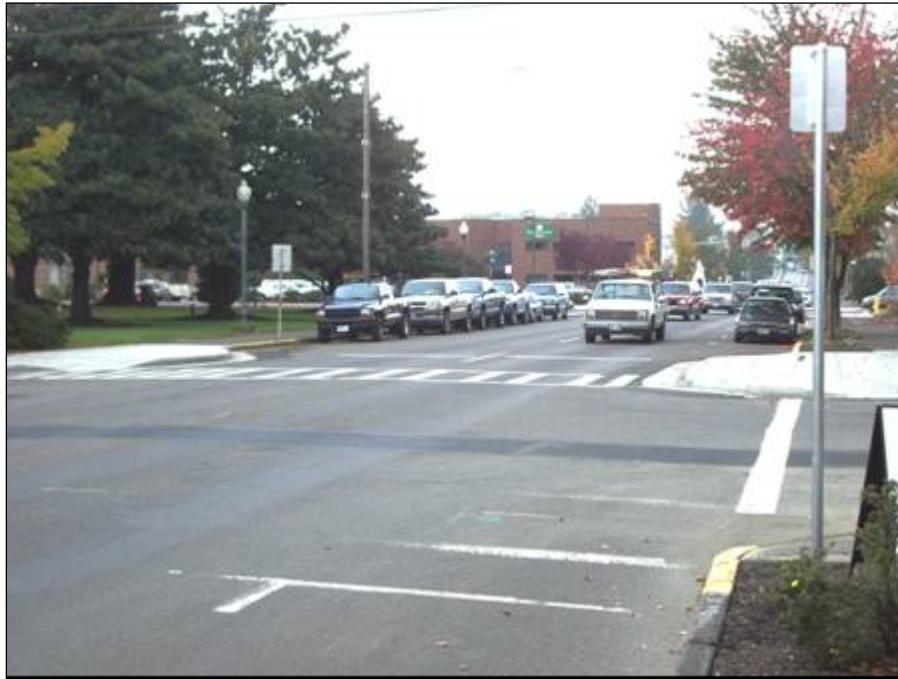
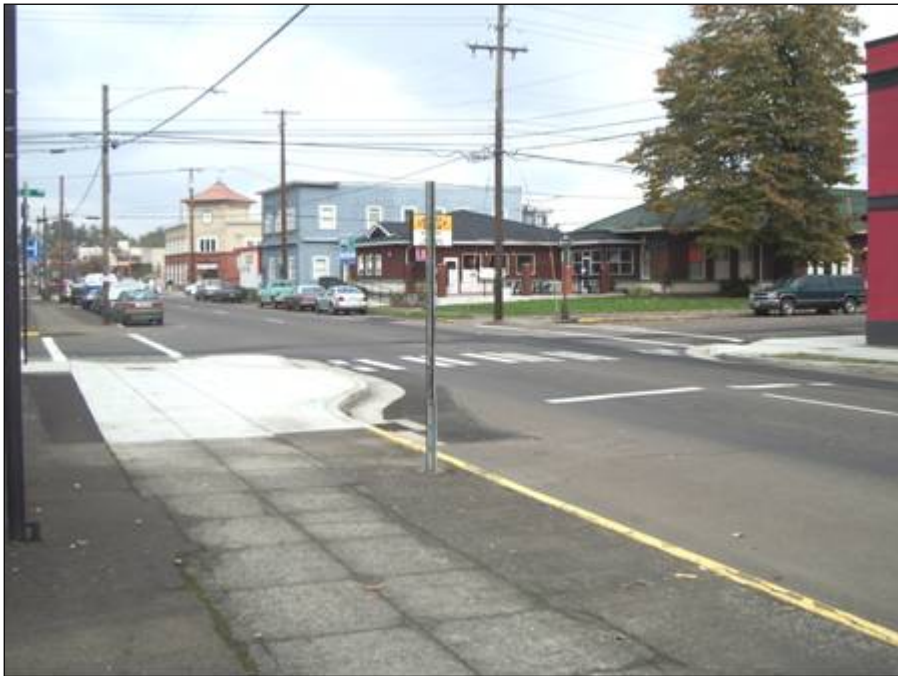
Figure 2.2: 5th Ave./Ellsworth St. facing north

Figure 2.3: 5th Ave./Lyon St. facing north

The 5th Avenue intersections at Ellsworth and Lyon (Figures 2.2 and 2.3) both only have near side marked crossings with curb extensions and advance stop bars. There are no curb extensions or marked crossings for the farside crosswalk. The minor crossings have parallel stripes.

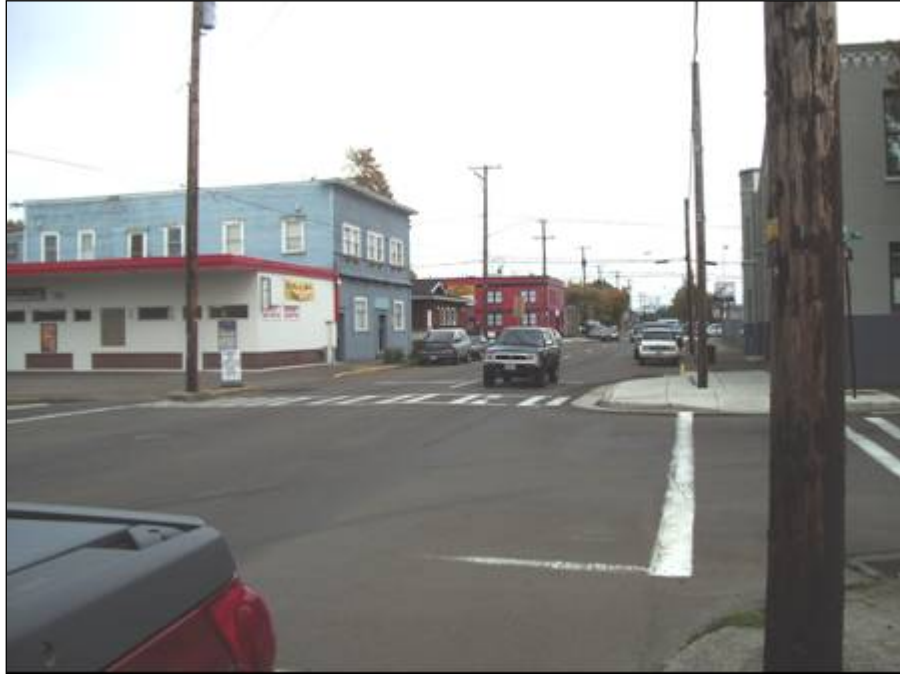
Figure 2.4: 4th Ave./Lyon St. facing south

This study focuses the research effort on the intersection of 4th Ave. and Lyon Street (Figure 2.4). The nearside crosswalk of this intersection provides for a unique treatment-and-control study opportunity. A curb extension has been installed at the west side of the crosswalk, but the east side has been left with the original curb line because a driveway is nearby. Similar to the intersections at 5th Avenue, the minor streets have parallel stripe markings with no curb extensions. There is also no marked farside crosswalk on Lyon Street. Pedestrian attractors for this crosswalk include the Old Armory Building, which serves as a meeting hall, located at the west end of the crosswalk and a liquor store and bank, located east of 4th and Lyon. This intersection also provides a link between the Hackleman Historic District and the downtown sector.

The nearside crosswalk at 4th Avenue and Lyon Street allowed for a comparison of pedestrians crossing from the curb extension side and those crossing from the side without a curb extension. This unique crossing also allowed for the evaluation of advance stop bars with and without a pedestrian waiting on a curb extension. This comparison also benefited from the same motorist population, continental marking, and visual environment.

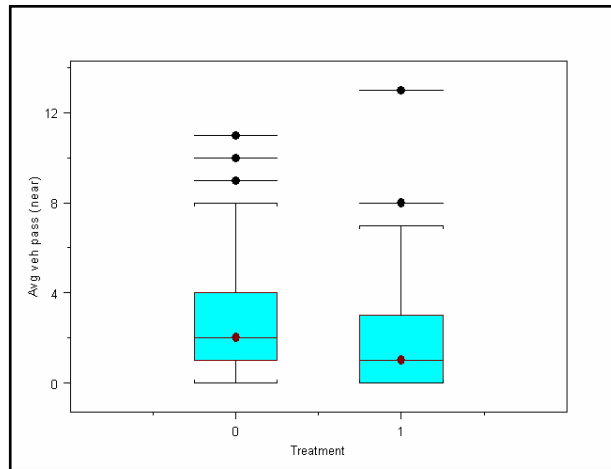
Figure 3.0: Number of vehicles that pass in NEAR lane before pedestrian-cross

Figures 3.0 and 3.1 show the spread of the number of vehicles that passed before a crossing in the near and far lanes respectively. In both lanes the treatment (curb extension) side had a lower mean, but they also had the overall highest number of vehicles that passed before a pedestrian cross. These high values seem to be a random event, because the observations showed that the pedestrian was in plain view and there were no other factors that were different from other crossings.

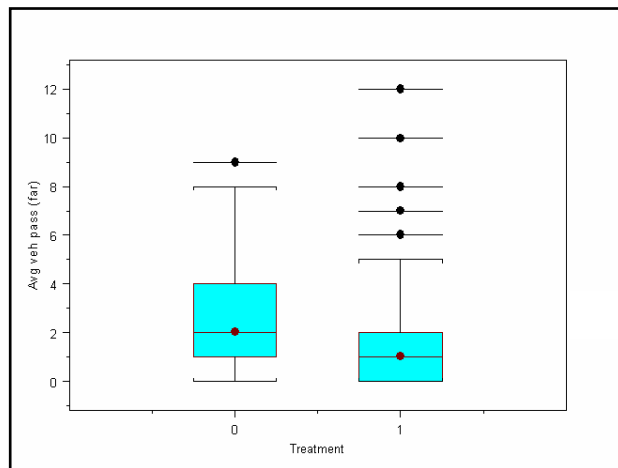
Figure 3.1: Number of vehicles that pass in FAR lane before pedestrian-cross
