**A FIELD STUDY TO EVALUATE PERMEABLE PAVEMENT
SURFACE INFILTRATION RATES, RUNOFF QUANTITY,
RUNOFF QUALITY, AND EXFILTRATE QUALITY**

A thesis submitted to the Graduate Faculty of
North Carolina State University
In partial fulfillment of the
Requirements for the Degree of
Master of Science

BIOLOGICAL AND AGRICULTURAL ENGINEERING

2005

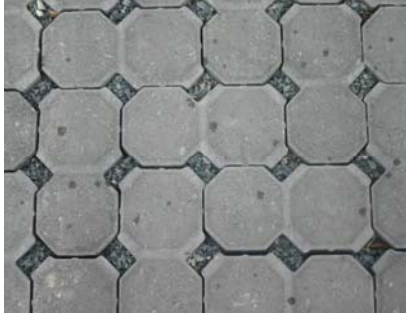
Figure 1a. PICP

Figures 1a, 1b, and 1c show examples of Concrete Grid Pavers (CGP), Permeable Interlocking Concrete Pavers (PICP), and Porous Concrete (PC). Photoanalysis, a procedure that uses close-up photographs of surfaces was applied to determine the percent of a permeable pavement surface area that was impermeable due to the pavement block. The remaining surface area was considered to be the open or void area. CGP paving systems are comprised of concrete blocks with internal voids and gaps between the blocks. Photoanalysis determined that CGP surface was approximately 30% open, or void. In this study, the sites examined had voids filled with either sand or No. 78 stone, ASTM D448 (ASTM, 2003b). PICP are concrete block pavers that, when installed, have voids located at the corners and midpoints of the individual pavers. Photoanalysis determined that a PICP surface was at least 9% open, or void. Most previous and recent research conducted on permeable pavements focused on PICP systems (Balades et al., 1995; Pratt et al., 1995; Gerritts and James, 2002). PC is different from standard concrete, in that fine aggregate has been removed from the mix, allowing interconnected void spaces to form during curing.

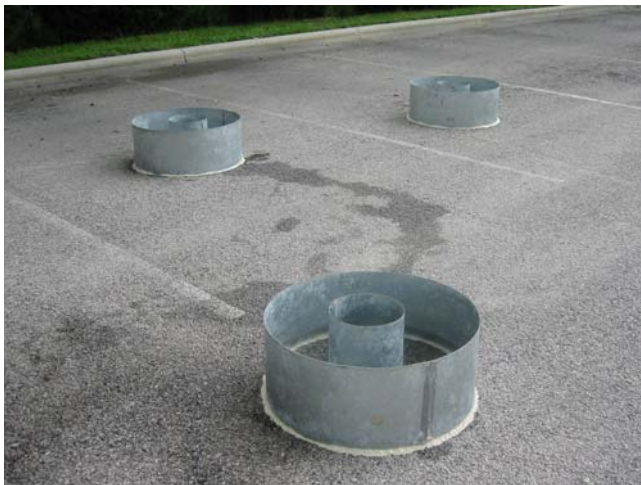
Once locations were selected for testing at each site, the inner ring was sealed to the test surface. A thin ribbon of putty, about 40 mm (1.5 in.) wide, was molded along the bottom edge of the inner ring. The ring was then placed putty side down and pressed to the surface. The putty was depressed to form a tight seal between the surface and the ring. The inner ring was then filled with water to a depth of approximately 50 mm (2 in.) above the testing surface to determine if any leakage to the outer ring existed, and whether hydraulic head would be maintainable during a Double-Ring Infiltrometer Test (DRIT). A hydraulic head was determined to be maintained if the water level rose while dispersing water into the rings using a submersible pump with a maximum flow of 1.6 l/s (25 gal/min). If hydraulic head was maintained during the trial, then a DRIT was conducted on the surface. The outer infiltrometer ring was sealed to the surface using putty in the same manner as the inner ring. The outer ring was then filled to a depth of approximately 50 mm (2 in.) above the testing surface to determine if any leakage from the outer ring formed that could not be compensated. Figure 2 shows three DRITs conducted simultaneously.

Figure 2. Typical arrangement and setup of double-ring infiltrometers at a site.

Once all leaks, if any, were plugged or manageable, both the inner and outer rings were filled to a depth between 125 mm (5 in.) and 175 mm (7 in.). The initial level of water in the inner ring,

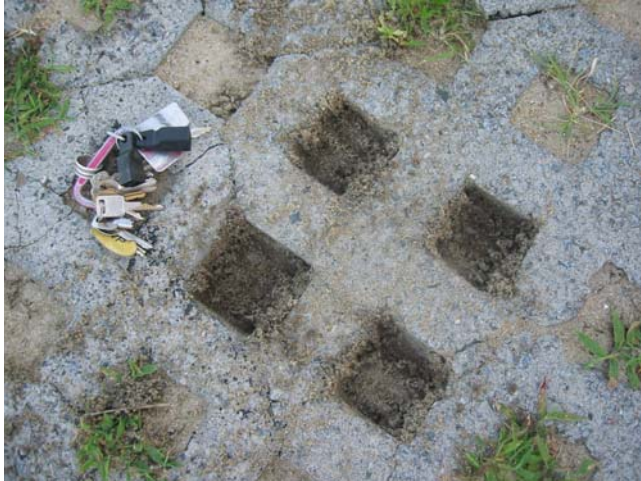
One goal of this study was to compare existing condition surface infiltration rates to simulated maintained condition surface infiltration rates for concrete grid pavers (CGP). At each CGP site three tests were conducted under existing conditions. After simulated maintenance three additional tests were conducted in different locations. An “existing” test was defined to be a surface infiltration test where the paver surface remained unaltered prior to the surface infiltration test. A “simulated maintenance” test was a surface infiltration test conducted where between 13 mm (0.5 in.) and 19 mm (0.8 in.) of void material was removed to simulate maintenance by a street sweeper (Stevens, 2001). Figure 3 displays a maintained CGP location. If the measured existing surface infiltration rates of a site were lower than 25 cm/h (10 in/h), a simulated maintenance test was conducted.

Figure 3. CGP surface after simulated maintenance was performed.

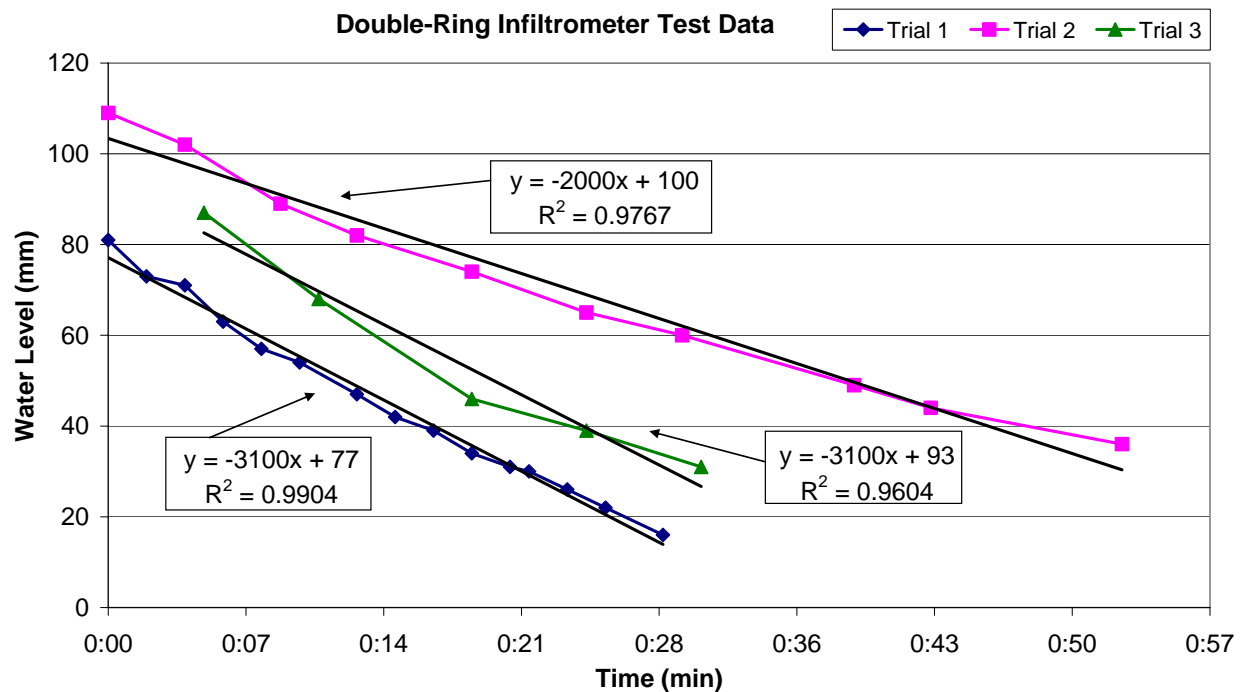
After data were collected, the water levels were plotted as functions of time for each surface infiltration test (Figure 4). The infiltration rate is equivalent to the maximum-steady state or average incremental infiltration velocity (ASTM, 2003a). Therefore, the slope of the least squares line for each test was determined to be equal to the surface infiltration rate of the tested surface. Furthermore, if it was determined that removing the initial two or three water level and time recordings from a test's dataset caused the least squares line to be more representative of the surface infiltration rate, then those initial data points were omitted from the calculation of the least squares line. The stated surface infiltration rate for each site was determined by averaging the results from the three test locations.

Figure 4. Typical graph of double ring infiltrometer inner ring depths with corresponding times from three surface infiltration tests at one site. Linear regression lines were applied to the data to determine the surface infiltration rate. data and regression lines.

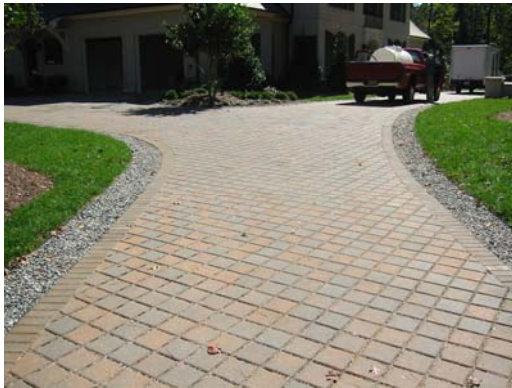
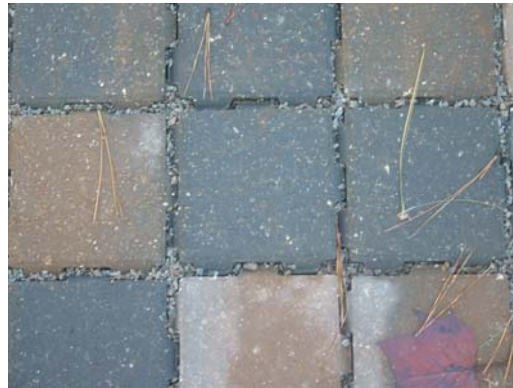
(ASTM, 2003), with a 5 cm (2 in.) layer of No. 78 stone between the two layers (Appendix A 25). Photo-analysis was used to determine that open, or void, space of PICP in Figure 2b was approximately four percent (4%) of the surface area. The storage basin under the pavers was divided into two separately drained basins of 185 m² (1996 ft²) and 243 m² (2619 ft²). Clay loam soil infiltration rates are typically too low for drainage basins to recurrently empty before subsequent rainfall events. Therefore, one 10 cm (4 in) corrugated plastic pipe drained each of the drainage basins. An ISCO 674[®] tipping bucket rain gauge connected to a data logger recorded precipitation rates. The storage basin, or pavement support layer, was lined with an impermeable geo-textile to prevent deep seepage and shrink/swell associated with some clay soils.

Figures 2a and 2b. Cary monitoring site and close up of the PICP surface.

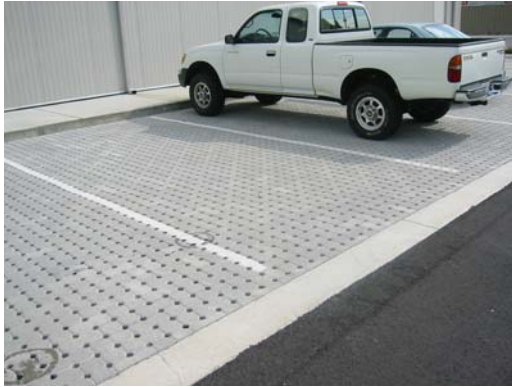
surface area. The 8 cm (3 in.) thick UNI[®] Eco-stone[®] pavers overlaid 8 cm (3 in.) of No. 72 stone, which were, in turn, laid over 20 cm (8 in.) of washed No. 57 stone (ASTM, 2003) (Appendix A 16).

Figures 3a and 3b. Goldsboro monitoring site and close up of the PICP surface.

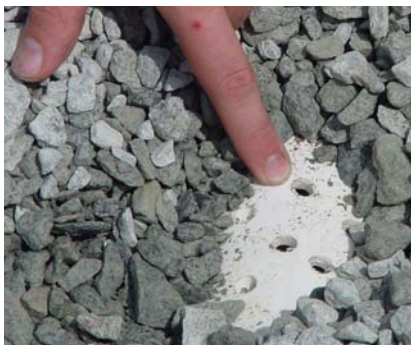
An 8 cm (3 in) PVC pipe was installed under a section of the PICP during construction for exfiltrate sample collection. Holes were cut into the pipe to allow infiltrate to fill the pipe (Figure 4). The pipe drained approximately 120 m² (1300 ft.²) of PICP (Appendix C) and was capped by a hand valve. To capture asphalt runoff, the drive path was graded so that runoff would flow towards a metal channel, where water samples were collected by a Sigma 900TM automated sampler on a temporal basis.

Figure 4. PVC drainpipe with infiltrate holes installed under PICP in stone layer at the Goldsboro site.

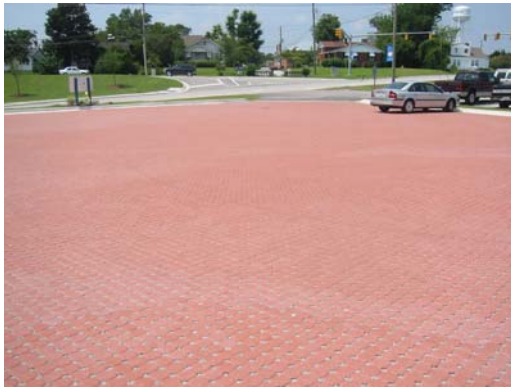
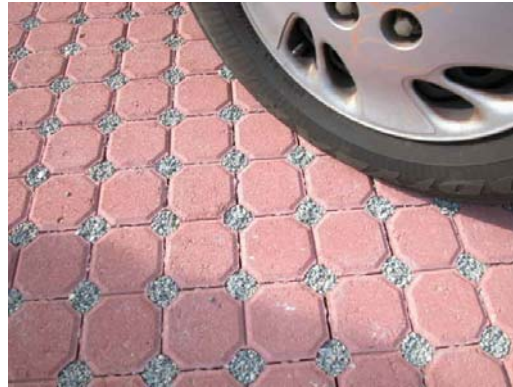
Figures 5a and 5b. Swansboro monitoring site and close up of PICP at the site.

The eastern-most site, Swansboro, was a public parking lot (Figure 5a) constructed in the fall of 2003 with an area of 740 m² (8000 ft²) (Appendix D). Eight (8) cm (3 in.) thick UNI[®] Eco-stone[®] pavers overlaid 8 cm (3 in.) of No. 72 stone, which overlaid 20 cm (8 in.) of washed No. 57 stone (ASTM, 2003) over an in-situ sandy soil (Appendix A 20). By photo-analysis, open space of PICP in Figure 5b was approximately nine percent (9%) of the surface area. The site was slightly sloped (0.4%) so that runoff would flow to a concrete swale, which emptied into a weir box to measure runoff rates. An 8 cm (3 in) PVC drainpipe was installed in the drainage basin during construction to collect exfiltrate for water quality analysis. A hand valve, which opened for sample collection and drainage, capped the drainpipe. The site was constructed to collect runoff and exfiltrate samples for water quality from PICP and monitor rainfall intensities and runoff rates.

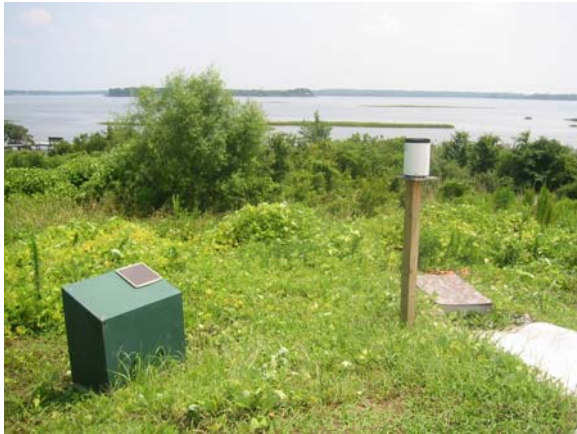
Figure 6. Swansboro monitoring layout from left to right: housing for sampler and bubbler, rain gage, weir box, and runoff spillway.

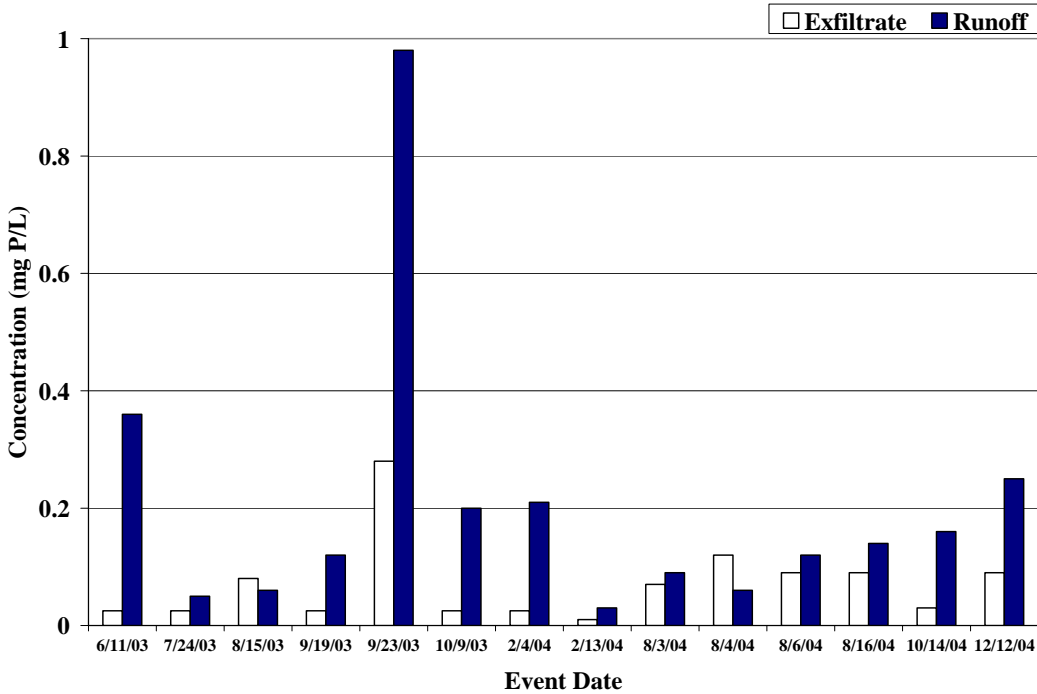
The last seven runoff samples analyzed may express a trend of seasonal variation as determined by May et al (2001). Phosphorus is bound in the late spring and early fall by plant uptake and then released during the winter months (May, 2001) during die off.

Figure 10. TP concentrations for asphalt runoff and PICP exfiltrate from Goldsboro from June 2003 through December 2004.
