Evaluation of Innovative Bike-Box Application in Eugene, Oregon

William W. Hunter

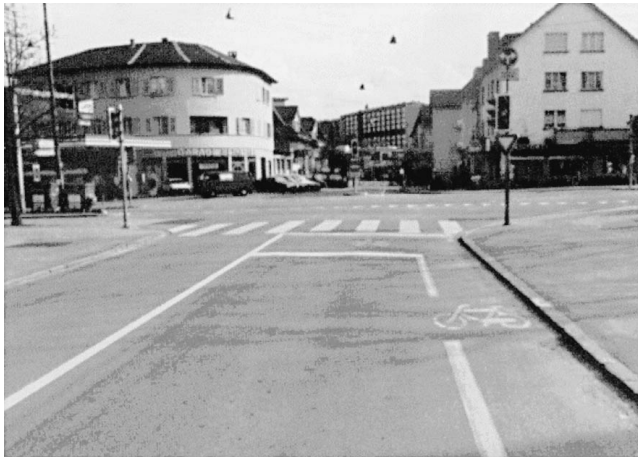
“Bike box” is the term that has gained popularity in the United States for a European treatment usually known as the advanced stop bar (Figure 1). The box is a right angle extension to a bike lane (BL) at the head of the intersection. The box allows bicyclists to get to the head of the traffic queue on a red traffic signal indication and then proceed first, before motorized traffic, when the traffic signal changes to green. Such a movement is beneficial to bicyclists and eliminates conflicts when, for example, there are many right-turning motor vehicles next to a right-side BL. Being in the box, and thus at the front of the traffic queue, also tends to make bicyclists more visible to motorists.

FIGURE 1 European bike box.

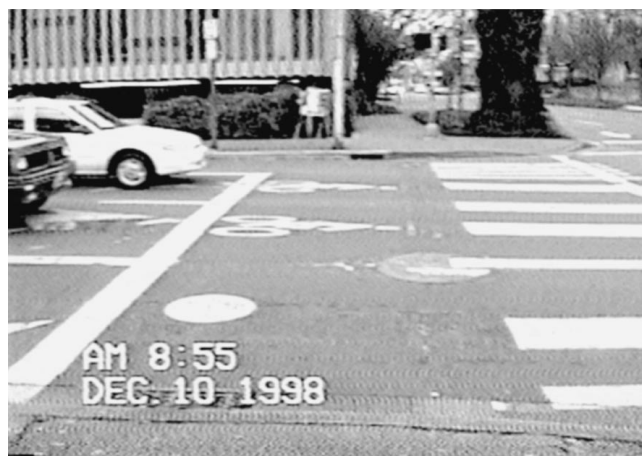
It was determined through observation that the box should be lengthened for the purpose of promoting understanding and visibility by motorists and easier use by bicyclists. This was accomplished by removing about 1 m of the pedestrian crosswalk. The original layout by the paint crew also had traffic lane lines within the box, rather than a large rectangular box in front of two traffic lanes. This was corrected when the box was enlarged, but the result was a box that extended across all three lanes. This was not ascertained until some time later, and the decision was made to leave this configuration in place. Thus, this evaluation pertains to a bike box that extended across all three travel lanes on the street (Figure 4). While the bike box should have been extended in front of only the combination through/right-turn lane, and not in front of the right-turn-only lane, bicyclists tended to use the box correctly anyway (i.e., positioning themselves in front of the combination lane). Thus, the evaluation was not jeopardized. (Note: When the evaluation ended, the bike box was reconfigured to extend across only two traffic lanes.)

FIGURE 4 Enlarged bike box extending across all three lanes of traffic.

The original configuration of the bike box was relatively short in length, about 1.8 m. A standard bicycle logo was placed in the box in front of both the through lane and through/right lane.

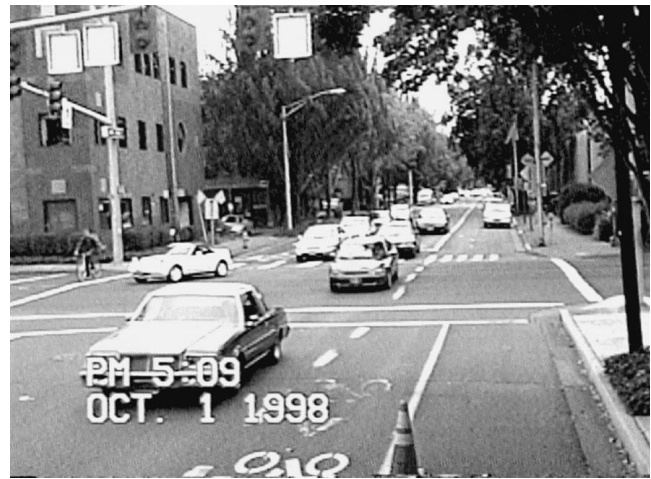
The location of the conflict was also coded. In the before period, two conflicts occurred within the intersection proper (one while bicyclists were crossing from left to right in the crosswalk and one while bicyclists were approaching from the right in the road) and eight after the intersection. The eight conflicts after the intersection involved the bicyclist crossing from left side to right side BL. In the after period, two occurred before the box, six within the intersection proper, and two after the intersection. No conflicts occurred while bicyclists were using the bike box as intended (i.e., approaching from left side BL and then moving into the box). It appeared that the bicyclists were able to gauge the timing of the signal quite well. One conflict in the after period occurred when a bicyclist was crossing from left to right in the crosswalk and the signal changed from red to green. Three of the after period conflicts resulted from bicyclists approaching from the sidewalk on the right hand side of the street, continuing straight ahead, and then crossing in the Seventh Avenue pedestrian crosswalk. This placed the bicyclist in a position where he or she was difficult to be seen by motor vehicles making a right turn, particularly motor vehicles turning right from the combination through/right lane in the middle (Figure 6).

**FIGURE 6** Conflict when bicyclist comes off right sidewalk and onto street.

moving from left to right across the travel lanes after the intersection. Two of the 10 conflicts in the after period were of this type. Six after conflicts took place within the intersection proper, but three of these involved bicyclists coming off the right sidewalk and conflicting with right-turning motor vehicles. No conflicts took place while bicyclists were using the bike box in the normal sense.
