# Effects of Bicycle Boxes on Bicyclist and Motorist Behavior at Intersections

The City of Austin Bicycle Team  
Jeff Loskorn, Alison Mills, John Brady, Jen Duthie, Randy Machemehl  
Center for Transportation Research  
The University of Texas at Austin  
Phone: (512) 471-4541, Fax: (512) 475-8744  
Email: [jloskorn@gmail.com](mailto:jloskorn@gmail.com)

Report Submitted August 2, 2010

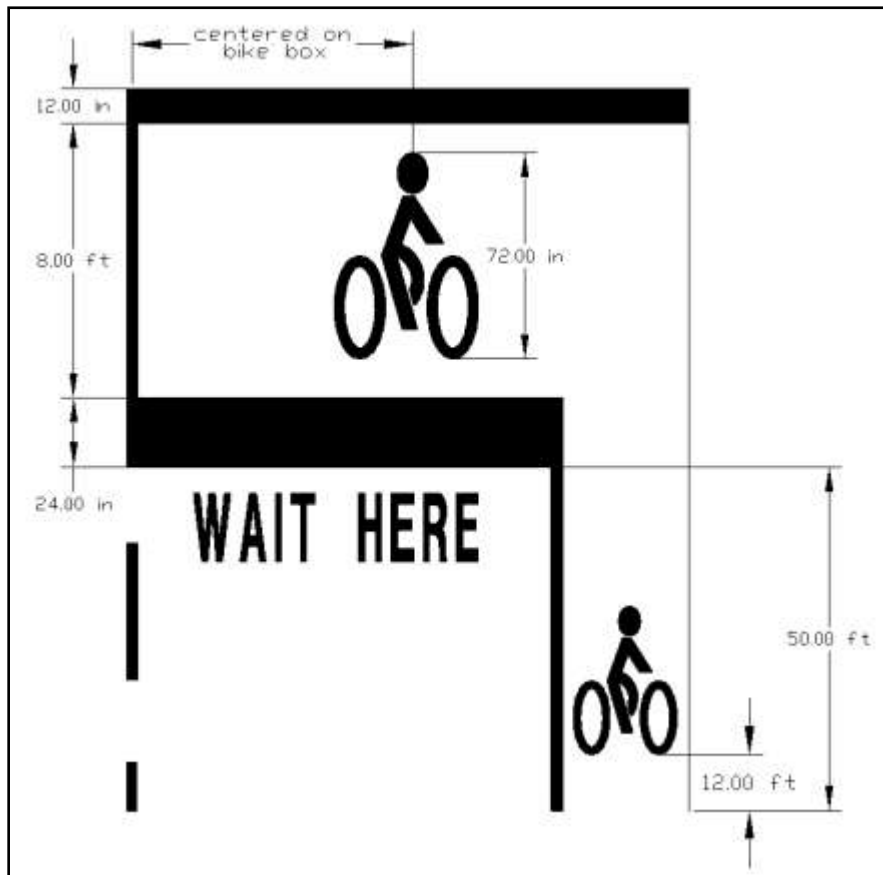
**Figure 1. Dimensions of bicycle box**

The dimensions of the bicycle box are shown in Figure 1. The bicycle box consists of a 24-inch advanced stop bar and an eight foot deep box (based on bicycle box measurements in Eugene, Oregon) containing a bicycle symbol. Before bicycle box installation, both intersections studied in Austin had the motorist stop line set back 4.5 feet from the crosswalk (measurement taken between the painted lines). After bicycle box installation, this distance increased to between 8 and 8.5 feet. "Wait Here" is painted on the roadway to instruct motorists to wait at the stop bar. The cost of the "Wait Here" symbol is \$267.66. Cold thermoplastic material was purchased at \$4.46 per square foot and was used for the box and approaching bicycle lane. As recommended by the National Committee on Uniform Traffic Control Devices (NCUTCD), a chartreuse (or strong yellow green) color was used. The material is embedded with corundum for traction. In addition, bicycle symbols were installed at the beginning of the green thermoplastic and in the middle of the bicycle box. Each symbol costs \$98.21. Given these numbers, an eight foot deep bicycle box in a ten foot wide lane costs \$1596.92 in materials.

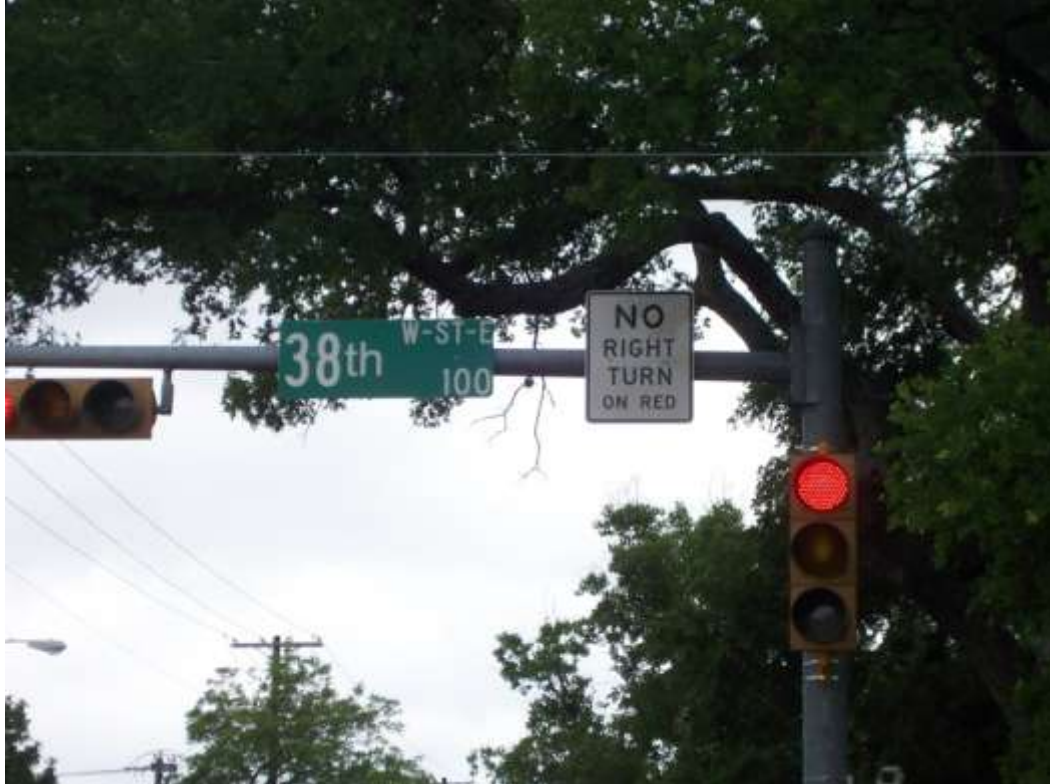
**Figure 2. The "No Right Turn On Red" sign installed at 38th Street**

Additionally, "No Right Turn on Red" signs were installed when the color was added to the bicycle boxes in attempts to prevent motorists from encroaching on the bicycle box and to further prevent right-hooks, where a right turning motorist sideswipes a bicyclist traveling straight through the intersection. The "No Right Turn on Red" sign installed at Speedway and at 38th Street is shown in Figure 2.

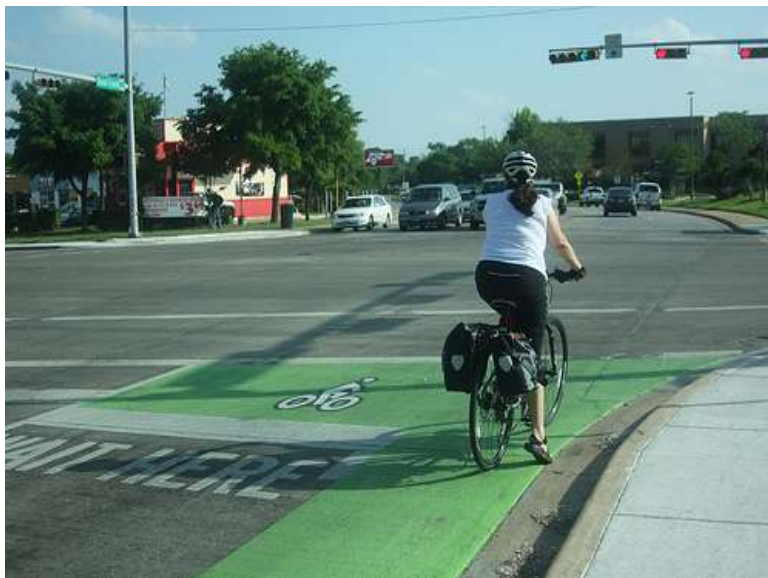
**Figure 3. The bicycle box on Shoal Creek Boulevard at Anderson Lane**

A bicycle box was installed on Shoal Creek Boulevard heading south to alert motorists of the presence of bicycles at the intersection and give bicyclists the right-of-way as they transition from the bicycle lane to the stretch of roadway where the bicycle lane ends briefly. Figure 3 shows the colored bicycle box and Figure 4 shows a map of the intersection and the location of the bicycle box.

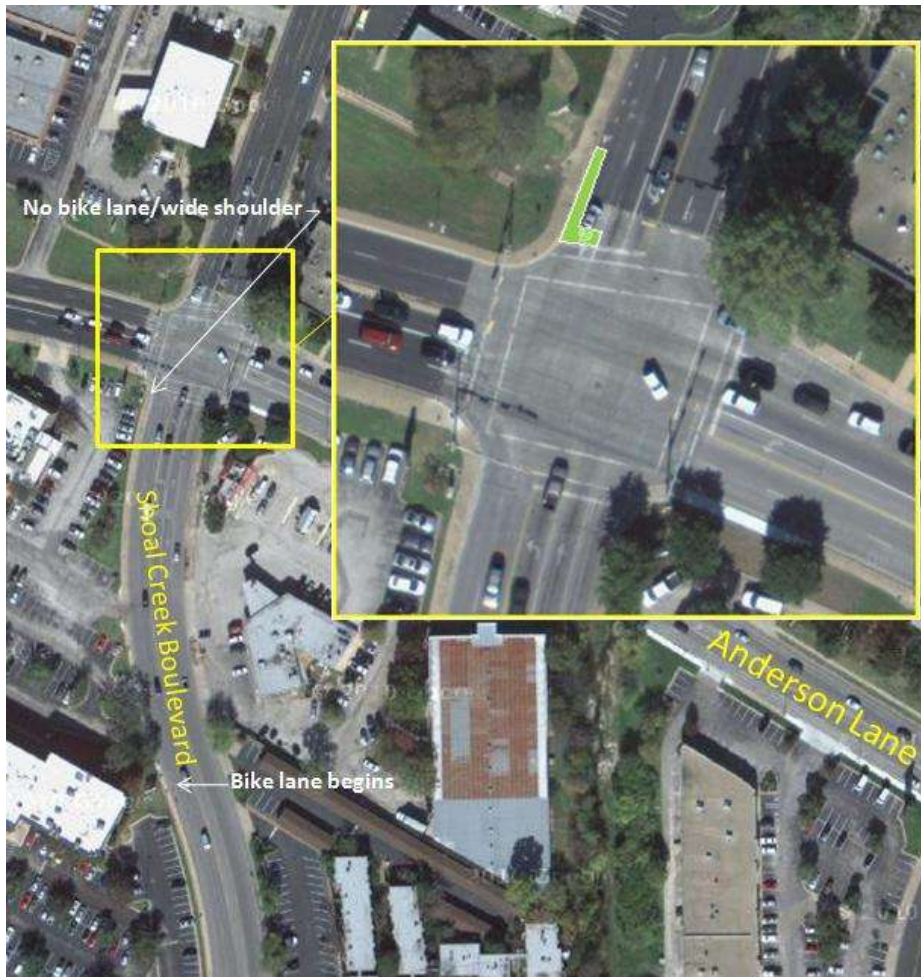
Figure 4. The intersection of Shoal Creek Boulevard and Anderson Lane

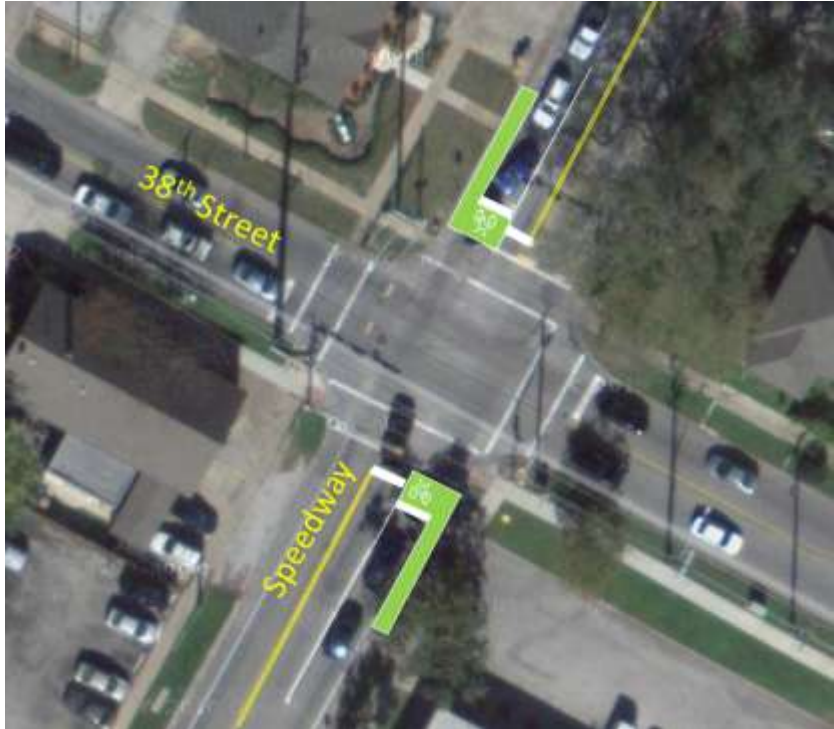
**Figure 5. The intersection of Speedway and 38th Street**

Speedway is primarily a one lane street that runs north-south through The University of Texas and connects the Hyde Park area with campus. Bicycle lanes in both directions make this facility attractive to many students living north of campus. Bicycle boxes were installed on both sides of Speedway at 38th Street to alert motorists to the presence of bicycles at the intersection and give them the right-of-way. The researchers hypothesized that bicyclists would be less likely to use the bicycle box at this location because the bicycle lane continues on the downstream side of the intersection. Data was collected on northbound Speedway during afternoon hours as students departed the university. A map of the intersection and the location of the bicycle boxes is shown in Figure 5. The posted speed limit is 25 mph and the observed hourly traffic volumes ranged from 150 vph to 250 vph in the afternoon.

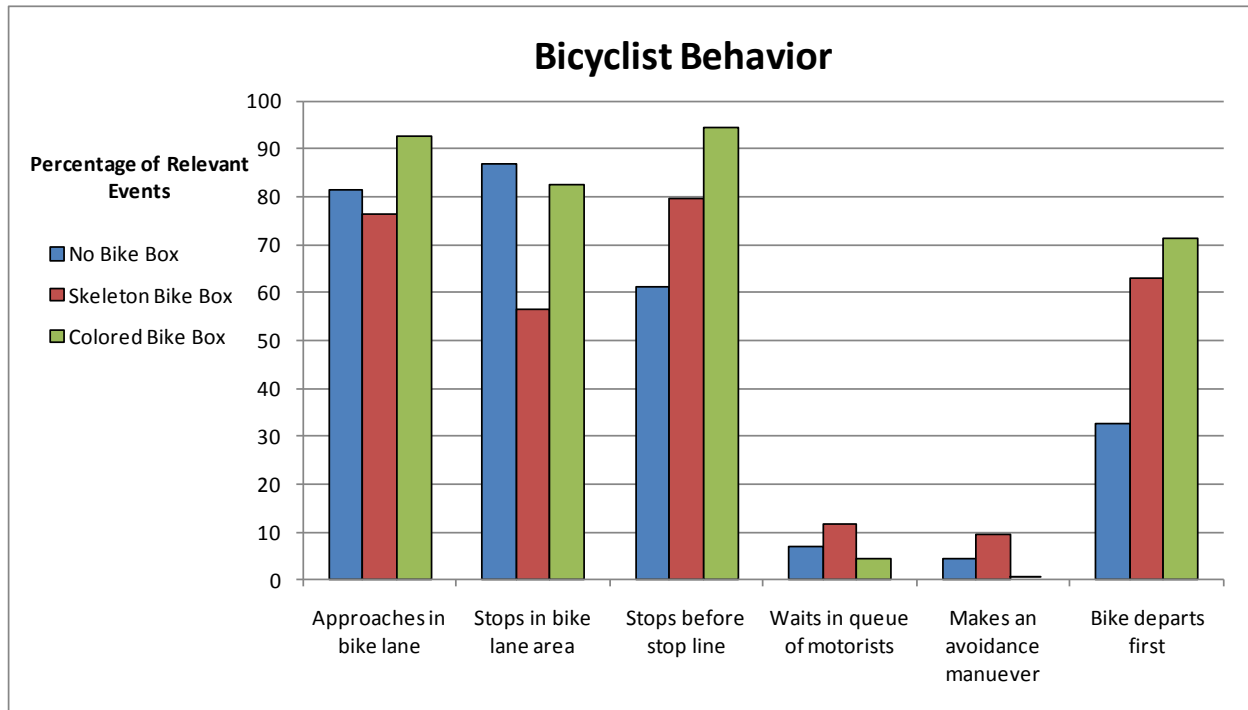
**Figure 6. Bicyclist behavior on Shoal Creek Boulevard and Anderson Lane**

Figure 6 shows the changes in bicyclist behavior before the bicycle box existed, after the skeleton bicycle box was installed, and after the chartreuse color was added. The percentage of bicyclists who approached the intersection in the bicycle lane remained about the same after the bicycle box skeleton was installed. However, after the color was added to the bicycle box the percentage of bicyclists who approached the intersection using the bicycle lane significantly increased from 77% to 93% ( $p = 0.001$ ). This may suggest that the colored lane leading to the bicycle box encourages bicyclists to approach in the bicycle lane rather than the full lane.

The proportion of bicyclists that stopped before the stop line increased significantly after each phase of bicycle box installation as shown in Figure 6. This suggests that the bicycle box skeleton and added color were successful in encouraging bicyclists to stay behind the stop line within the bike box area. The percentage of bicyclists that departed first at the intersection also steadily increased after each phase of installation. This increase proved to be more significant from the before condition to the skeleton bicycle box condition than from the skeleton bicycle box condition to the implementation of color ( $p < 0.001$  versus  $p = 0.267$ ). This could indicate that the presence of the bicycle box causes motorists to be more aware of the presence of bicyclists and are letting them depart first. However, the higher percentage of bicyclists departing first may simply be attributed to the fact that the motorist stop bar is advanced four feet further from the intersection when the bicycle box is in place than under the original conditions. Even though bicyclists are stopping further back from the intersection (because they are encroaching on the crosswalk less frequently), right-turning and through-movement motorists are stopping even further back (behind the advanced stop line) and are often allowing the bicyclists to pull into the intersection first.

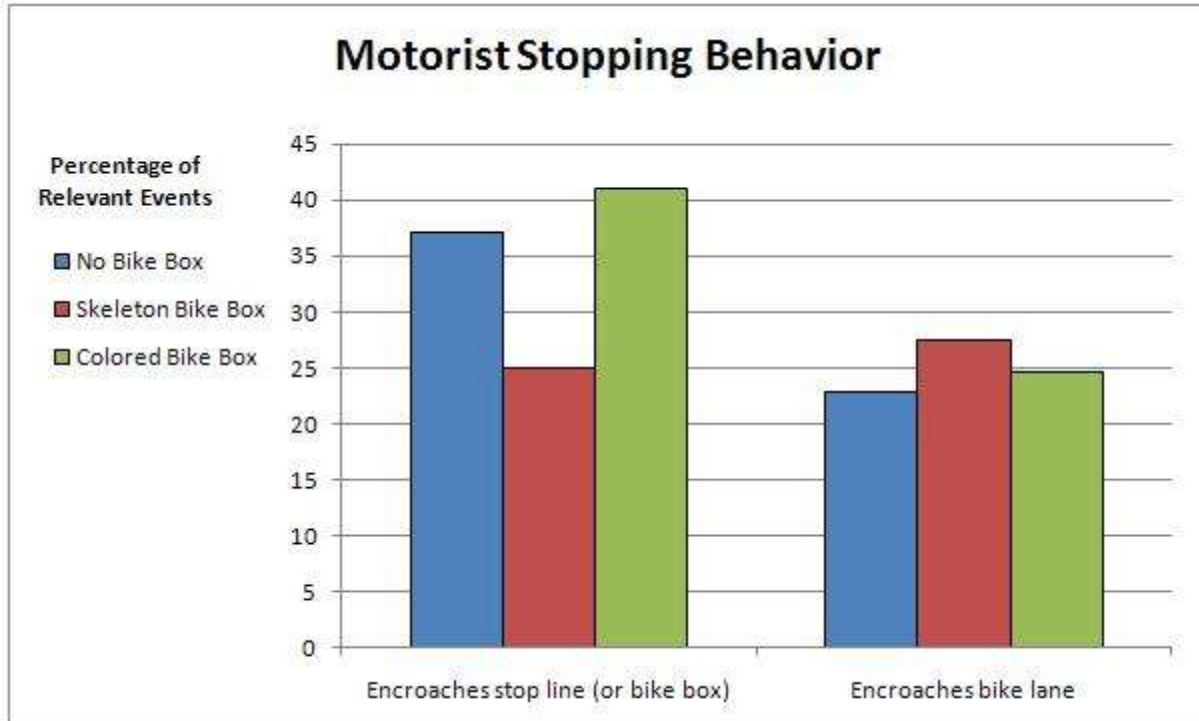
**Figure 7. Motorist stopping position when a bicyclist is present at Shoal Creek Boulevard and Anderson Lane**

Motorist stopping behavior is shown in Figure 7. The percentage of motorists that encroached on the stop line decreased after the bicycle box skeleton was installed. However, this change did not prove to be significant ( $p = 0.167$ ). After the color was added the percentage of motorists encroaching on the stop line significantly increased to approximately 41%, a value comparable to the Phase 1 condition value of 37% ( $p = 0.099$ ). One hypothesis for why this occurred is that motorists were inclined to initially comply with the new site design, but as it became clear that the percent of time when a bicyclist was in the box was low, they began to ignore the advanced stop line. The incidence of encroachment on the bicycle lane remained mostly constant over the different phases of implementation.

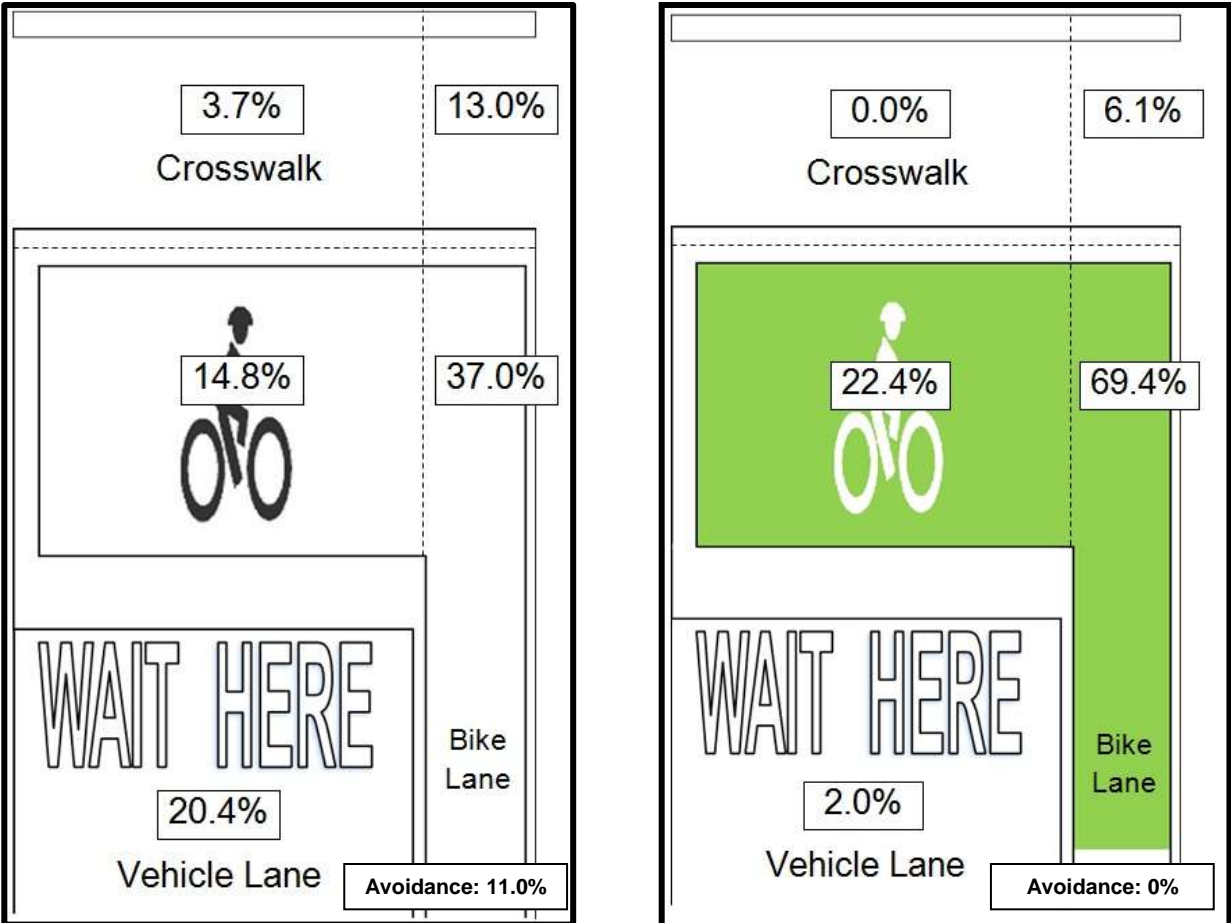
**Figure 8. Bicyclist stopping position by percentage on Shoal Creek Boulevard before and after color is added to the bicycle box**

Figure 8 shows the percentage of bicyclists that stopped in each location at Shoal Creek Boulevard and Anderson Lane before and after color was added to the bicycle box. Only events when a bicyclist had the opportunity to access the bicycle box are shown. A bicyclist had the opportunity to access the bicycle box when a motorist did not encroach on the bicycle lane or stop line and there was no additional bicyclist blocking the bicycle box. This figure supports the assertion that the color in the bicycle box encourages bicyclists to stay within the bicycle box area. The percentage of bicyclists in this area increased while the percentage of bicyclists in the queue and beyond the stop line decreased. Ultimately, not taking into account the bicyclists who avoid, the percentage of bicyclists who stopped behind the stop line in the bicycle box area increased from about 52% to 92%. This increase proved to be significant ( $p < 0.001$ ).

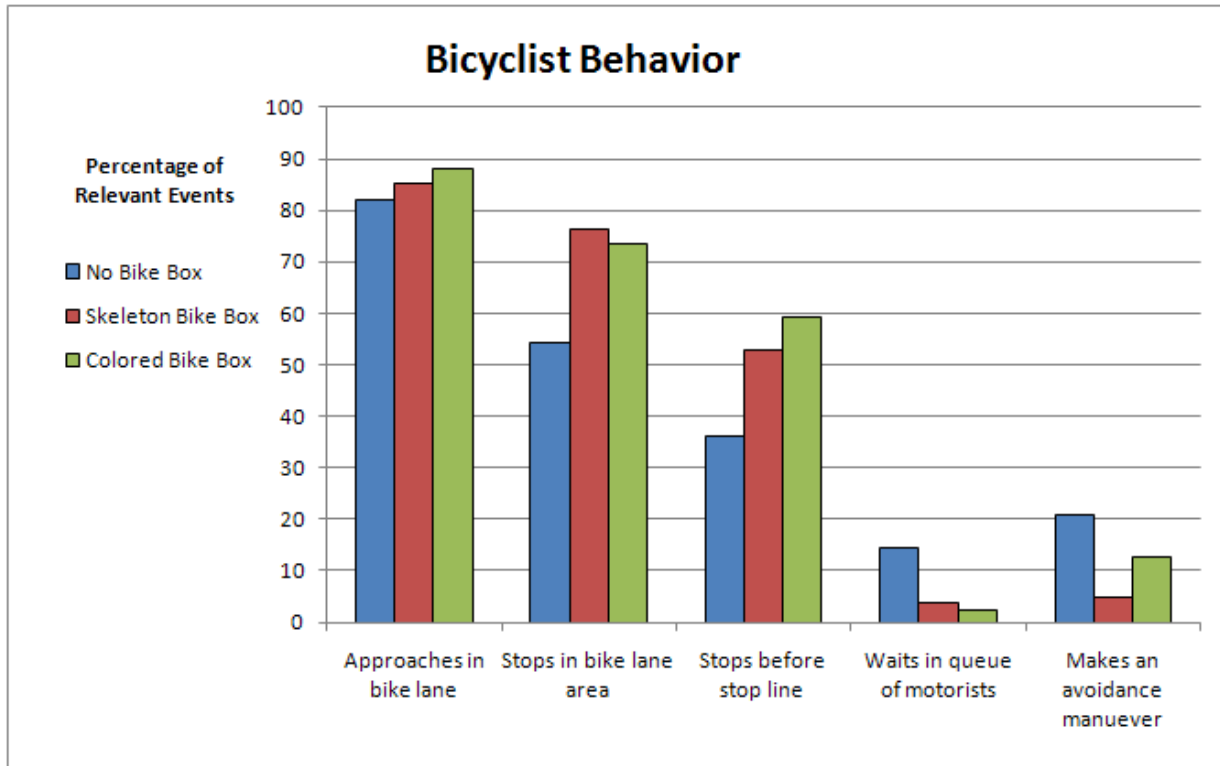
**Figure 9. Bicyclist behavior on Speedway and 38th Street**

Figure 9 shows changes in bicyclist behavior before any bicycle box existed, after the skeleton bicycle box was installed, and after the chartreuse color was added. There was a steady increase in the number of bicyclists that use the bicycle lane on their approach to the intersection. This fact combined with the significant decrease in the percentage of bicyclists that waited in a queue of motorists ( $p=0.007$ ) and the increase in the percentage of bicyclists that stopped before the stop line ( $p=0.015$ ) after the skeleton bicycle box was installed suggests that bicyclists used the facilities at the intersection more appropriately and predictably. Also, a significant increase in the percentage of bicyclists that stopped in the bicycle lane area was observed when the skeleton bicycle box was installed ( $p=0.001$ ). Stopping in the bicycle lane area is a viable, safe option for the bicyclist. Due to the advanced stop bar the bicyclist is still positioned in front of the motorist and can be clearly seen. Since the bicycle lane continues on the other side of the intersection, bicyclists at this location might find it unnecessary to maneuver into the bicycle box area away from their straight line path. The problem that resulted from bicyclists stopping in the bicycle lane area was that it hindered following bicyclists from entering the bicycle box. Often a queue of bicyclists would develop in the bicycle lane causing the bicyclists further back in the queue to be at a greater risk of being right-hooked. Lastly, a significant decrease in the percentage of avoidance maneuvers ( $p<0.001$ ) was observed when the skeleton bicycle box was installed, although this percentage did increase slightly after the

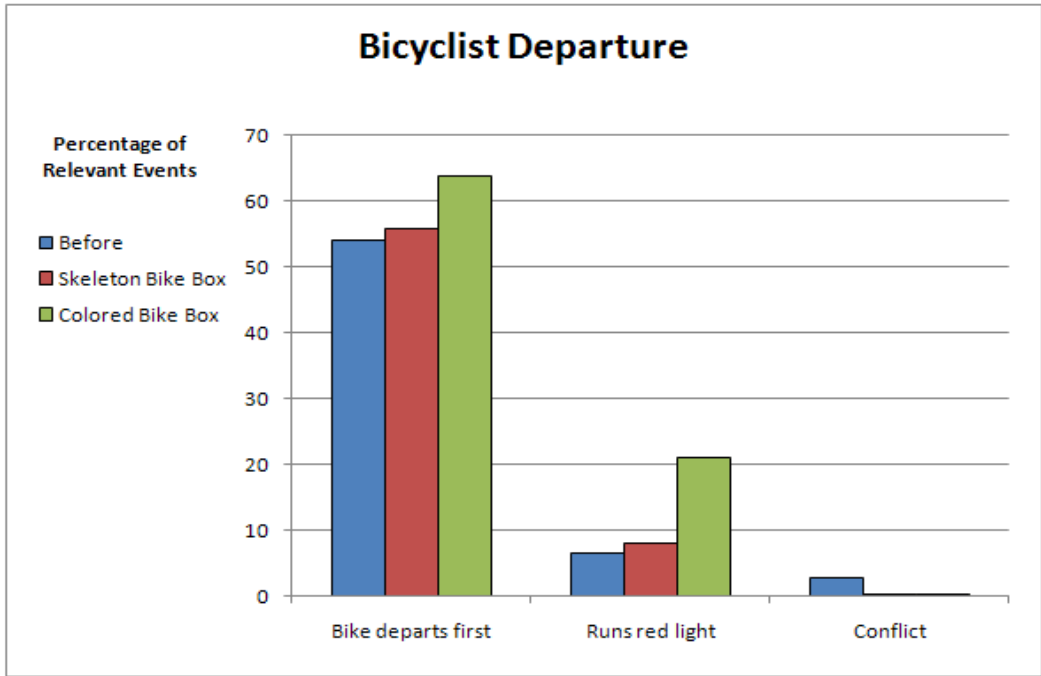
**Figure 10. Bicyclist departure movements on Speedway and 38th Street**

Safety was also quantified by how the bicyclist and motorist depart the intersection. Figure 10 shows an increase in the percentage of bicyclists that depart the intersection before a motorist after each stage of implementation ( $p=0.224$ ), which may suggest that motorists are more aware of the presence of a bicyclist at the intersection and therefore more likely to yield to them when the light turns green. Unfortunately, a significant increase in the percentage of bicyclists that ran a red light was observed ( $p<0.001$ ), which could be due to the higher percentage of bicyclists positioning themselves in front of motorists.

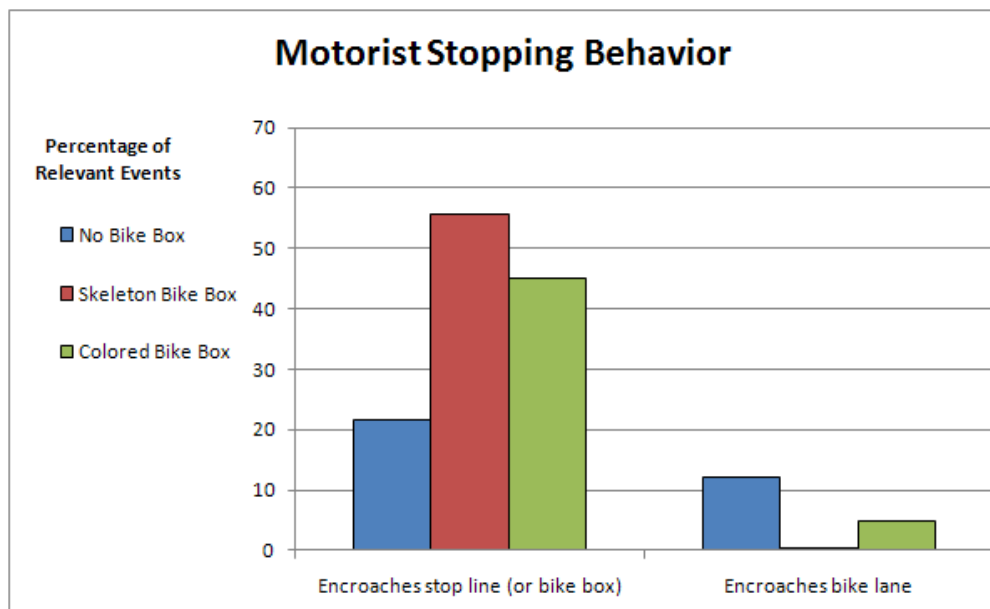
**Figure 11. Motorist stopping position when a bicyclist is present at Speedway and 38th Street**

Additionally, motorist stopping position was recorded and is shown in Figure 11. Considerably more motorists encroach on their stop line after the skeleton bicycle box was installed ( $p < 0.001$ ), which could be due to motorists being unaware of the intention of the bicycle box. After the color was added, a significant change in the percentage of motorists stopped behind the bicycle box in the appropriate place was observed ( $p = 0.002$ ). The motorist encroachment results showed a trend opposite to that found on Shoal Creek. More research is needed to study this issue. Another positive result of the bicycle box was the decrease in the percentage of motorists that encroach on the bicycle lane after the installation of the skeleton bicycle box ( $p = 0.003$ ), which allows for bicyclists to safely bypass a queue of motorists and access the bicycle box. The small increase in motorists encroaching the bicycle lane after color was added ( $p = 0.058$ ) could be partially attributed to some motorists exiting a driveway located just before the intersection. The majority of bicycle lane encroachment observed during the pre-bicycle box phase was done by motorists approaching the intersection on Speedway, not exiting the driveway. Lastly, the percentage of motorists making an illegal right turn on red was recorded. Contrary to Shoal Creek Boulevard, only 5.3% of motorists made an illegal right turn after the bicycle box and the “No Right Turn On Red” sign was installed at this location. Also, the bicycle volume on this facility was much higher than on Shoal Creek Boulevard (20-60 bicyclists per hour as opposed to 0-30 bicyclists per hour). This could contribute to the more desirable motorist behavior at Speedway than at Shoal Creek Boulevard. Since motorists are more likely to encounter a bicyclist along Speedway, they may be more cognizant of a bicycle facility as well as the bicyclist itself. The low percentage of illegal right turns combined with the high volume of bicyclists make this site well suited for a bicycle box.

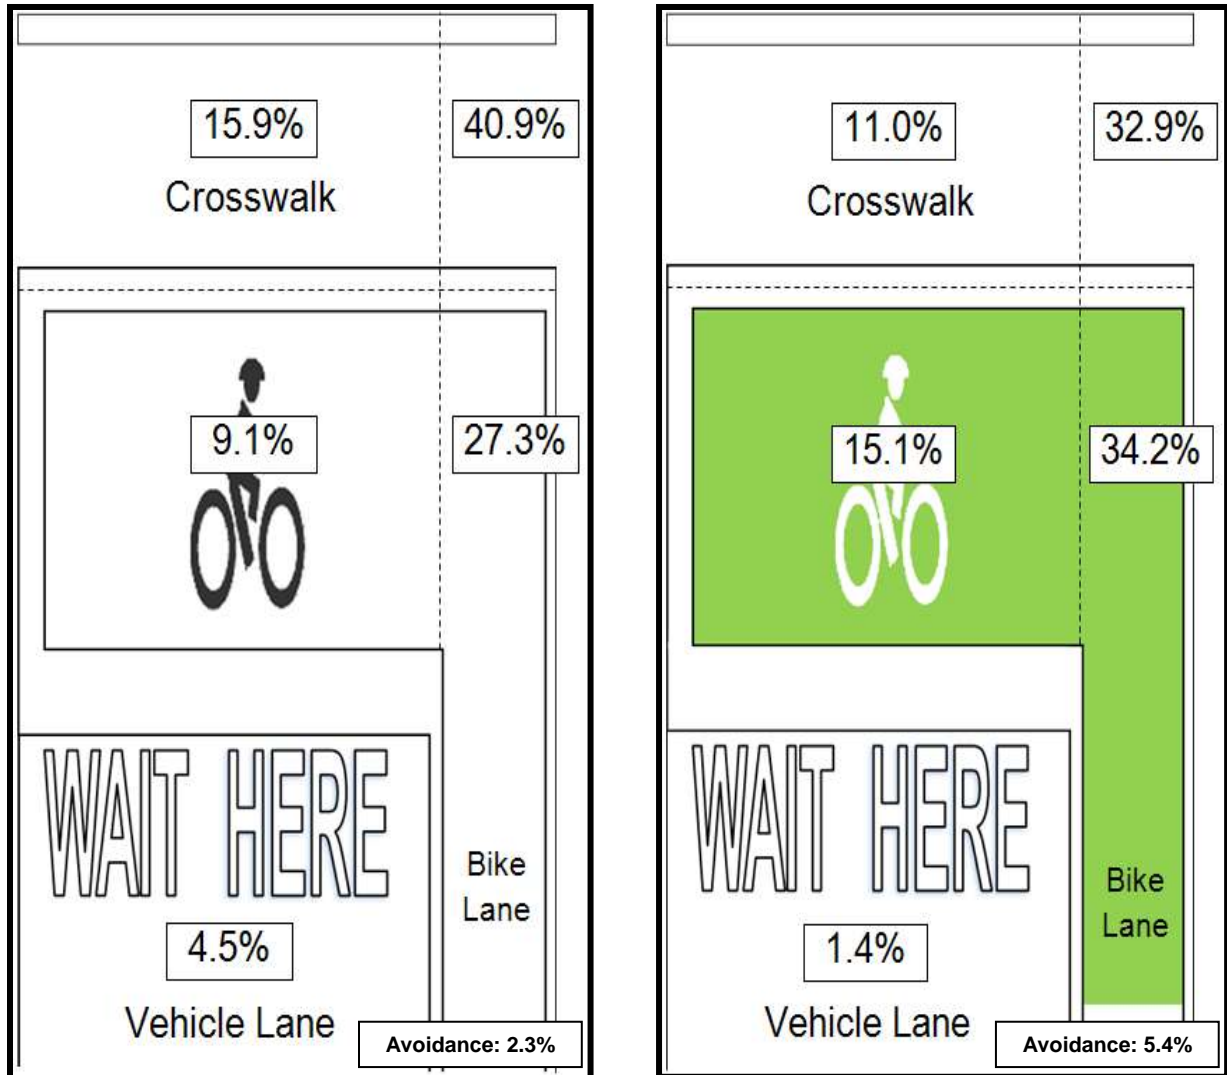
**Figure 12. Bicyclist stopping position by percentage on Speedway before and after color is added to the bicycle box**

Figure 12 shows the percentage of bicyclists stopped in each location at Speedway and 38th Street before and after color was added to the bicycle box. Only events when a bicyclist was given the opportunity to access the bicycle box are shown. A bicyclist had the opportunity to access the bicycle box when a motorist did not encroach on the bicycle lane or stop line and there was no additional bicyclist blocking the bicycle box. After the chartreuse was added, bicyclists stayed within the colored area 13% more often, indicating a positive reaction to the color. A higher percentage of bicyclists began using the bicycle box correctly and did not encroach on the crosswalk ( $p=0.329$ ). Although the most significant decrease in bicyclists waiting in the queue occurred after the installation of the skeleton bicycle box ( $p=0.007$ ), the addition of the color further encouraged bicyclists to bypass the queue and access the bicycle box ( $p=0.516$ ). Overall, only 25% of bicyclists stopped in or in front of the bicycle box when the skeleton was installed and 26.1% used the bicycle box after color was added. An ideal use of the bicycle box on southbound Speedway is shown below in Figure 13. One hypothesis of why the percentage of bicyclists using the bicycle box itself is low is the continued bicycle lane on the downstream side of the intersection. Since nearly all bicyclists were traveling straight through the intersection, it is likely that bicyclists did not see the need to maneuver into the bicycle box and were comfortable waiting in the bicycle lane area.

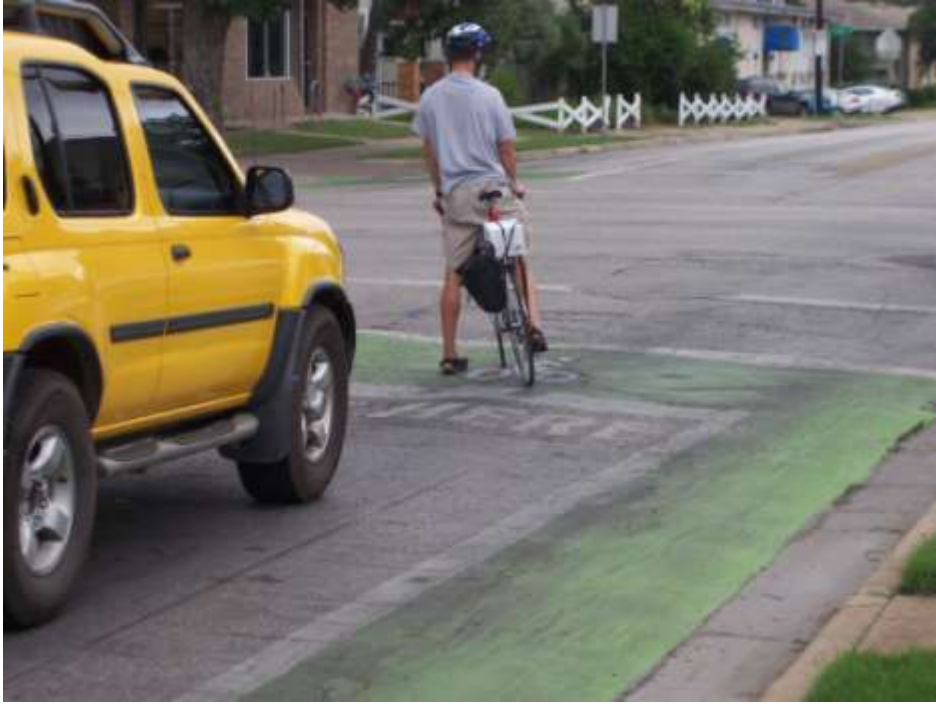
**Figure 13. Bicyclist using bicycle box on southbound Speedway at 38th Street**

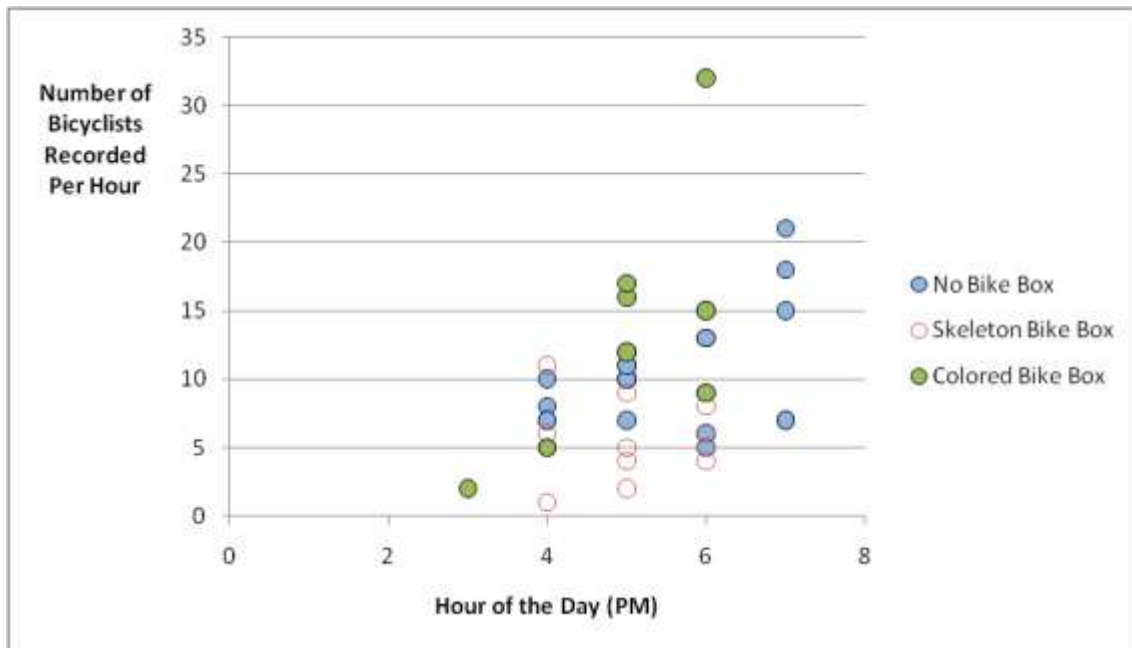
Figure 14. Number of bicyclists recorded each hour of the day on Shoal Creek Boulevard

Figure 14 and Figure 15 show the total number of bicyclists observed by hour of the day at Shoal Creek Boulevard and Speedway, respectively. Shoal Creek Boulevard experienced an increasing number of bicyclists as the afternoon progressed for all three phases. Based on the high number of bicyclists between 5:00 PM and 7:00 PM, Shoal Creek Boulevard is most likely a commuter route with about 10 bicyclists an hour. Bicycle volumes on Speedway also increased as the afternoon progressed, but had a slightly more constant trend. This could be due to its proximity to The University of Texas since students tend to have more flexible schedules than typical commuters. On average, about 10 bicyclists per hour and 30 bicyclists per hour traveled along Shoal Creek Boulevard and along Speedway, respectively.

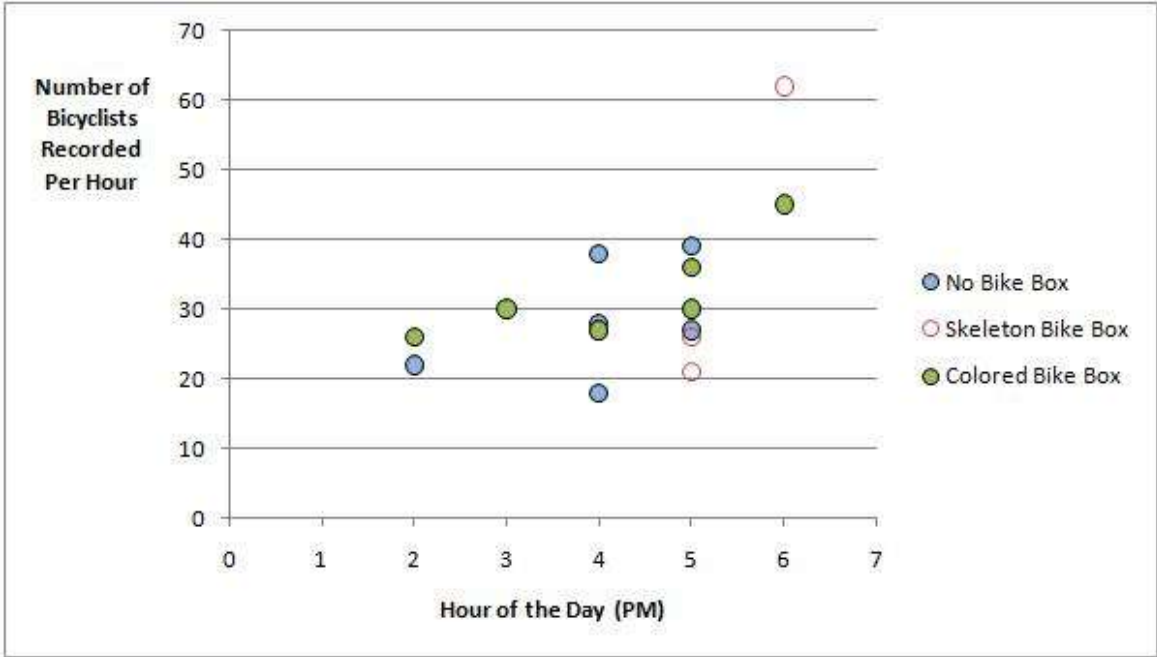
**Figure 15. Number of bicyclists recorded each hour of the day on Speedway**

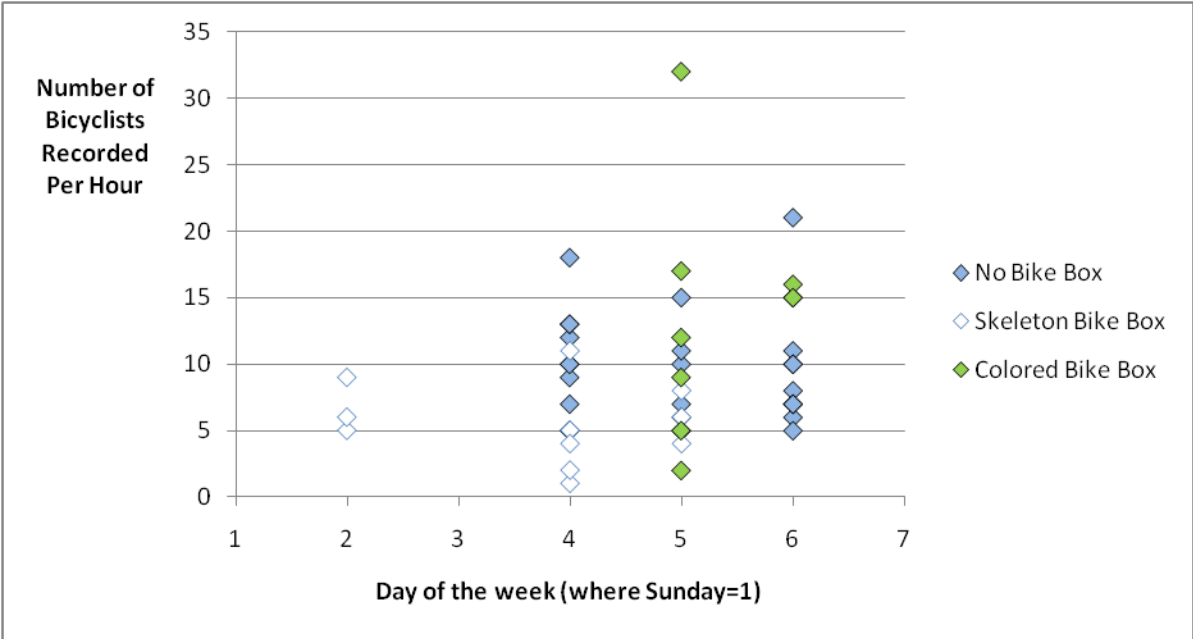
**Figure 16. Number of bicyclists recorded each day of the week on Shoal Creek Boulevard**

Figure 16 and Figure 17 show the total number of bicyclists observed each day of the week at Shoal Creek Boulevard and Speedway, respectively. Both sites show a varying number of bicyclists for each day of the week. Bicycle volumes on Shoal Creek Boulevard were observed to range from five to 10 bicyclists per hour, while they range from 20 to 40 bicyclists per hour on Speedway over the course of the week.

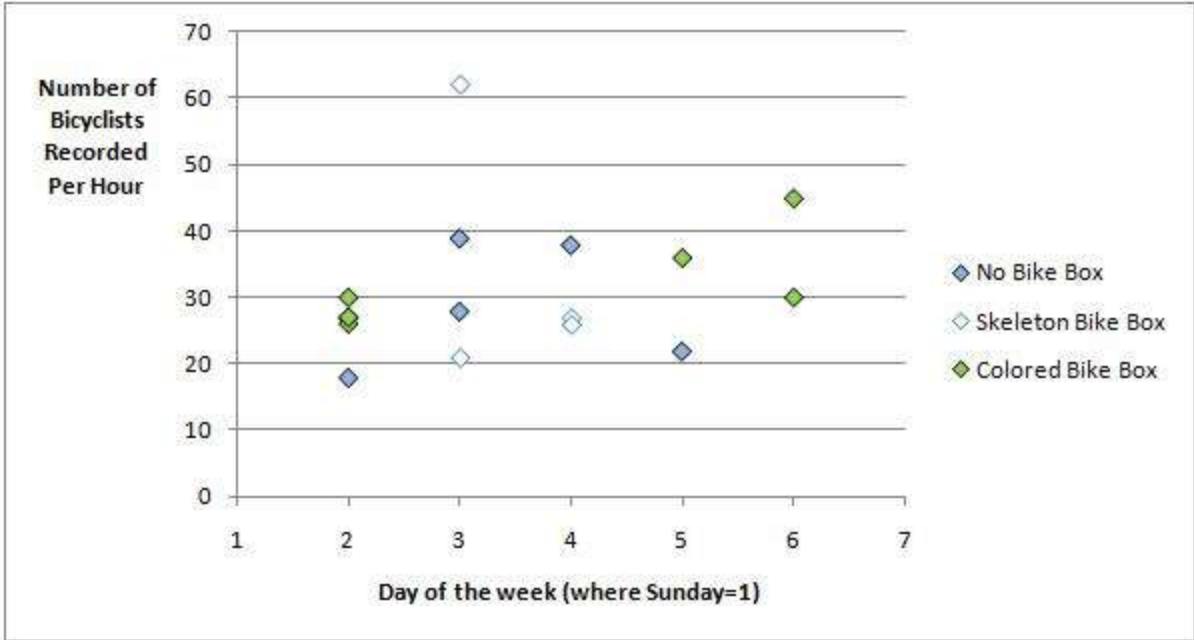
Figure 17. Number of bicyclists recorded each day of the week on Speedway

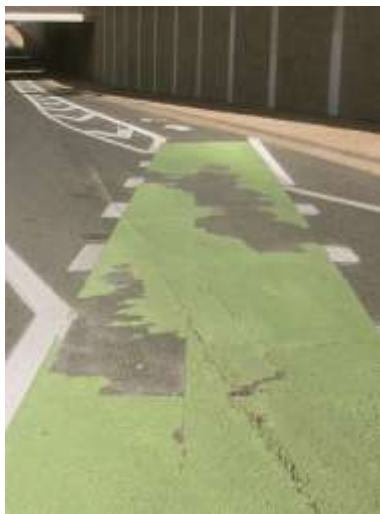
**Figure 18. Deteriorating thermoplastic on Dean Keaton Street at one of the I-35 exit ramps (breaking up in sheets)**

An installation error of the colored thermoplastic on Dean Keaton at the IH-35 exit ramp led to its quick deterioration. While waiting for the oil layer to dry, one of the crew members spilled a large amount of water onto the oil. This water eventually led to inadequate bonding between the pavement and the thermoplastic, which resulted in the thermoplastic breaking up (illustrated in Figure 18).

Also, the quality of pavement was a contributing factor to the quick deterioration of the colored thermoplastic, shown in Figure 18. In particular, the pavement on Speedway at 38th Street is cracked and uneven from the high volume of bus traffic. Clearing debris from the deep cracks of the application surface was nearly impossible; applying the oil-layer to these same cracks and the other surface flaws was also troublesome. The resultant colored thermoplastic was only tenuously bonded to the street surface at best.

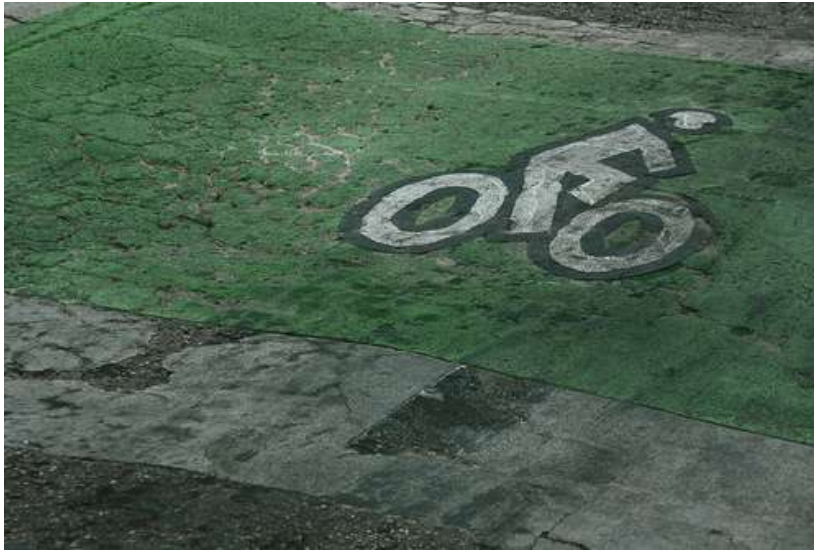
**Figure 19. Poor quality of road led to the deterioration of the thermoplastic bike boxes on Speedway**

Additionally, the colored thermoplastic on Speedway was discolored very quickly (see Figure 19). This discoloration is likely due to the heavy bus traffic on Speedway, where there is a peak hourly volume of over 15 buses/hour. This discoloration may have been compounded by the buses, wider than personal cars, driving in the colored lane. Another concern with the thermoplastic is shown in Figure 20. It is unclear whether the uneven application of thermoplastic shown in the photograph is the result of a misapplication, the rough nature of the street surface, or a deterioration problem.

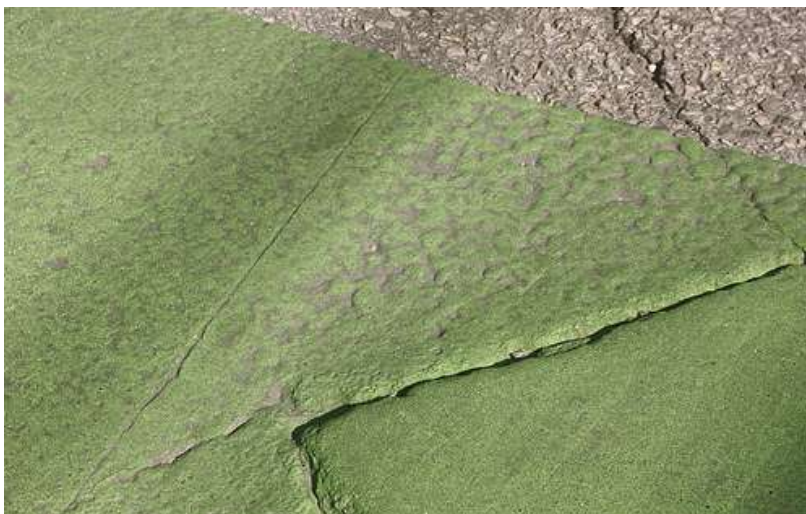
**Figure 20. Thermoplastic thinning on the colored lane on San Jacinto Boulevard**

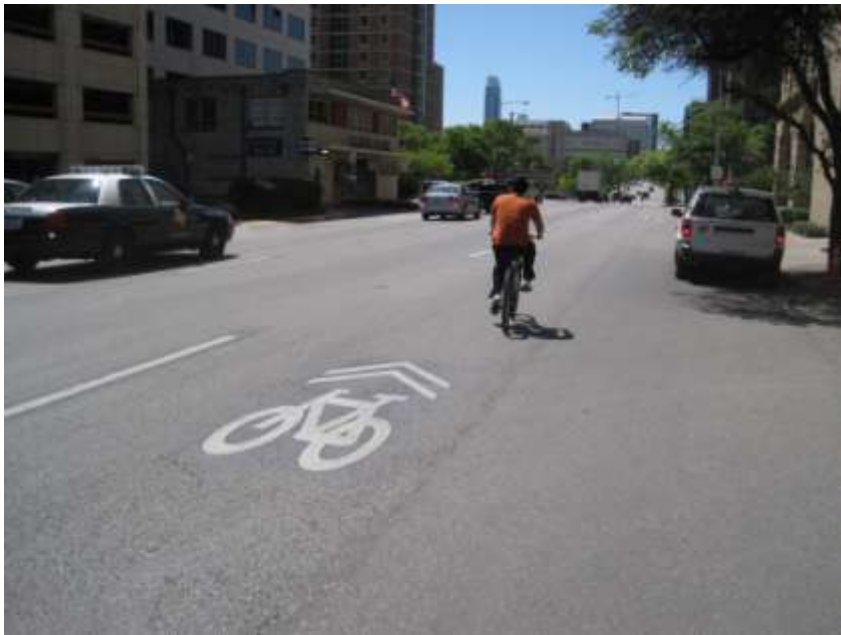
**Figure 21. Central placement of sharrow resulted in thriving thermoplastic five months after installation.**

All sharrows were installed on top of a painted black box in order to provide visual contrast. Additionally, all sharrows were installed in the outside travel lanes. The sharrows on Guadalupe, Lavaca, and 51st Streets were installed in the center of the outside travel lanes as described by Figure 21. Each sharrow was individually placed in order to keep the sharrow out of the typical wheel paths and to avoid driveways where entering and exiting vehicles would have more variable wheel paths. By placing the sharrows outside of wheel paths the integrity of the thermoplastic was maintained.

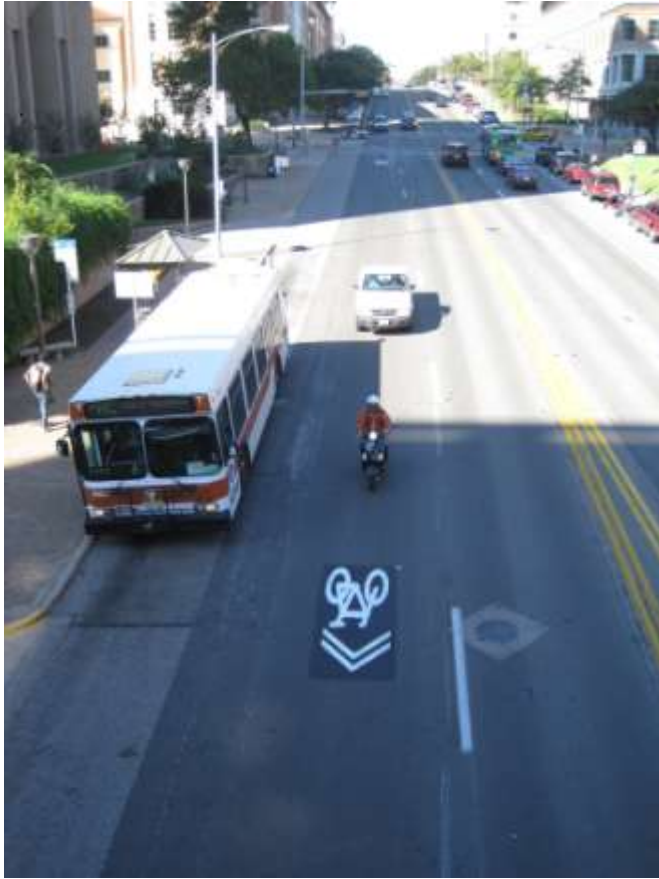
**Figure 22. Central placement of sharrows on east-bound, downhill Dean Keeton Street**

The east-bound sharrows on Dean Keeton Street were installed in the center of the outside travel lanes (see Figure 22) in the same manner as the sharrows on Guadalupe, Lavaca, and 51st Streets. Like these other streets, centralizing the east-bound Dean Keeton Street sharrows helped to preserve the thermoplastic. Another reason these sharrows were installed in the center of the travel lane was to keep them out of the path of buses. Dean Keeton Street has an extremely high volume of bus traffic (peak hourly volume of 40 buses/hour) and there a number of bus stops requiring buses to enter and exit the outer travel lane as shown in Figure 22. Finally east-bound bicyclists are also able to reach faster speeds because of the downhill allowing bicyclists and cars to travel at similar speeds.

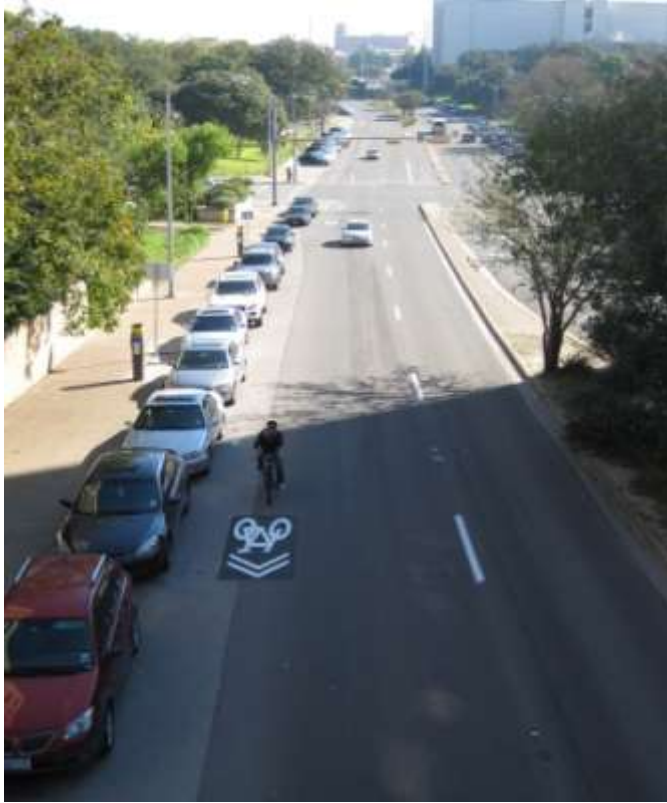
**Figure 23. Curb-justified placement of sharrows on west-bound, uphill Dean Keeton Street**

The west-bound sharrows on Dean Keeton differed from the other locations as these sharrows were aligned closer to the curb (see Figure 23). These sharrows were aligned closer to the curb for the following reasons: the outside travel lane on west-bound Dean Keeton was very large, there were no bus stops, the sharrows were only utilized to provide a bicycle facility to link two bicycle lanes, and west-bound bicyclists slow down to travel uphill.
