# Effects of Shared Lane Markings on Bicyclist and Motorist Behavior along Multi-Lane Facilities

The City of Austin Bicycle Team  
John Brady, Jeff Loskorn, Alison Mills, Jen Duthie, Randy Machemehl  
The Center for Transportation Research  
The University of Texas at Austin  
Phone: (512) 471-4541  
Fax: (512) 475-8744  
Email: [johnbrady.jb@gmail.com](mailto:johnbrady.jb@gmail.com)

Submitted July 15, 2010

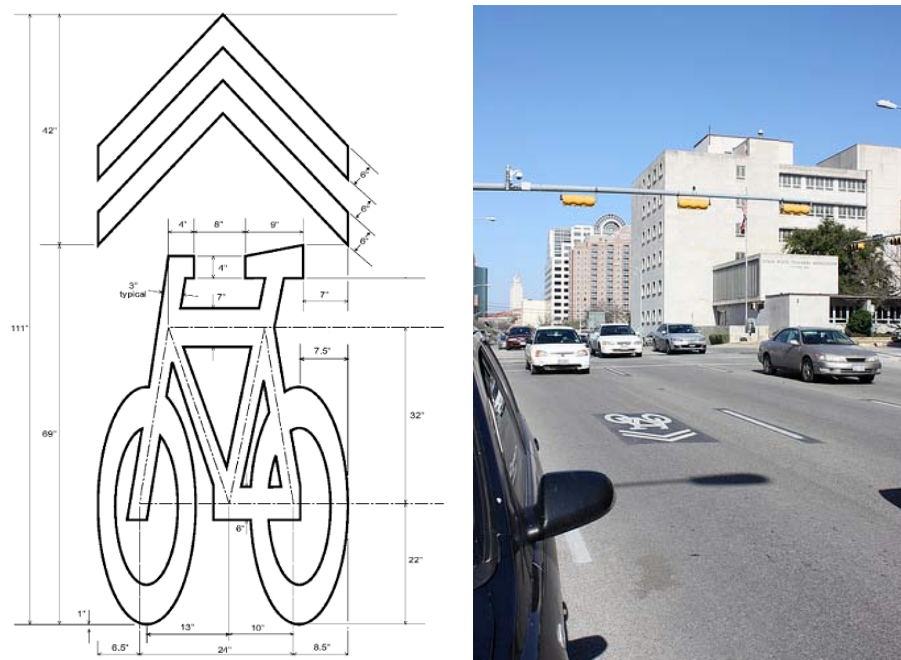
The design of the Shared Lane Marking used in this experiment is shown in Figure 1. This design was recommended by the National Committee on Uniform Traffic Control Devices' Bicycle Technical Committee and measures 3.25 feet wide by 9.25 feet tall and is unmistakably similar to the Shared Lane Marking described in the 2009 MUTCD. The Shared Lane Markings were always placed in a manner consistent with the applicable MUTCD standards and guidance. In this paper, Shared Lane Markings are referred to as sharrows—a common shortening of 'share the road arrow.'

**Figure 1. A drawing and photograph of the Shared Lane Marking used in this study**

Thermoplastic sharrows were purchased for \$123 each and were installed by a crew of five City of Austin employees for \$69 each. In a single day, the crew could install up to 30 markings for a total cost of \$5,760.

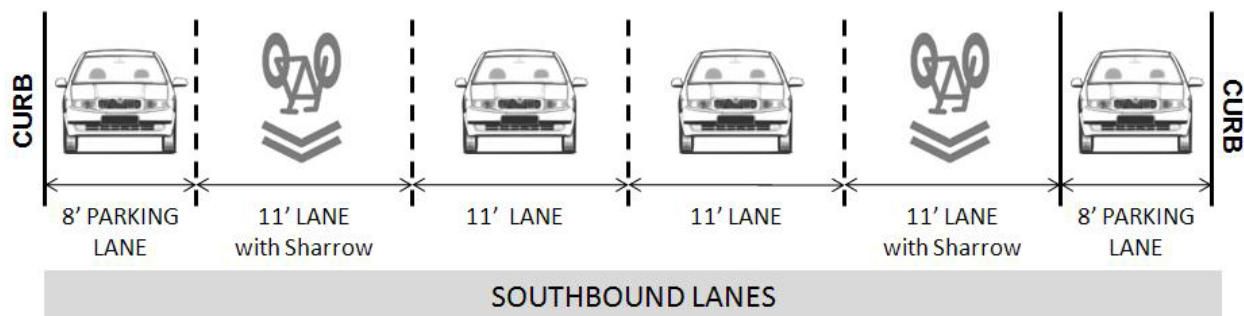
Between W 20<sup>th</sup> Street and W Cesar Chavez Street, Guadalupe Street is a four lane, one-way southbound street that extends from the southern edge of campus to the southern end of downtown. Before the study began, Guadalupe was a common corridor for bicyclists despite heavy traffic and narrow outside lanes. Sharrows were installed at the beginning of each block in the center of both the rightmost and leftmost vehicle lanes—since bicycling in the leftmost lane of a one-way facility is appropriate for left-turning bicyclists. An additional pair of sharrows was placed on the north side of the intersection of Guadalupe and 12<sup>th</sup> Street to assist with data collection. A cross-section of the street is shown in Figure 2. Typical AM peak traffic volumes ranged from 800 vehicles per hour to 1100 vehicles per hour, while PM peak traffic volumes were as high as 1650 vehicles per hour. The posted speed limit on the studied section of Guadalupe Street is 30 mph.

**Figure 2. A cross-section of Guadalupe Street approaching the intersection with 12<sup>th</sup> Street**

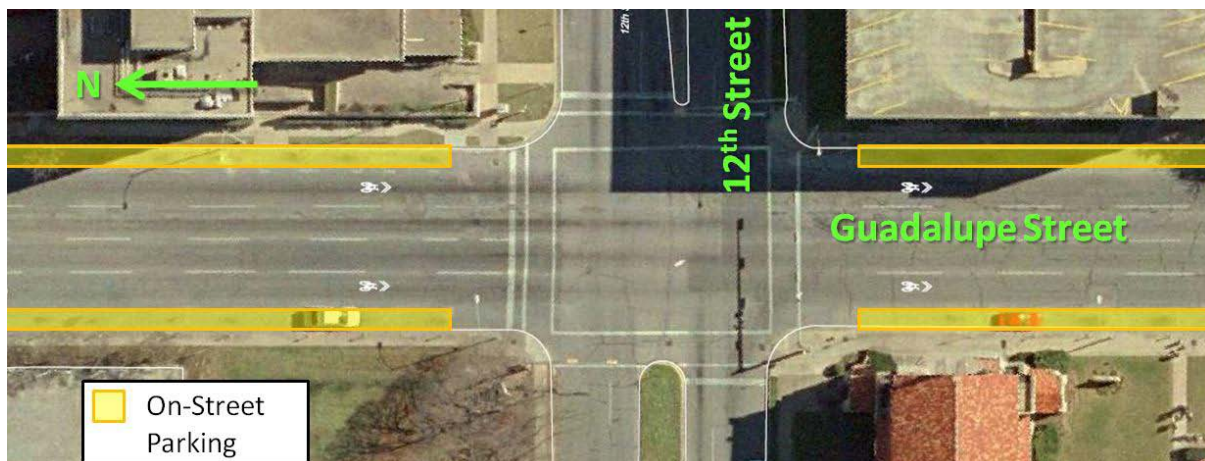
Data was collected by a traffic camera mounted at the intersection of Guadalupe Street and 12<sup>th</sup> Streets in downtown Austin. The camera was positioned to record southbound traffic as it approached 12<sup>th</sup> Street. One unique feature of the Guadalupe site is that on-street parking is provided along both sides of the facility, represented by the shaded area in Figure 3. During peak commuting hours (when data was collected) the parking spaces were rarely full, allowing bicyclists to bypass queues by riding in the empty parking spaces.

**Figure 3. A map of the intersection of Guadalupe and 12th Street**

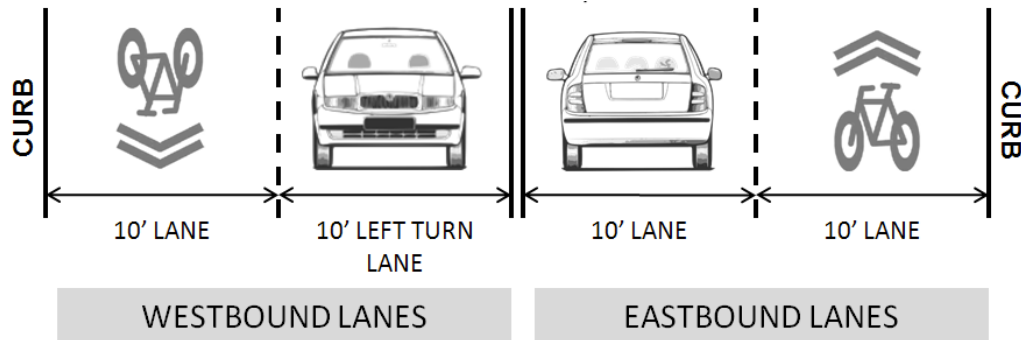
E 51<sup>st</sup> Street is a four-lane arterial that connects the suburban neighborhoods of north-central and north-east Austin. The facility has bicycle lanes west of Airport Boulevard and east of IH-35, but the lane width between Airport Boulevard and IH-35 is narrow, forcing bicyclists and motorists to share the road. In order to increase the bicycling appeal of this route, sharrows were placed in the rightmost lane along both the east- and westbound directions of this segment in the center of the lane. A cross-section of the site is shown in Figure 4.

**Figure 4. Cross-section of Westbound 51st Street approaching the intersection with Airport Boulevard**

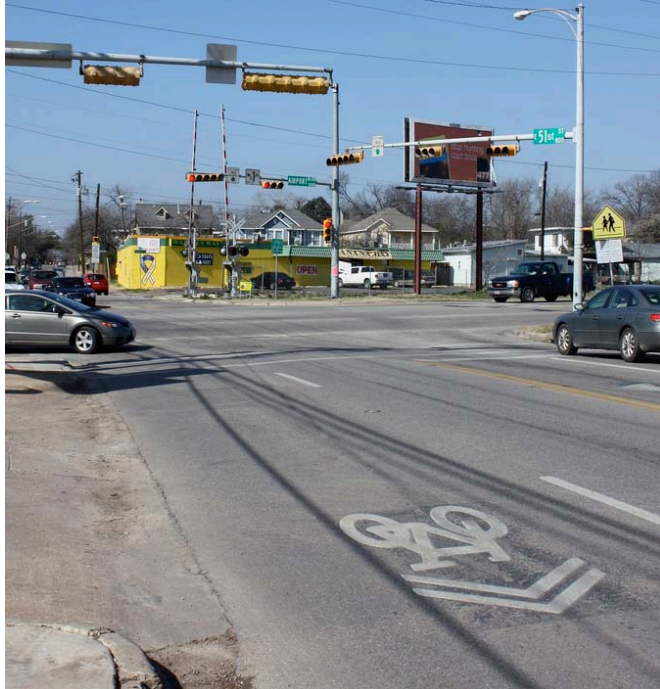
A traffic camera located at the intersection of Airport Street and E 51<sup>st</sup> Street captured traffic moving in both directions along the eastern leg of the E 51<sup>st</sup> Street and Airport Boulevard intersection. Traffic volumes were typically around 400 vehicles per hour in both the AM and PM peak periods and the speed limit is 30 mph. Bicyclists approaching the intersection (traveling west) were presented with different traffic conditions than bicyclists departing the intersection (traveling east). In order to account for these differences, each direction was considered separately. Figure 5 shows a sharrow installed at the study location on E 51<sup>st</sup> Street.

**Figure 5. Shared Lane Marking installed on E 51st Street**

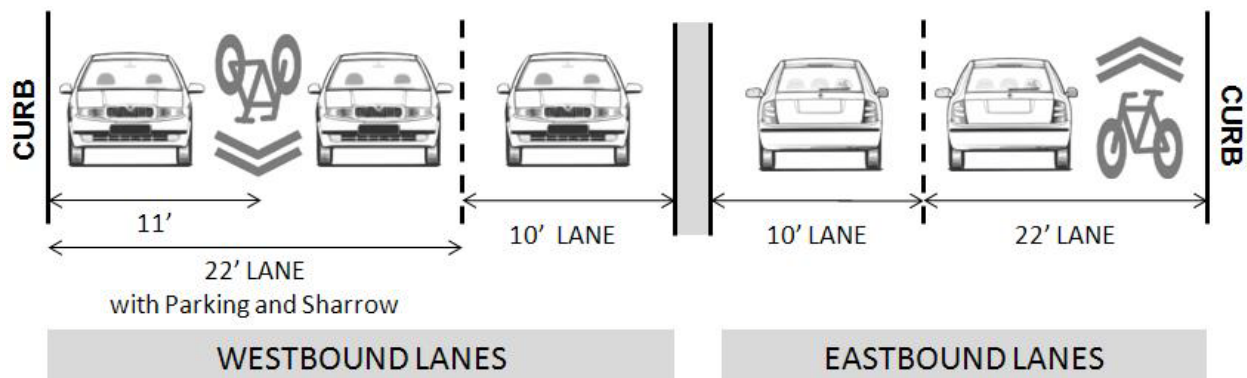
Dean Keeton Street is an east-west arterial that runs along the north side of The University of Texas at Austin campus. In Summer 2009, bicycle lanes were installed for the segment of Dean Keeton Street east of San Jacinto Boulevard as well as where space permitted on segments of Dean Keeton Street west of San Jacinto Boulevard. Where space did not permit the installation of bicycle lanes in accordance with City of Austin standards, sharrows were installed in August 2009. A cross-section of the roadway is shown in Figure 6. This paper compares the data collected after the installation of the bicycle lanes (but before the addition of the sharrows to the gaps) to the data collected after the installation of the sharrows.

**Figure 6. Cross-section of Westbound Dean Keeton Street departing the intersection with San Jacinto Boulevard**

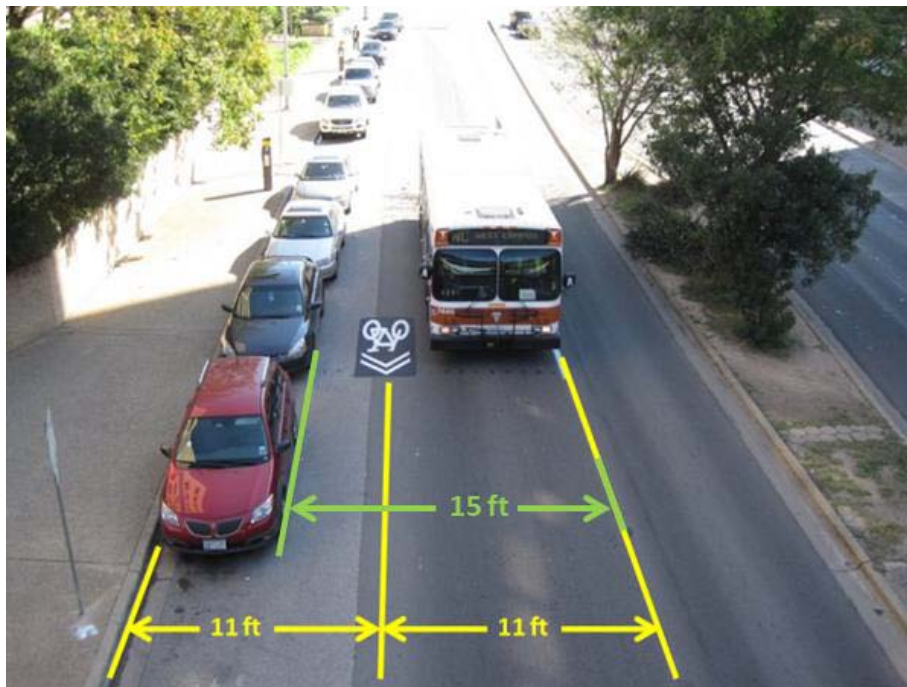
Data for this site was collected from a vantage point above the west leg of the intersection of Dean Keeton Street and San Jacinto Boulevard. Traffic volume along Dean Keeton Street was typically around 500 vehicles per hour and the speed limit is 35 mph. From this location, bicyclists were recorded traveling westbound just after departing the intersection. Sharrows were not installed in the center of the lane, but rather off to one side. In accordance with MUTCD standards, sharrows were centered 11 feet from the curb, leaving 11 feet between the sharrow's center and the next full lane. Figure 7 shows the studied segment of Dean Keeton Street near San Jacinto Boulevard.

**Figure 7. Shared Lane Marking position near the study site on Dean Keeton Street**

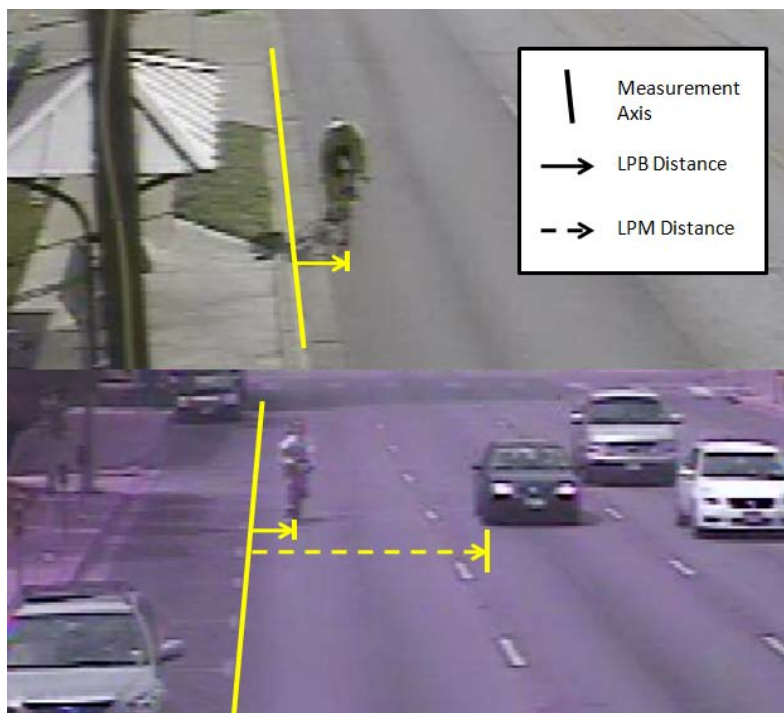
To evaluate safety as defined above, several elements of the environment, bicyclist behavior, and bicyclist-motorist interaction were recorded. Although no single measurement can comprehensively measure bicyclist and motorist safety, the improvement of several safety indicators can contribute to the conclusion that safety is indeed improved. Among the measurements taken were: traffic volume, position of motor vehicles and bicycles during passing and non-passing events, percent of motor vehicles that change lane to pass or make an incomplete passing maneuver, percent of bicyclists traveling with traffic (as opposed to against traffic or on sidewalks), and percent of bicyclists who bypassed a queue of stopped vehicles. Figure 8 illustrates how measurements of the bicyclist lateral position (BLP) and motorist (MLP) were recorded.

**Figure 8. Method for taking BLP and MLP measurements using different measurement axes**

- Bicyclist lateral position (BLP) – BLP is a measure of the bicyclist's position within the lane. Due to geometric differences, BLP was measured in a manner most consistent with each site's unique configuration. On 51<sup>st</sup> Street, BLP was measured as the lateral distance between the bicyclist's front wheel and the curb. On Guadalupe Street, BLP was measured as the lateral distance between the bicyclist's front wheel and the on-street parking space delineation marking. On Dean Keeton, no parking space delineation marking existed, so BLP was measured as the lateral distance between the bicyclist's front wheel and the parked motor vehicle's outer edge.

- Motorist Lateral Position (MLP) – MLP is defined as the distance between the motorist's curb side wheel and the appropriate measurement point—curb, delineation marking, or parked motor vehicle—as explained in the BLP definition.

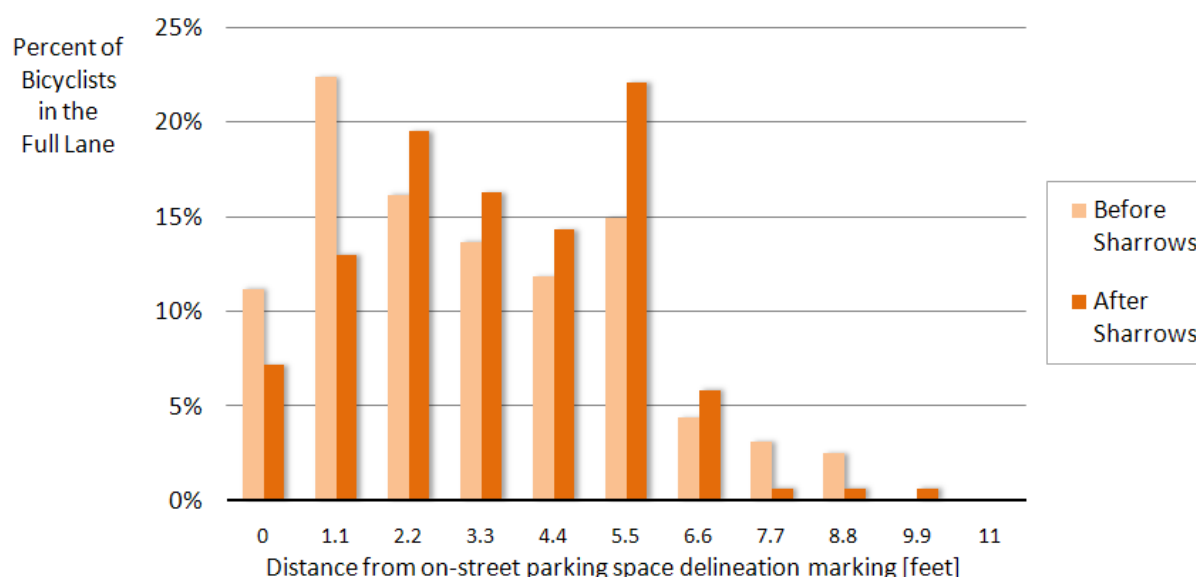
Figure 9 shows the distribution of BLP during mid-block travel on Guadalupe Street. Note that the center of the sharrow was placed 5.5 feet from the parking space delineation markings. After the sharrows were installed, the average BLP increased by 4.4 inches from 3.14 feet to 3.51 feet. More importantly, the mode<sup>1</sup> increased from 1.1 feet to 5.5 feet. Figure 6 shows that the percentage of bicyclists riding in the center of the lane (defined as BLP between 4.4 and 6.6 feet) increased significantly from 31% to 42% after the installation of the sharrows. Overall, the lateral position data suggests that the sharrow encouraged bicyclists to ride with a stronger lateral position and more predictably than before. This trend is also evident in the substantial decrease of bicyclists observed riding further than 7 feet from the lane edge. A significant change in BLP during passing events was not observed at this site.

**Figure 9. Distribution of bicyclist lateral position along Guadalupe Street during non-passing events**

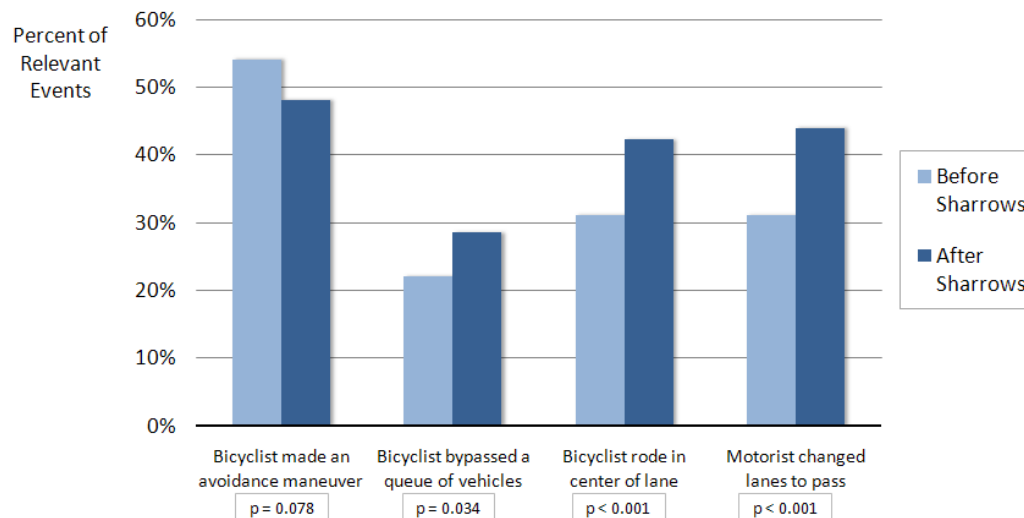
The histogram in Figure 10 shows four statistically significant results that suggest sharrows have a substantial influence on both motorist and bicyclist behavior. First, bicyclists were less likely to make an avoidance maneuver after the implementation of the sharrow and motorists were more likely to change lanes while passing after the implementation of the sharrow. Another interesting comparison shows that while bicyclists were less likely to make an avoidance maneuver, they were more likely to bypass a queue of stopped vehicles after the sharrows were in place. This may suggest that the sharrow encouraged bicyclists to assert themselves more when sharing the roadway with motorists.

**Figure 10. Notable comparisons on Guadalupe Street**

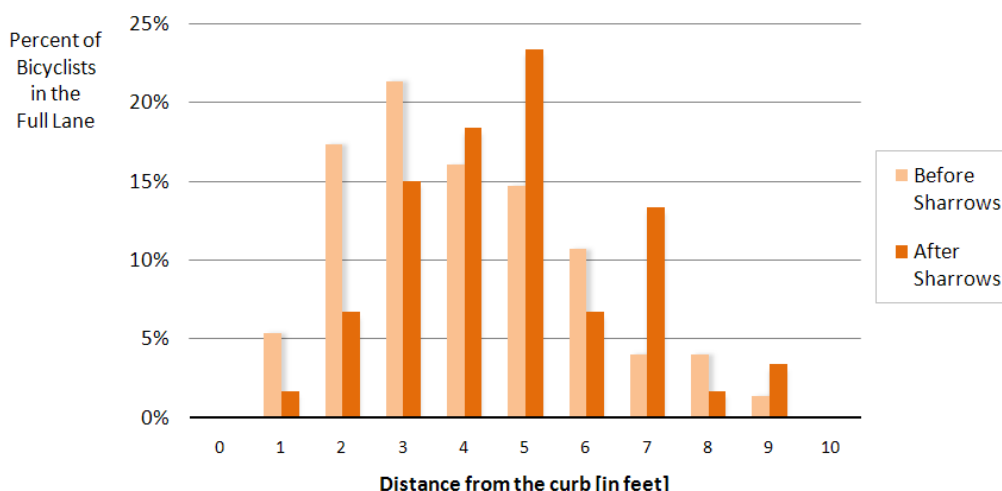
In general, the improvements in safety observed on 51<sup>st</sup> Street are similar to those seen on Guadalupe Street. As Figure 11 illustrates, bicyclists approaching the intersection of E 51<sup>st</sup> Street and Airport Boulevard were observed riding between one and ten feet from the curb face at mid-block. After the sharrows were installed, bicyclists tended to take a stronger position in the lane as evidenced by the increase in average BLP by 8 inches from 4.0 feet to 4.75 feet. As was the case on Guadalupe Street, the most significant result may be the increase in mode from 3 feet to 5 feet. Figure 12 shows that the proportion of on-street bicyclists who rode in the center of the lane (defined as an BLP between 4 and 6 feet) increased from 44% to 54%. The results for BLP or MLP during passing events are not presented because so few passing events were recorded in this direction—see Table 1. Since bicyclists approaching the intersection with Airport Boulevard often faced a queue of vehicles at low speeds, there were fewer opportunities for a passing event to occur.

**Figure 11. Distribution of bicyclist lateral position on 51<sup>st</sup> Street approaching Airport Boulevard during non-passing events**

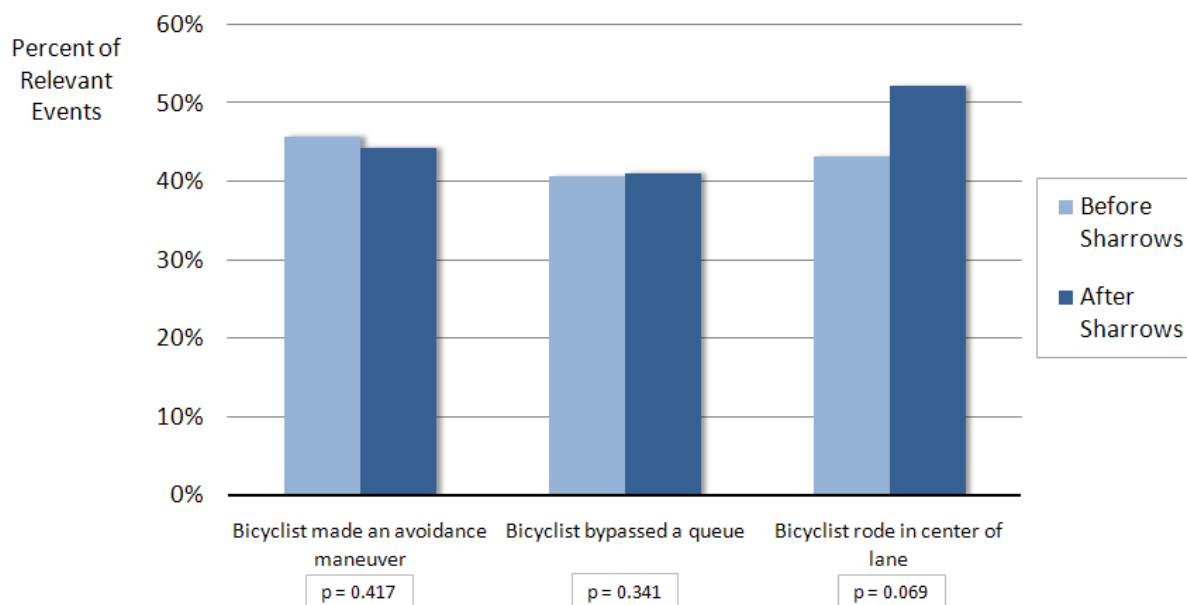
Figure 12 compares notable bicyclist behaviors before and after the implementation of the sharrows. Both the percentage of bicyclists who bypassed a queue or who made an avoidance maneuver remained unchanged after the installation of the sharrows. This may suggest that bicyclists on E 51<sup>st</sup> Street choose to ride on the sidewalk or ride around a queue of stopped vehicles for convenience, not for perceived lack of safety. The presence of the Shared Lane Marking led to a significant decrease—from 12% to 4%--of bicyclists riding against traffic on the sidewalk. As mentioned previously, the proportion of bicyclists riding in the center of the lane did increase substantially; indicating sharrows can be effective at encouraging bicyclists to take a strong position in the full lane.

**Figure 12. Notable comparisons on E 51st Street westbound approaching Airport Boulevard**

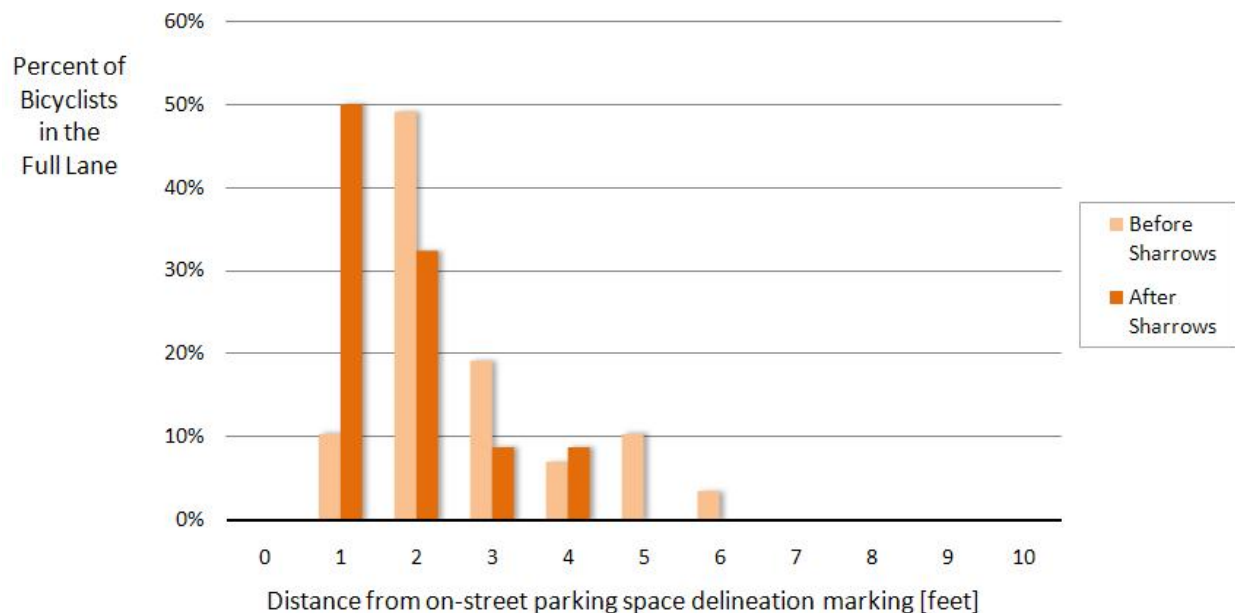
Bicyclists departing the intersection of E 51<sup>st</sup> Street and Airport Boulevard were frequently passed by motorists. Relative to the BLP measured on other sites, bicyclists on E 51<sup>st</sup> Street took a very weak position in the lane during passing events. Figure 13 compares the BLP before and after the implementation of the sharrows. After the sharrow installation, the mode increased from 1 foot to 2 feet and the percent of bicyclists riding in the middle of the lane increased significantly. This shift suggests that when a sharrow is present, bicyclists are willing to take a stronger position in the lane, even when being passed.

**Figure 13. Distribution of bicyclist lateral position on E 51st Street departing Airport Boulevard during passing events**

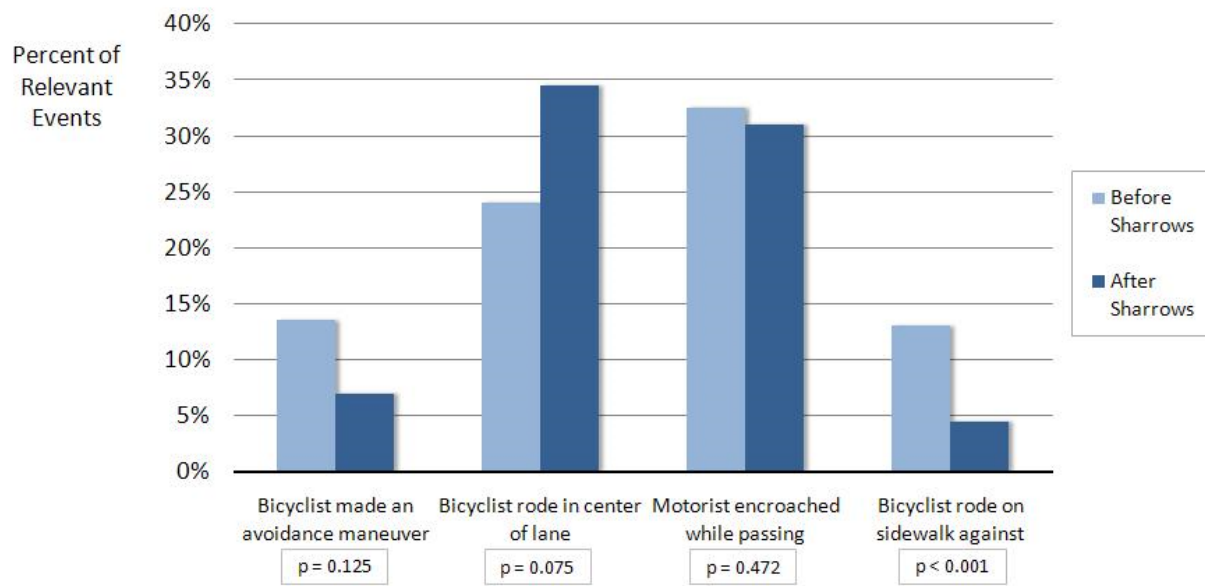
Avoidance maneuvers were relatively rare at this site and after the installation of the Shared Lane Markings the proportion of avoiding bicyclists decreased further as illustrated in Figure 14. The percentage of bicyclists occupying the center of the lane (defined as BLP between 4 feet and 6 feet) during non-passing events increased significantly. This change, along with the substantial increase in bicyclists riding in the center of the lane during passing events suggests that the sharrow markings encouraged bicyclists to properly share the road with vehicles, even when faced with a high number of passing events. Although not shown in Figure 14, the presence of the sharrow marking led to a significant decrease—from 12% to 4%—of bicyclists riding against traffic on the sidewalk along E 51<sup>st</sup> Street.

**Figure 14. Notable comparisons on E 51st Street Eastbound departing Airport Blvd**

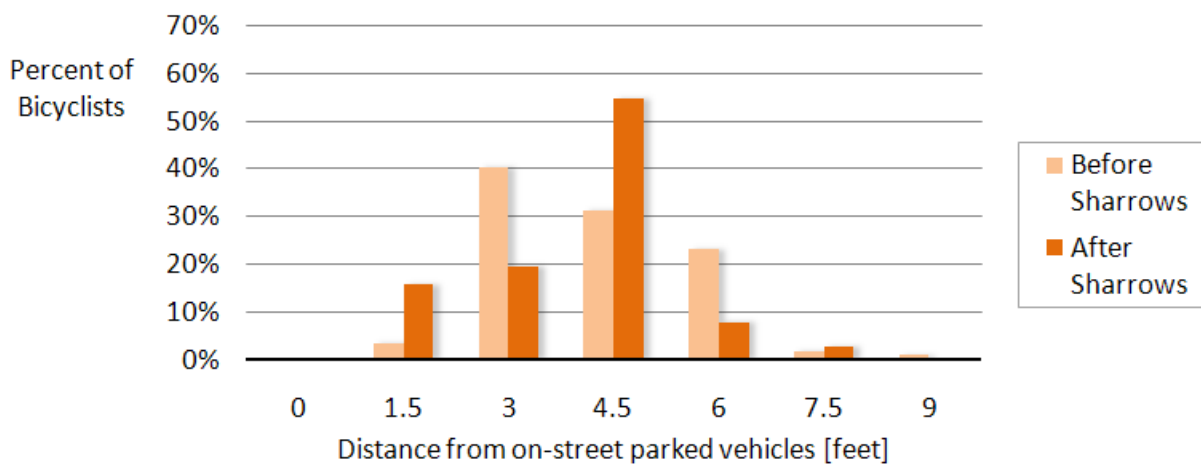
As mentioned in site description, the unique site geometry and the fact that bicyclists departing an intersection are frequently passed by motorists made bicyclist safety during passing events a key concern for this site. Figure 15 and Figure 16 compare bicyclist lateral position before and after the sharrow installation for both passing and non-passing events, respectively. The most significant trend suggests that after the sharrow installation, bicyclists tend to behave more predictably. In the before conditions, bicyclist position during passing events varied between 1.5 feet and 4.5 feet, while after the installation, nearly 70% of bicyclists rode at 3 feet. A similar but less pronounced trend can be observed for non-passing events. Although the decrease in standard deviation of BLP during passing events is noticeable, tests show that the change is not statistically significant ( $p=0.363$ ). Together, this information suggests that the sharrow can substantially influence the consistency of bicyclist lateral position.

**Figure 15. Distribution of bicyclist lateral position on Dean Keeton Street during non-passing events**

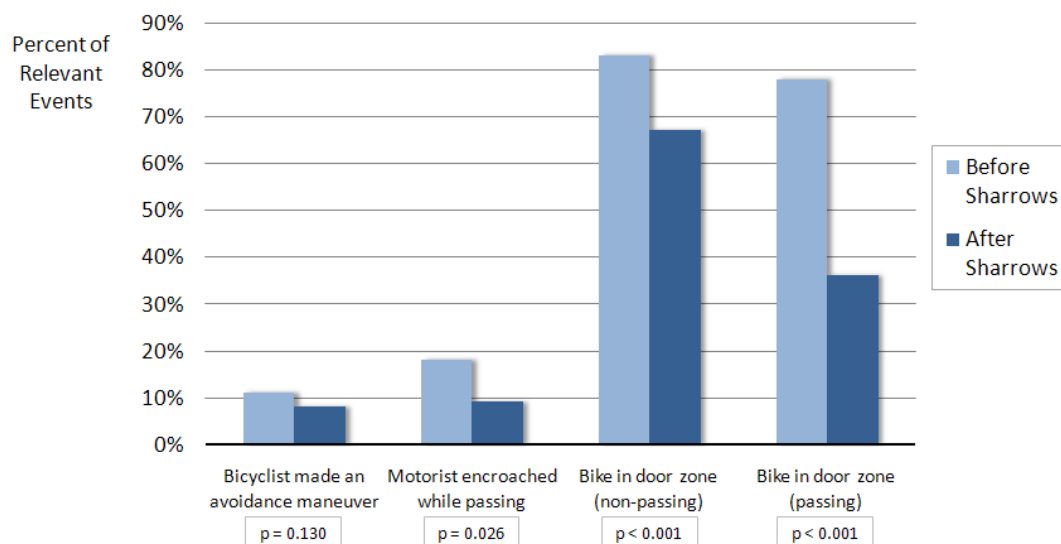
As illustrated in Figure 17, instances of bicyclist avoidance decreased substantially after the sharrows were installed and the proportion of passing motorists who encroached on the adjacent lane decreased as well. This change, coupled with the increased predictability of bicyclist position during passing events, suggests that motorists feel more comfortable passing bicyclists when the sharrow is present and are therefore less likely to encroach on the adjacent lane when passing. (Note that the dimensions of Dean Keeton Street do not require motorists to change lanes to pass.) Taken together, these results suggest that sharrows can be effective as a tool to connect areas where bicycle lanes are not continuous.

**Figure 17. Notable comparisons on Dean Keeton Street**

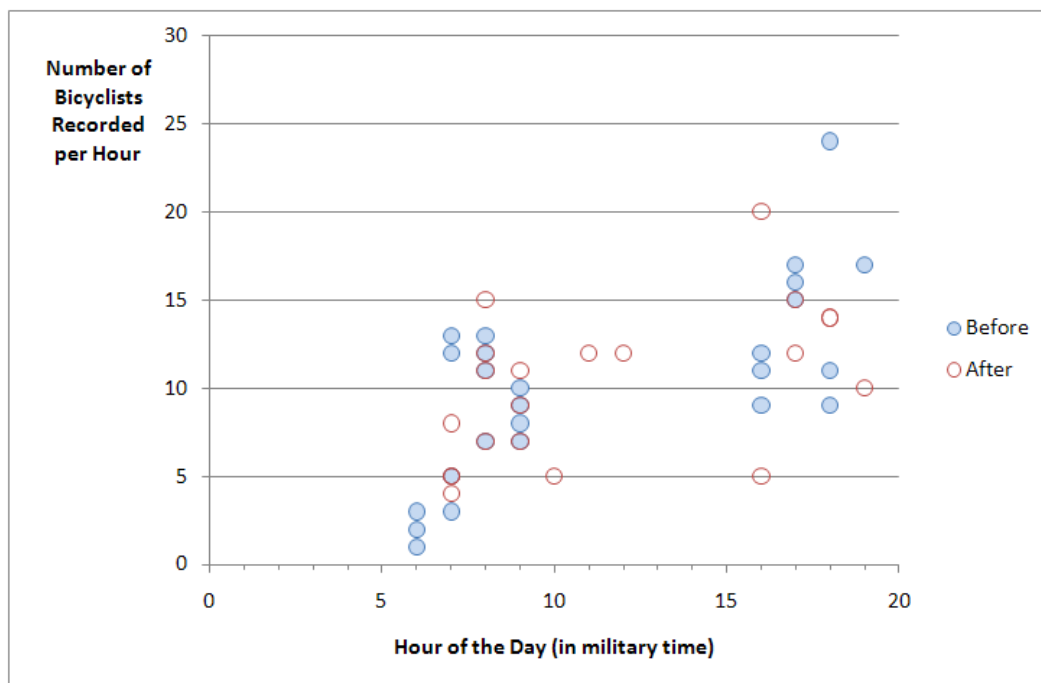
The following figures illustrate the level of bicycle traffic that E 51st Street, Guadalupe Street, and Dean Keeton Street received before and during the course of this study. Figures A1, A2, and A3 show the number of bicyclists recorded at each site for each hour of the day, expressed in military time (where 15 represents 1500 hours, or 3:00pm). At both Airport Boulevard and Guadalupe Street the number of bicyclists per hour was generally higher in the afternoon peak. Also, the number of bicyclists per hour at E 51st Street, and Guadalupe Street increased with time during the morning peak hours and decreased with time during the afternoon peak hours. These trends are similar to ridership trends observed on Lamar Boulevard, which was observed during a “Bicycles May Use Full Lane” sign study. There is a high, but variable number of bicycles per hour along Dean Keeton Street, so few conclusions can be drawn about bicyclist patterns at this location. The variability in bicyclist volume is most likely due to site’s close proximity to the University of Texas. The before data was collected while summer classes were in session at the University, while the after data was collected during the fall semester. The increase in bicycle volume on Dean Keeton street would be due in large part to the increase in student population during the fall semester.

**Figure A1: Number of bicycles recorded each hour of the day on E 51st Street**

*Note: These data points include bicyclists traveling in both directions along 51st Street*

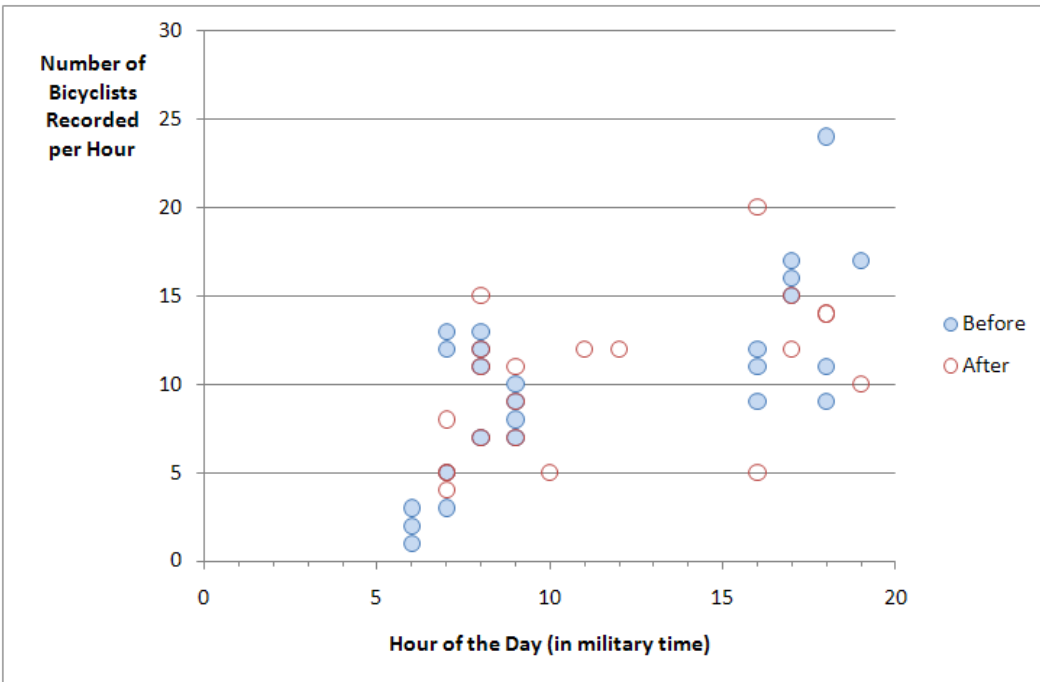
**Figure A2: Number of bicycles recorded each hour of the day on Guadalupe Street**

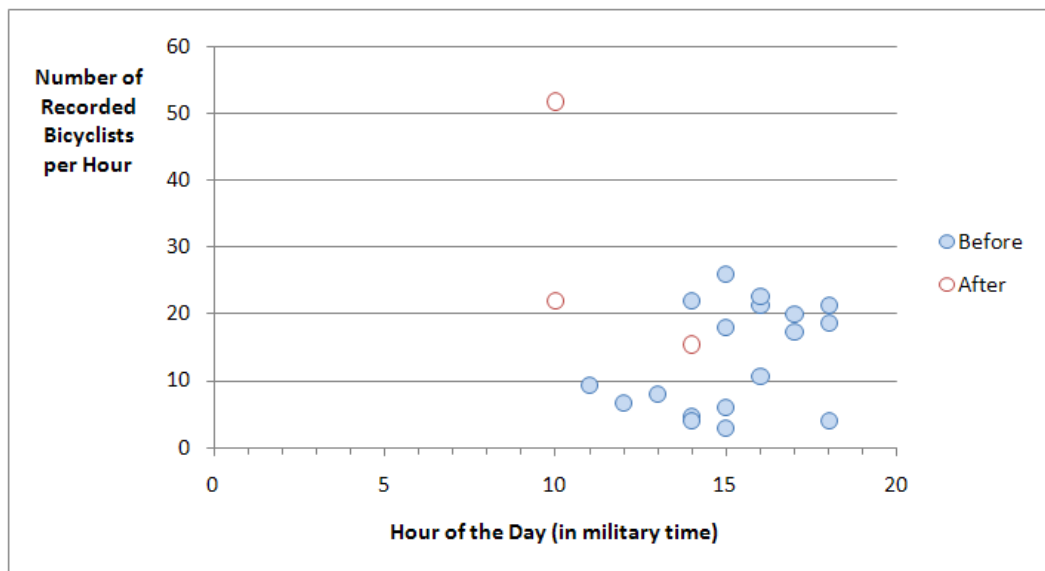
**Figure A3: Number of bicycles recorded each hour of the day on Dean Keeton Street**

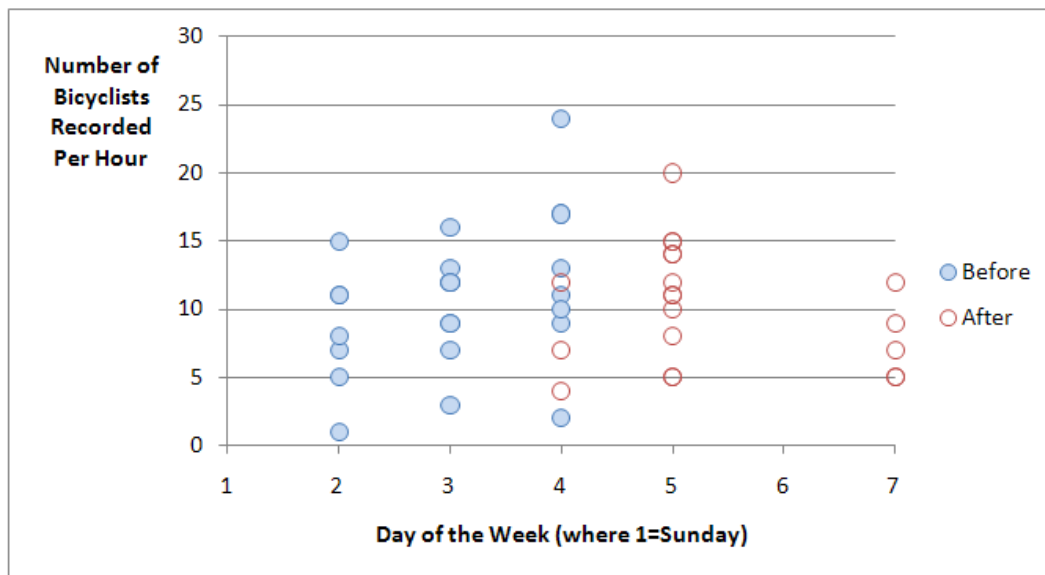
Figures A4, A5, and A6 show the number of bicyclists recorded per hour for each day of the week along E 51st Street, Guadalupe Street, and Dean Keeton Street, respectively. E 51st Street, experienced a higher hourly volume of bicyclists (9.9 bicyclists per hour) than Guadalupe Street (8.0 bicyclists per hour), but both volumes were relatively constant for each weekday. This trend contributes to the hypothesis that E 51st Street and Guadalupe Street are primarily used as commuter routes. The average volume along Dean Keeton was 16.1 bicyclists per hour and was relatively constant for each day of the week as well. This indicates that despite bicyclist volume varying each hour of a day, Dean Keeton Street experiences consistently high ridership each day of the week.

**Figure A4: Number of bicycles recorded each day of the week on E 51st Street**  
*Note: These data points include bicyclists traveling in both directions along 51st Street*

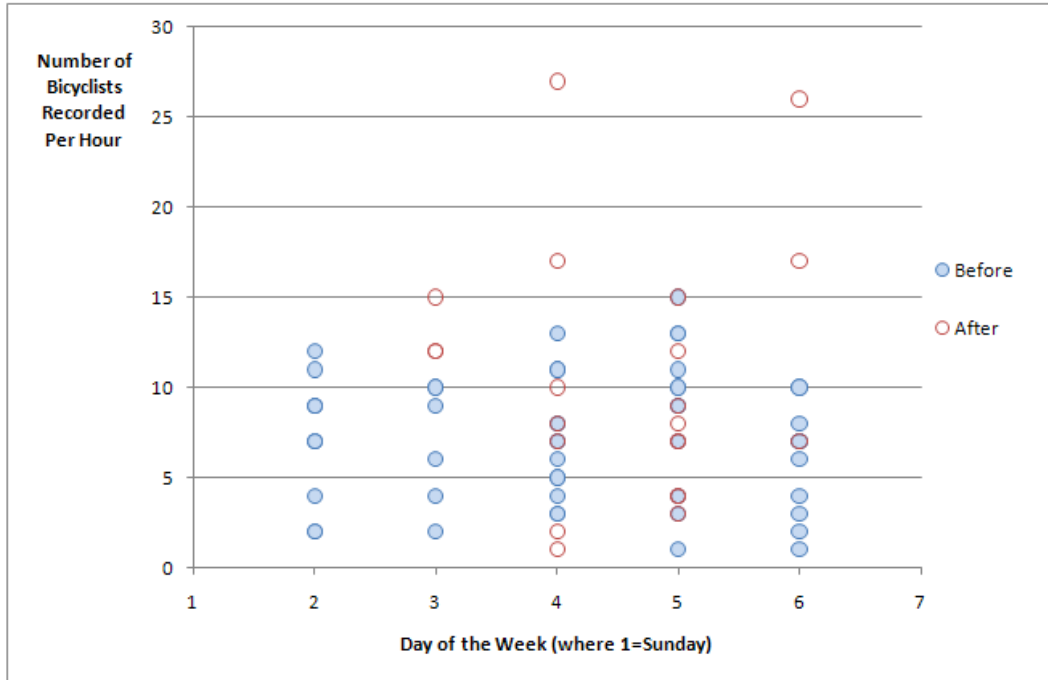
**Figure A5: Number of bicycles recorded each day of the week on Guadalupe Street**

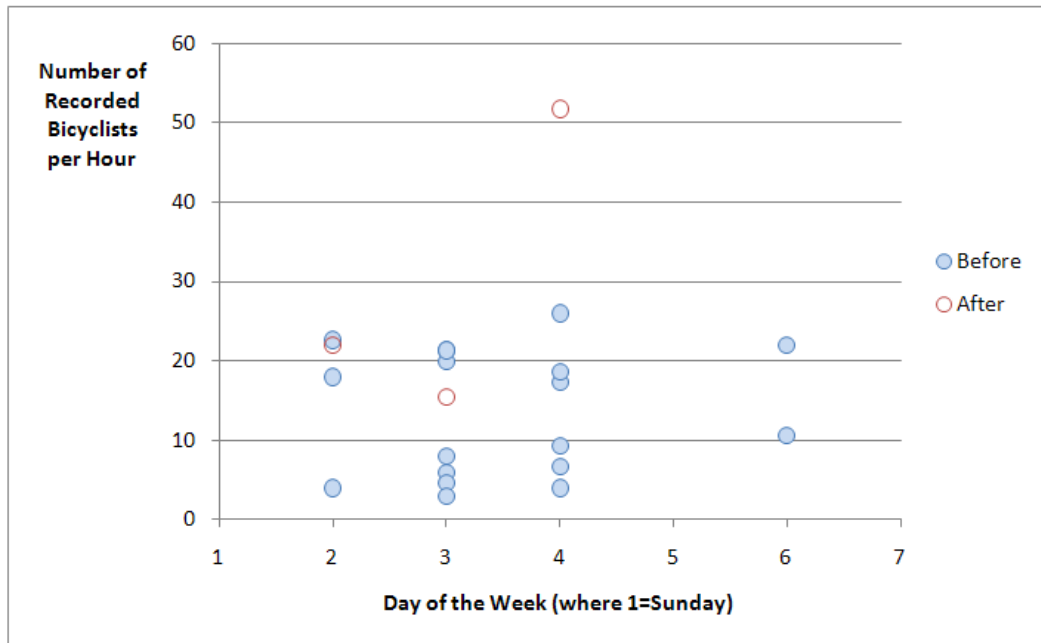
**Figure A6: Number of bicycles recorded each day of the week on Dean Keeton Street**

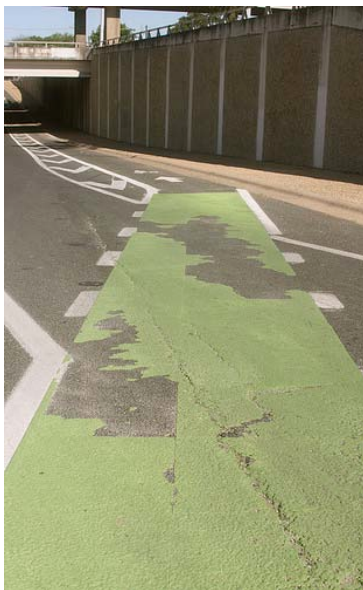
An installation error of the colored thermoplastic on Dean Keaton at the IH-35 exit ramp led to its quick deterioration. While waiting for the oil layer to dry one of the crew members spilled a large amount of water onto the oil. This water eventually led to inadequate bonding between the pavement and the thermoplastic, which resulted in the thermoplastic breaking up (illustrated in Figure B1).

**Figure B1. Deteriorating thermoplastic on one of the I-35 exit ramps (breaking up in sheets)**

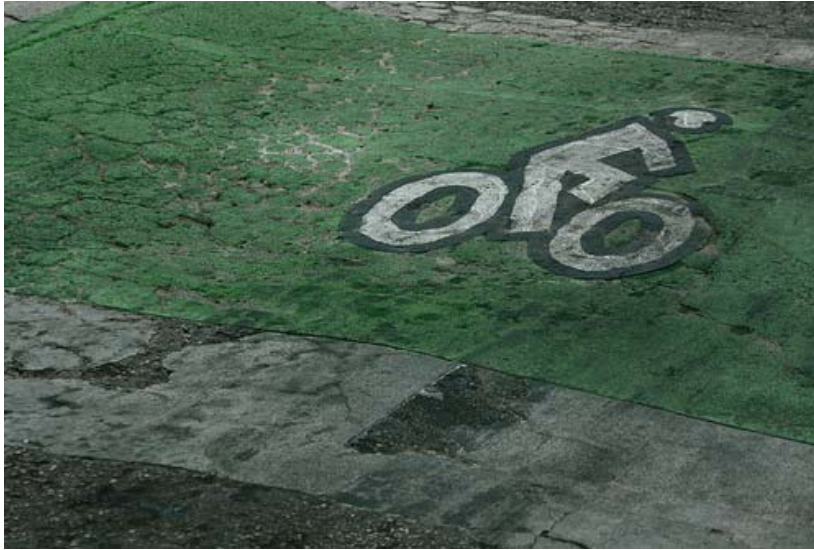
The quality of pavement was a contributing factor to the quick deterioration of the colored thermoplastic, illustrated in Figure XX. In particular, the pavement on Speedway at 38th Street is cracked and uneven from the high volume of bus traffic. (The street is scheduled for

reconstruction in the next few years.) Clearing debris from the deep cracks of the application surface was nearly impossible; applying the oil-layer to these same cracks and the other surface flaws was also troublesome. The resultant colored thermoplastic was only tenuously bonded to the street surface at best.

**Figure B2. Poor quality of road lead to the deterioration of the thermoplastic bike boxes on Speedway Boulevard**

Installing colored thermoplastic on new pavement would be the optimal situation. In the future, the City of Austin will most likely be applying a fresh asphalt surface (seal coat, microsurface, or overlay) before the installation of any proposed colored thermoplastic. A fresh street surface will provide a surface free of cracks and other defects, which could lead to erroneous installation and quick deterioration. These properties also lessen the importance of the oil layer in creating a bond between the pavement and thermoplastic.

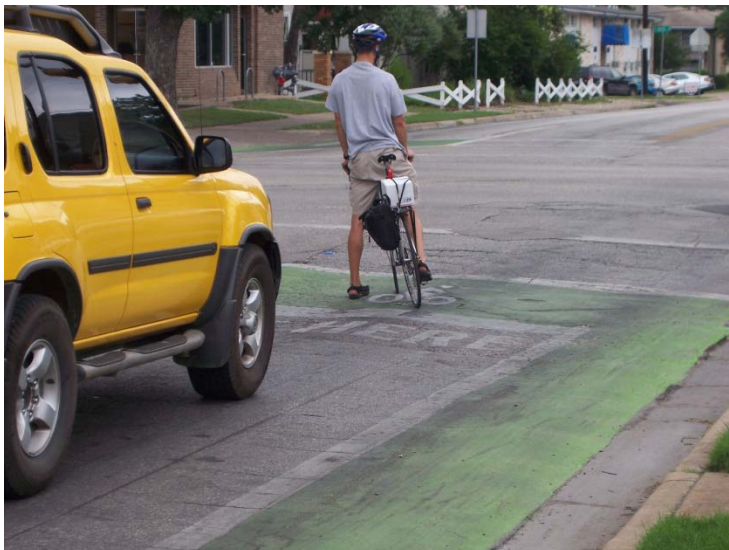
Additionally, the colored thermoplastic on Speedway was discolored very quickly (see Figure B2). This discoloration is likely due to the heavy bus traffic on Speedway, where there is a peak hourly volume of over 15 buses/hour. This discoloration may have been compounded by the buses, wider than personal cars, driving in the colored lane. Another concern with the thermoplastic is shown in Figure B7. It is unclear whether the uneven application of thermoplastic shown in the photograph is the result of a misapplication, the rough nature of the street surface, or a deterioration problem.

**Figure B3. Poor quality of road lead to the deterioration of the thermoplastic bike boxes on Speedway Boulevard**

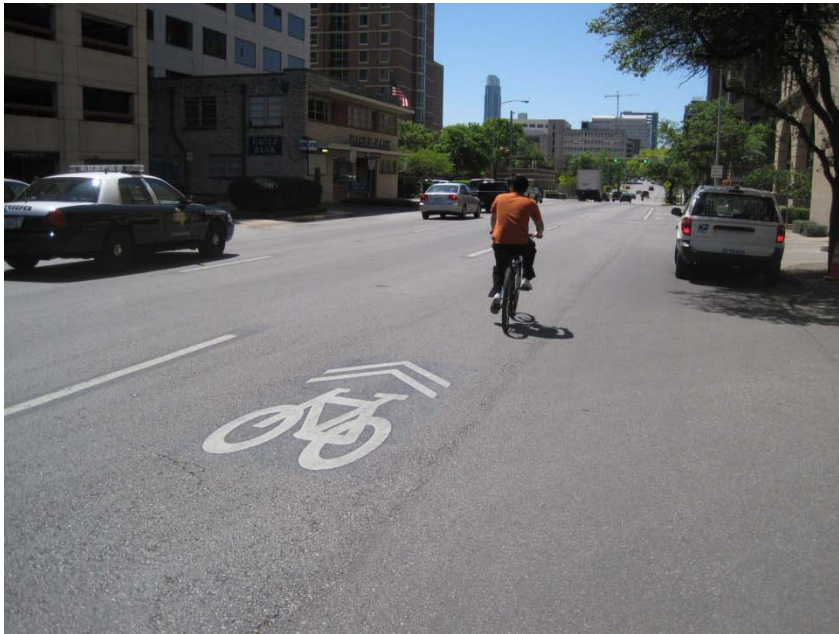
All sharrows were installed on top of a painted black box in order to provide visual contrast. Additionally, all sharrows were installed in the outside travel lanes. The sharrows on Guadalupe, Lavaca, and 51st Sts were installed in the center of the outside travel lanes as described by Figure B4. Each sharrow was individually placed in order to keep the sharrow out of the typical wheel paths and to avoid driveways where entering and exiting vehicles would have more variable wheel paths. By placing the sharrows outside of wheel paths the integrity of the thermoplastic was maintained.

**Figure B4. Central placement of sharrow resulted in thriving thermoplastic five months after installation.**

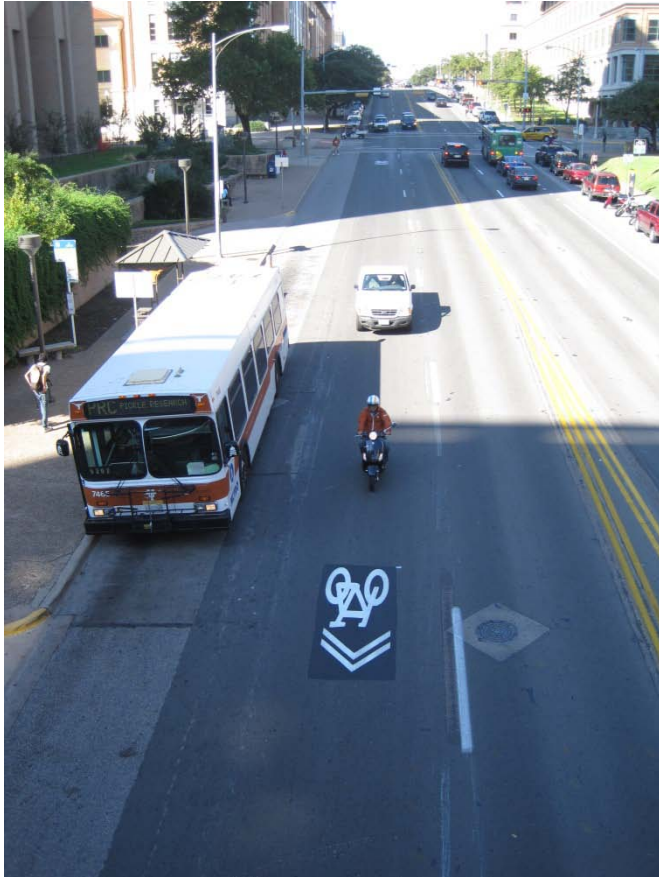
The east-bound sharrows on Dean Keeton St were installed in the center of the outside travel lanes (see Figure B5) in the same manner as the sharrows on Guadalupe, Lavaca, and 51st Sts. Like these other streets, centralizing the east-bound Dean Keeton sharrows helped to preserve the thermoplastic. Another reason these sharrows were installed in the center of the travel lane was to keep them out of the path of buses. Dean Keeton St has an extremely high volume of bus traffic (peak hourly volume of 40 buses/hour) and there a number of bus stops requiring buses to enter and exit the outer travel lane as shown in Figure B5. Finally east-bound bicyclists are also able to reach faster speeds because of the downhill allowing bicyclists and cars to travel at similar speeds.

**Figure B5. Central placement of sharrows on east-bound, downhill Dean Keeton St.**

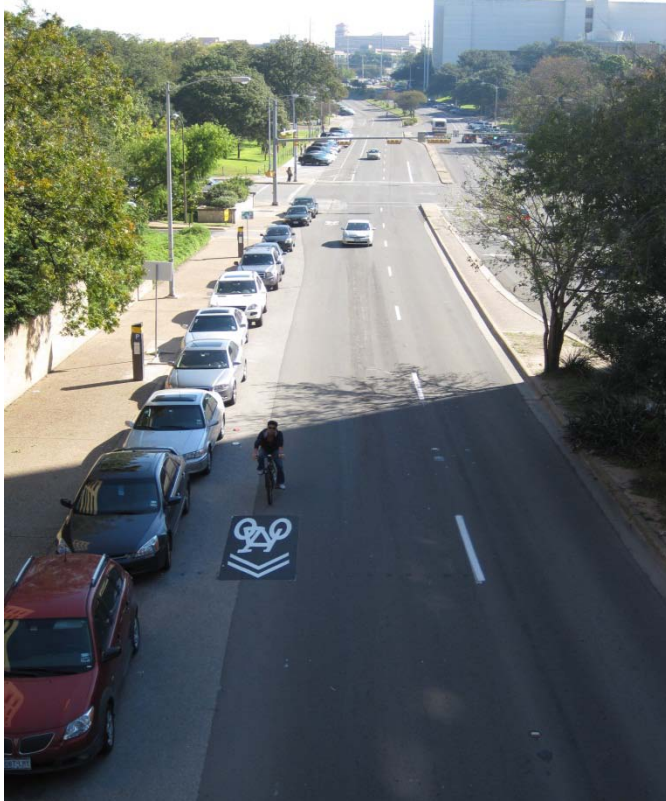
The west-bound sharrows on Dean Keeton differed from the other locations as these sharrows were aligned closer to the curb (see Figure B6). These sharrows were aligned closer to the curb for the following reasons: the outside travel lane on west-bound Dean Keeton was very large, there were no bus stops, the sharrows were only utilized to provide a bicycle facility to link two bicycle lanes, and west-bound bicyclists slow down to travel uphill.

**Figure B6. Curb-justified placement of sharrows on west-bound, uphill Dean Keeton St.**

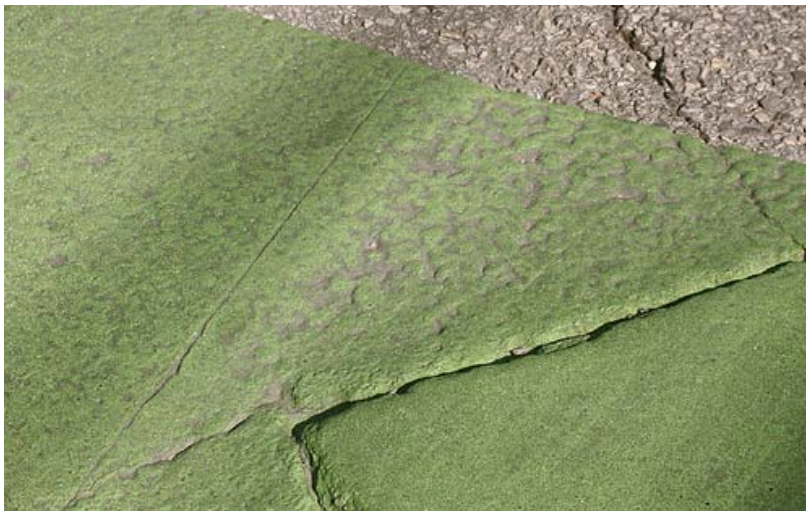
**Figure B7. Thermoplastic thinning on the colored lane on San Jacinto Boulevard**
