**FHWA Experimentation #4-298(E)  
Modified HAWK Signal and Bike Signal -  
Draft Report**

August 2, 2010

**FHWA Experimentation Number 4-298(E)**  
**Modified HAWK Signal and Bike Signal -- Portland OR**  
**Draft Report**

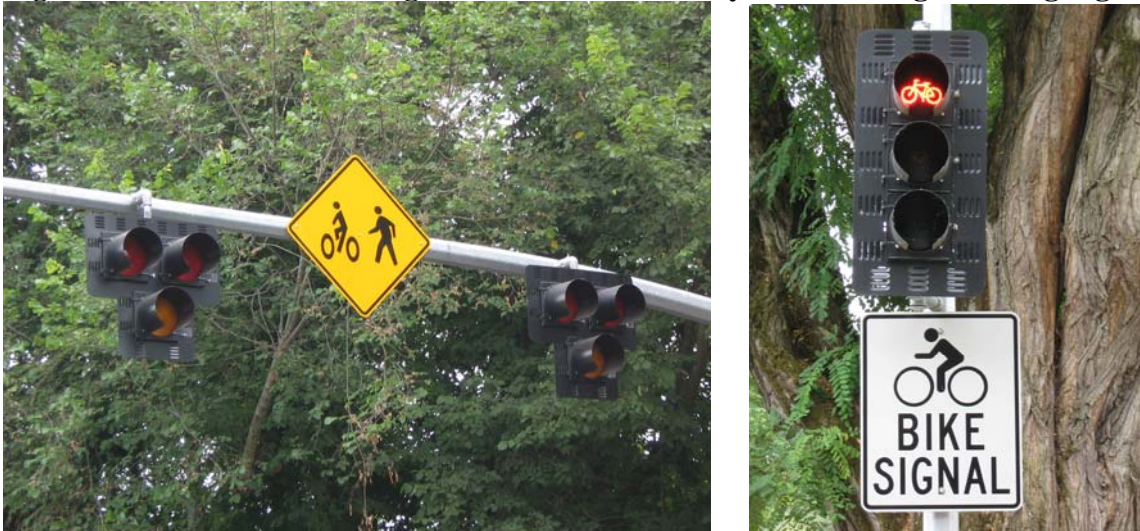
**Figure 2: E. Burnside Bike Signal and Pedestrian/Bicyclist Crossing Warning Sign**

Figure 2 shows the HAWK Signal with a Bicycle/Pedestrian Crossing Warning Sign installed overhead on the mast arm. Crossing warning signs were also installed on ground

mounted poles. Bicycle signals were installed on poles for each approach crossing the main street.

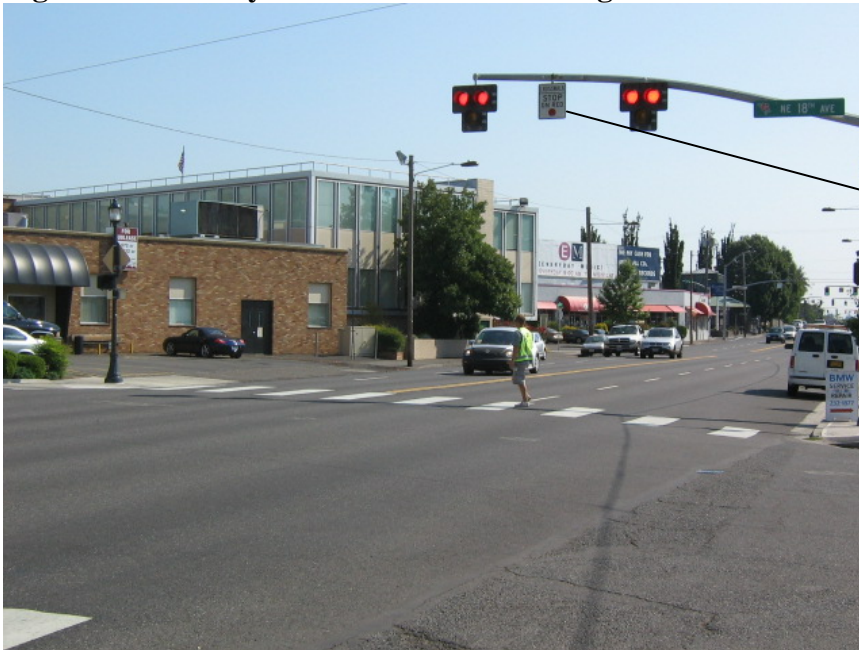
**Figure 4 NE Sandy Blvd at 18<sup>th</sup> Ave Looking East**

Figure 4 is a photograph of the easterly crosswalk showing the HAWK mast arm signals and the overhead regulatory sign.

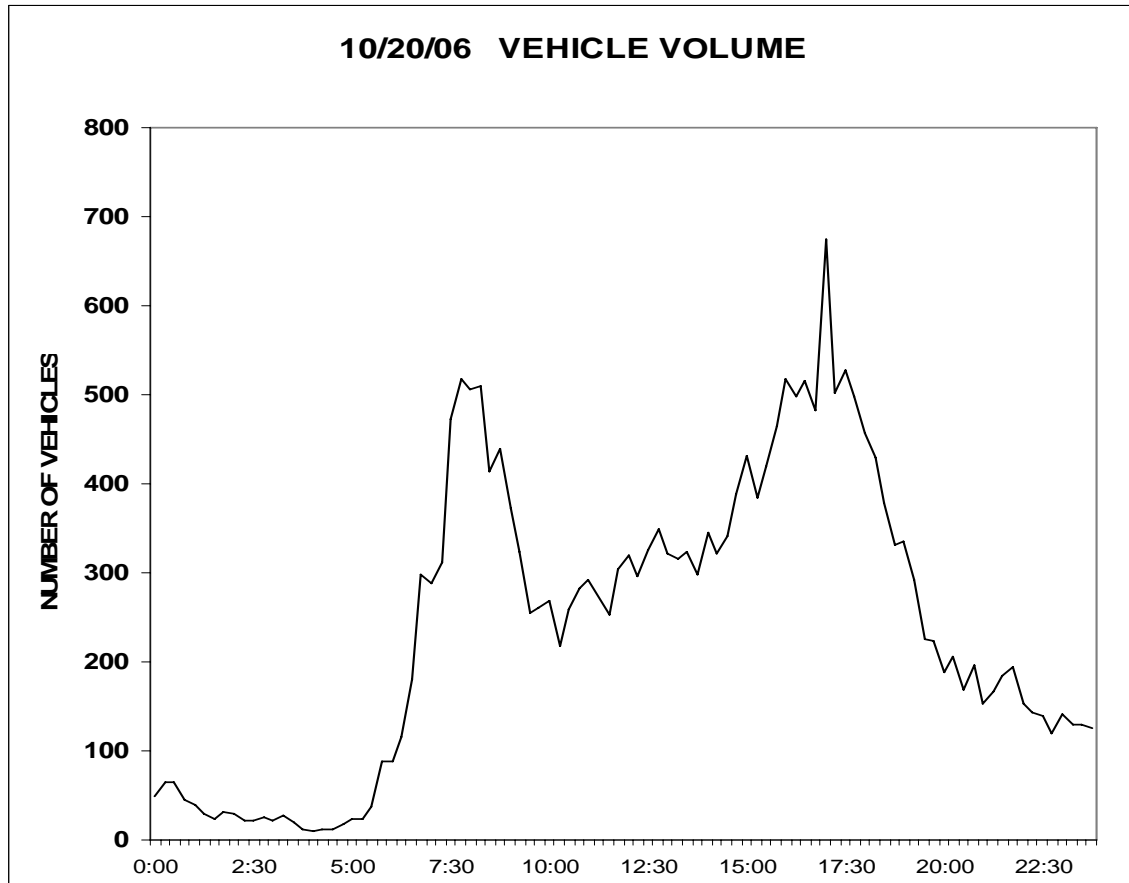
**Figure 7: 2006 Traffic Counts, Burnside/41<sup>st</sup>**

An evaluation of motorist compliance was performed at the intersection of East Burnside and 41<sup>st</sup> Avenue. Video logs and Programmable Logic Controller (PLC) data were reviewed. Figure 7 shows hourly traffic volumes on East Burnside that were counted on October 20, 2006, fifteen days after the HAWK signal was installed. Since the majority of traffic (16,681 out of 23,319 or 71.5%) occurred between the hours of 7 am (0700) and 6 pm (1800), the video logs and PLC data were retrieved for that time frame.

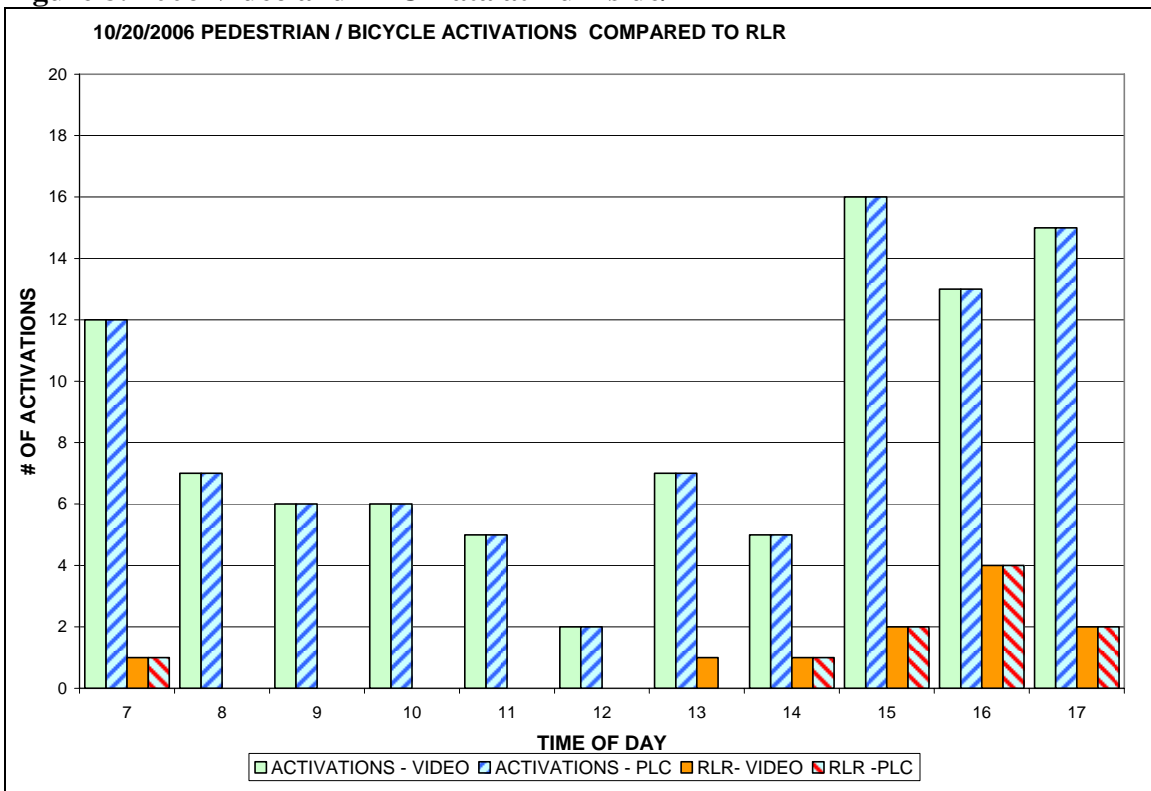
**Figure 8: 2006 Video and PLC Data at Burnside/41<sup>st</sup>**

In order to determine the initial motorist compliance rate, the total number of activations (complete HAWK signal cycles) and the number of activations with RLR were compared to determine the percentage of activations without RLR. Figure 8 summarizes observations taken from video logs as well data from the PLC. The video logs and PLC data were reviewed for Friday, October 20, 2006, from 7 am (0700) to 6 pm (1800). The video logs showed seven RLR events or a 92% compliance rate. The PLC data indicated ten RLR events or 89% compliance. This percentage is lower than the percentages published in NCHRP Report 562 (Reference 1), which reported a compliance rate for HAWK signals in the range of 94% to 100%.

Observations from video logs and data collected by the PLC indicated that, initially, Red Light Runners (RLR) occurred randomly during the signal operations. However, as drivers became accustomed to the operation of the HAWK signal, there were fewer RLR and the majority of RLR occurred during or immediately after the main street clearance interval. The video logs for October 20, 2006 showed 7 out of 11 or 64% RLR occurred

during the Yellow to Red transition and 4 out of 11 or 36% RLR occurred during the steady Red indication.

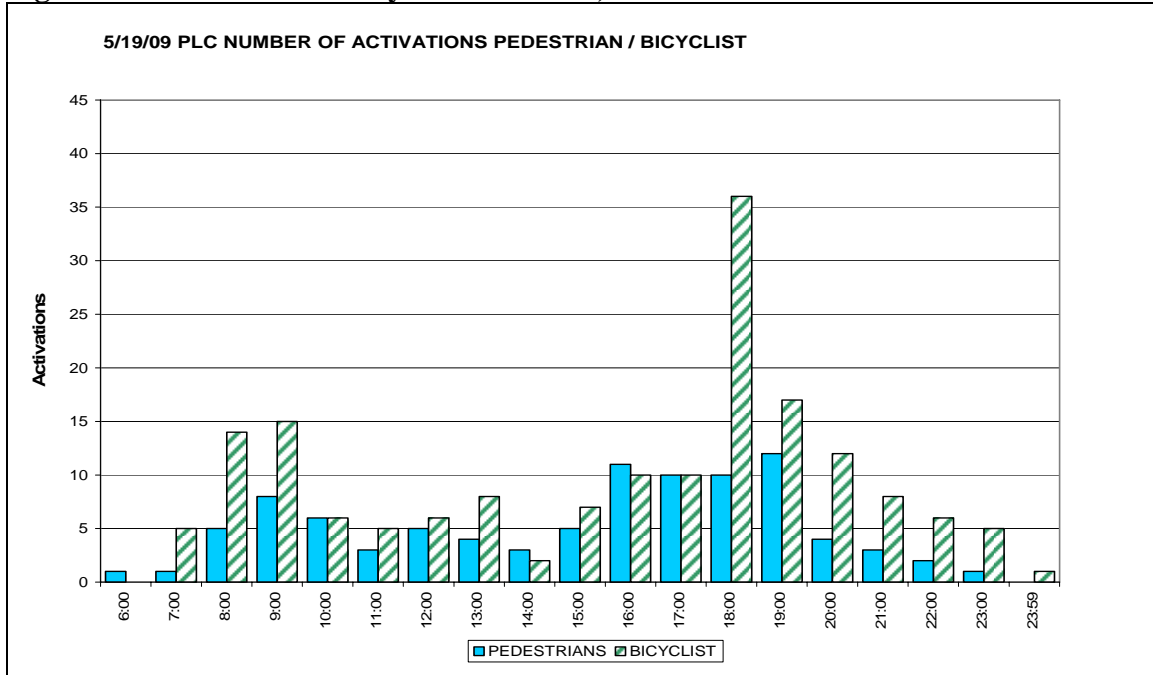
**Figure 10: Pedestrian & Bicycle Activations, Burnside/41st**

Figure 10 shows the pedestrian and bicycle activations over a 24 hour period at the intersection of East Burnside & 41<sup>st</sup> Avenue, which was taken from PLC data recorded on May 19, 2009. The number of activations increased during the peak hours, which may be indicative of the use of the HAWK signal to obtain crossing gaps when there were high traffic volumes on the arterial street.
