Evaluation of Automated Pedestrian Detection at Signalized Intersections

REPORT NO. FHWA-RD-00-097

August 2001

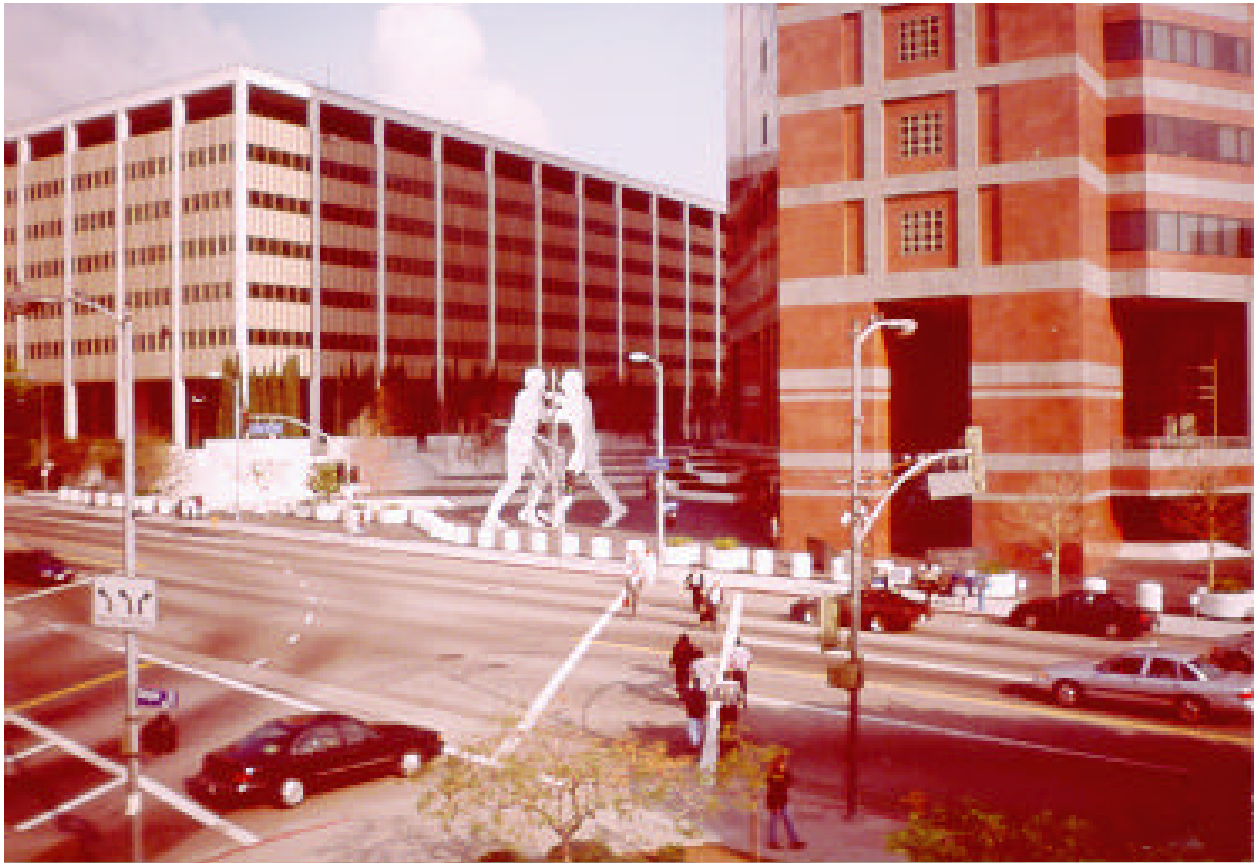
Figure 2. Temple and San Pedro (Los Angeles).

The Temple and San Pedro site is a “T” intersection (Figure 2). Temple Street is an east-west street and San Pedro Street comes from the south to form the “T.” There are marked crosswalks and push buttons across the east and south legs only. A sign directs pedestrians wishing to cross the west leg to the east leg. The signal controlling the south side crossing is on pedestrian recall. Automated pedestrian detectors were added to the east side crosswalk. On both the northeast and southeast corners, one detector picked up pedestrians who entered into the detection zone on the sidewalk (waiting to cross the street) and a second detector picked up pedestrians who were still in the crosswalk.

If a pedestrian was detected as still being in the crosswalk, the crossing time was extended by 0.2-s increments to a maximum of 6 additional seconds. The extended crossing time corresponded to a walking speed of 0.9 m/s (3.0 ft/s), compared with the customary 1.2 m/s (4.0 ft/s). During the extended crossing interval, the steady Don’t Walk signal was displayed and the onset of the green signal for opposing motorists (traveling on Temple) was delayed.

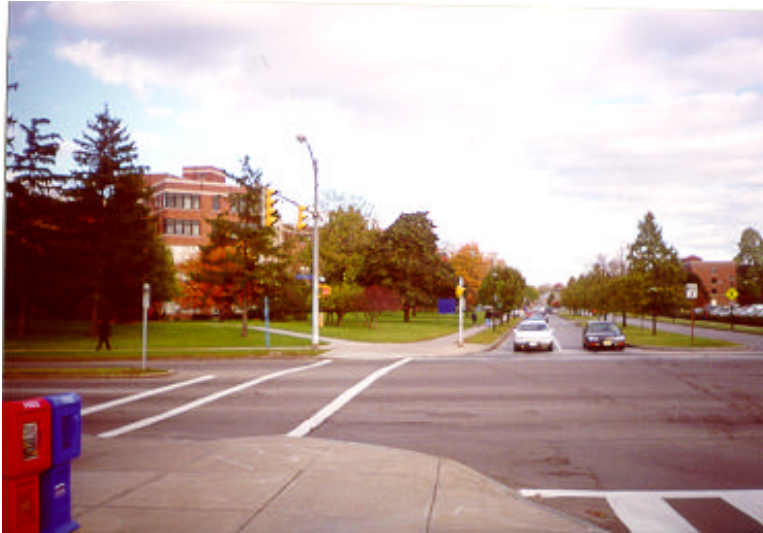
Figure 3. Crittenden and Lattimore (Rochester).

Lattimore Road is a north-south road, and Crittenden Boulevard is an east-west road (Figure 3). The west leg of this intersection is an entrance to a large parking lot. Both the north side and the south side crosswalks were controlled by push buttons. Each push button controlled both the north side and south side crosswalks. The signal controlling the east side crosswalk was on pedestrian recall. Unlike the other three crosswalks, the west side crosswalk was a ladder design, and was not controlled by a pedestrian signal. The north side crosswalk was the treatment site. It connected the parking lot to the University of Rochester medical complex. The south side crosswalk connects two parking lots.

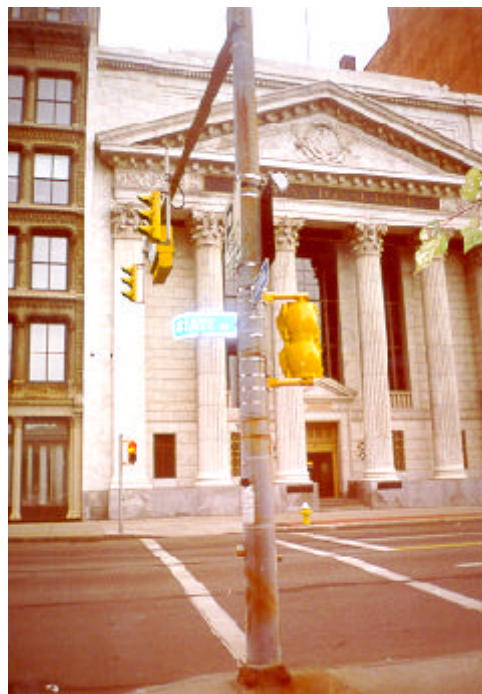
Figure 4. State and Corinthian (Rochester).

This intersection is in downtown Rochester. State Street is a north-south arterial, and Corinthian Street is a very short east-west street that forms a T-intersection to the west (Figure 4). The east end of Corinthian is a municipal parking garage. The north side crosswalk is controlled by a push button. There was no pedestrian signal controlling the east side crosswalk. The south leg did not have a

marked crosswalk. Traffic on State always had the green light unless there was a vehicle on Corinthian or unless a pedestrian pushed the button.

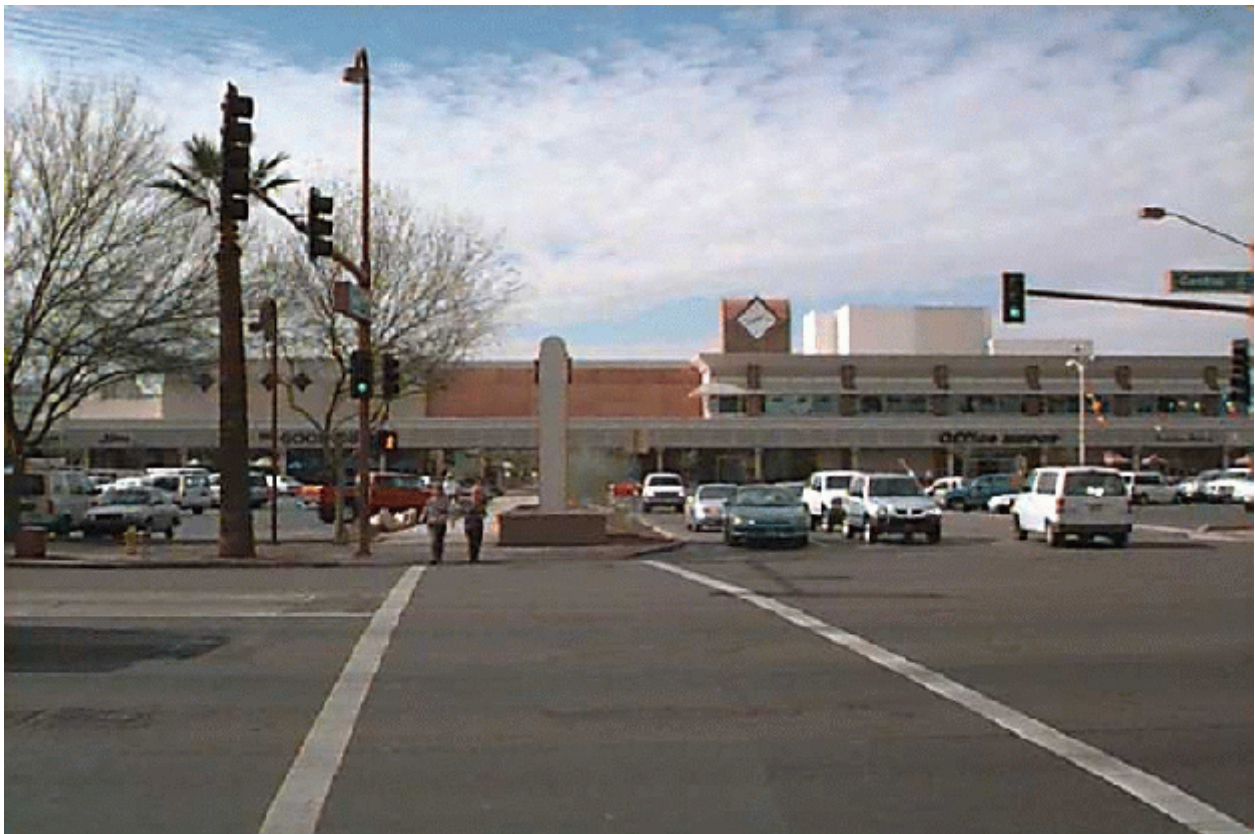
Figure 5. Central and Earll (Phoenix).

Central Avenue is a major arterial with seven lanes and an ADT of more than 38,000 (Figure 5). Earll Drive is a main driveway to Park Central Mall (west leg) and aligns with a local street on the east side of the intersection. The vehicle traffic on Earll is intermittent and the number of pedestrians crossing Central varies throughout the day. Since traffic volumes on Central are high for most of the day, fixed-time operation (which would provide a pedestrian Walk interval on every cycle, including times when pedestrians are not present) could cause substantial congestion.

Field testing was conducted at the intersection of Central and Earll Drive in central Phoenix. All pedestrians are required to cross Central Avenue on the south leg crosswalk. Pedestrians must use the push buttons on the southwest or southeast corners of the intersection to obtain a Walk signal and enough time to cross Central Avenue. Without pedestrian actuation, pedestrians will usually not have enough time to cross Central Avenue. The pedestrian detector was installed at the southwest corner of Central Avenue and Earll Drive to detect eastbound pedestrians waiting to cross Central Avenue. The detector was set up to supplement the pedestrian push button at the corner.

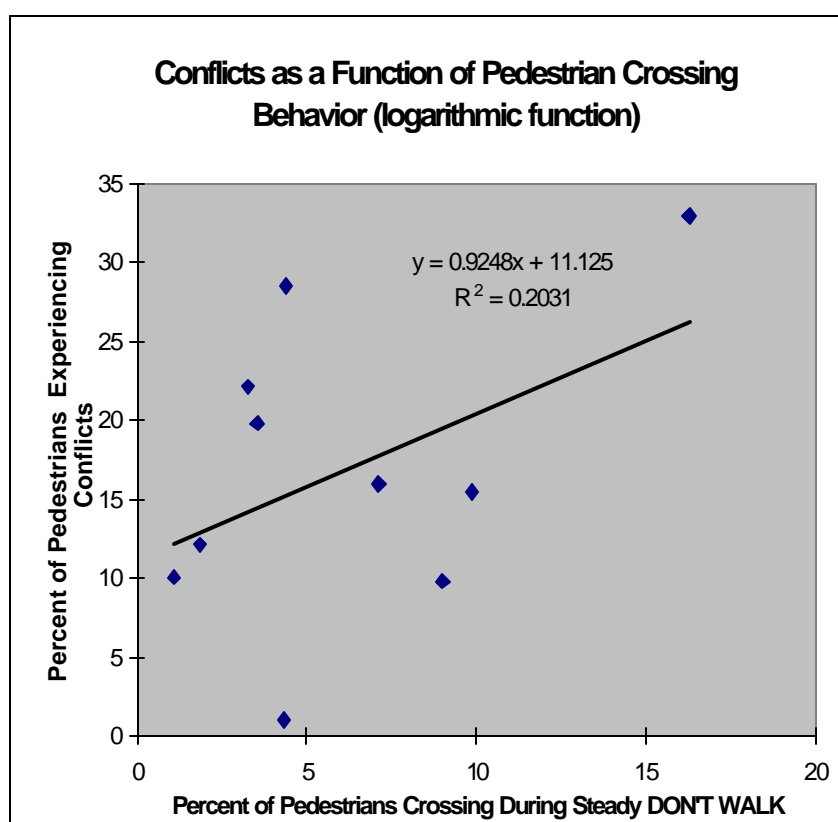
Figure 8 shows the relationship between conflicts and the likelihood of pedestrians crossing during the Don't Walk phase. A linear relationship accounts for only about 20 percent of the variance ($R^2 = 0.20$). Note that the y-intercept of the function would lead one to predict that about 10 percent of all pedestrians would still encounter some form of conflict even if the percentage of pedestrians beginning to cross during the Don't Walk signal was reduced to zero.

Figure 8. Pedestrian-vehicle conflicts as a function of the percentage of pedestrians crossing during the steady Don't Walk phase.

Logarithmic and exponential "fits" were found to offer no improvement over the simple linear function. While it was possible, for example, to account for almost twice the variance with a fourth-order polynomial, the process that might be responsible for producing such a complex relationship is not at all clear. More precise clarification of these relationships lies beyond the limited data provided by observations of these three sites. It is sufficient to say that as more pedestrians begin to cross during the
