Safety at Half-Signal Intersections in Portland, Oregon

Master of Science
in
Civil and Environmental Engineering

Portland State University
2015

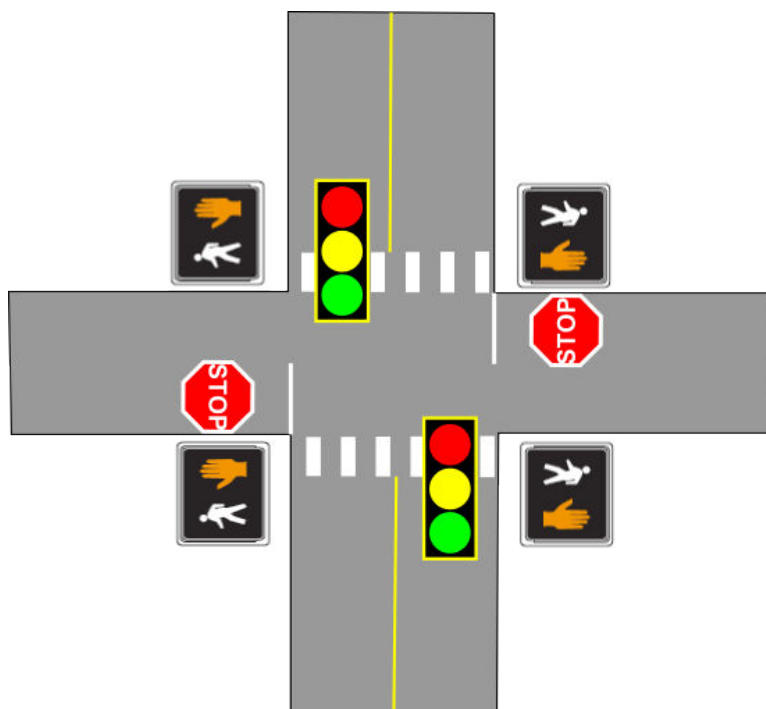
Figure 1: Half-Signal Simplified Overhead Layout

At an intersection the half-signal has a standard red-yellow-green traffic signal for automobiles on the major road, a stop sign for motorists on the minor road, and a pedestrian signal with actuation for pedestrians and/or bicyclists on the minor road. When the actuator is pressed, after some delay, traffic is stopped on the major road, pedestrians are given a walk indication, and bicyclists and motor vehicles on the minor road proceed after obeying the stop sign. Throughout the course of this thesis, the terms half-signal, pedestrian signal, and half-signalized intersection are used

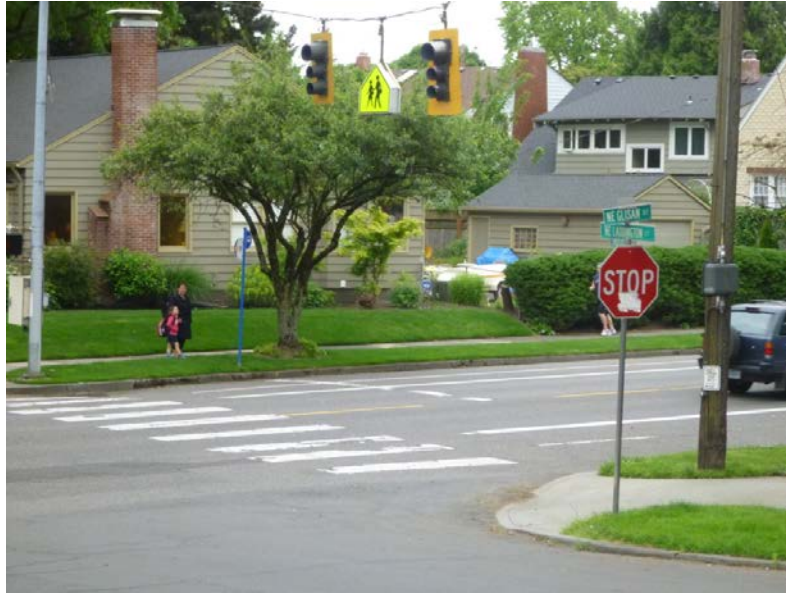
Figure 2: Half-Signalized Intersection, NE Laddington and NE Glisan, Portland, OR

interchangeably to indicate the type of intersection as described above and shown in Figure 2.

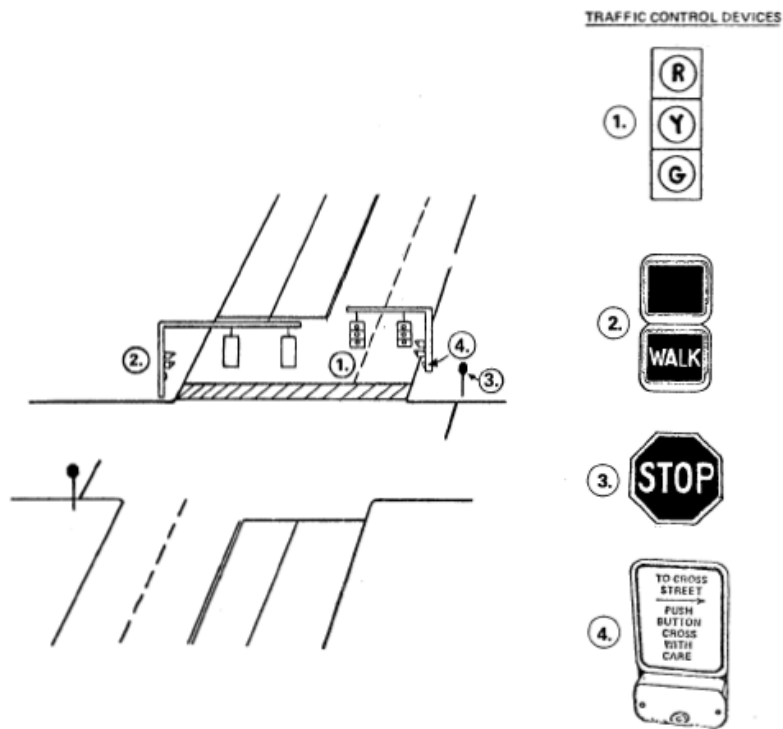
Figure 3: Typical Design of a Seattle, WA Half-Signal (8)

One design used in cities is shown in Figure 3. This design uses one crosswalk and one mast-arm or guide wire to support vehicular signals for both directions. This type of design was more popular due to its lower cost and was used in Lincoln, NE; Kansas City, MO; and Wichita, KS. This design is currently used in Seattle, WA. The current design in Seattle also includes signage at the unmarked pedestrian crossing that restricts crossing and directs pedestrians to use the adjacent signal and crosswalk.

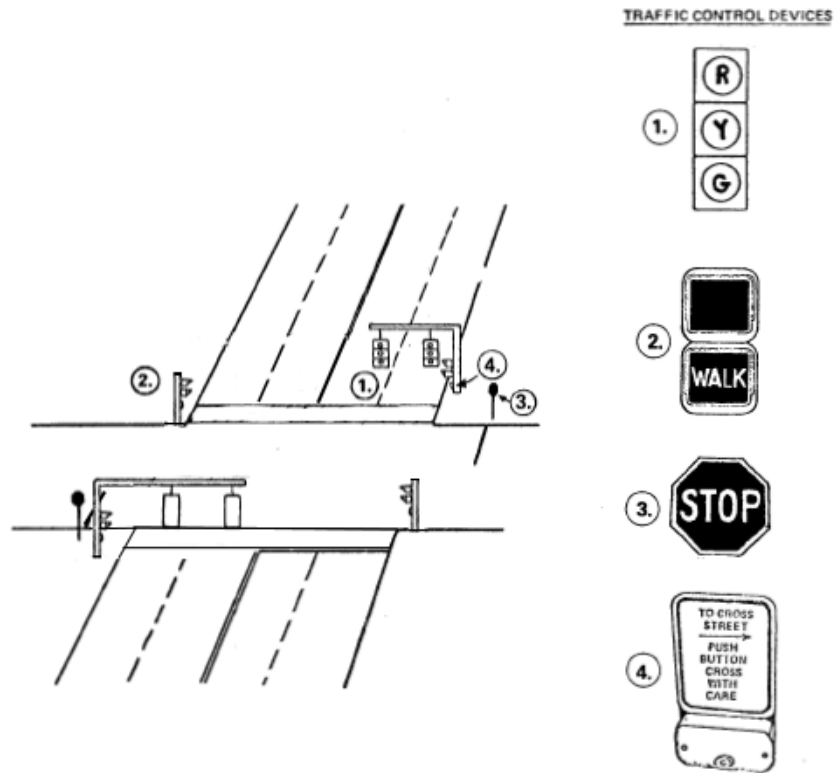
Figure 4: Typical Design of Portland, OR Half-Signal

By contrast, the half-signal installations in Portland, OR typically have two crosswalks and a signal post and mast-arm for both directions of travel. This configuration is shown in Figure 4. Half-signals in Portland also typically have two diamond-shaped pedestrian crossing signs on the mast-arm which flash prior to, during, and after signal actuation. At these locations there are typically also roadside pole-

mounted pedestrian crossing signs to alert motorists about the presence of pedestrians; these are not shown in Figure 4.

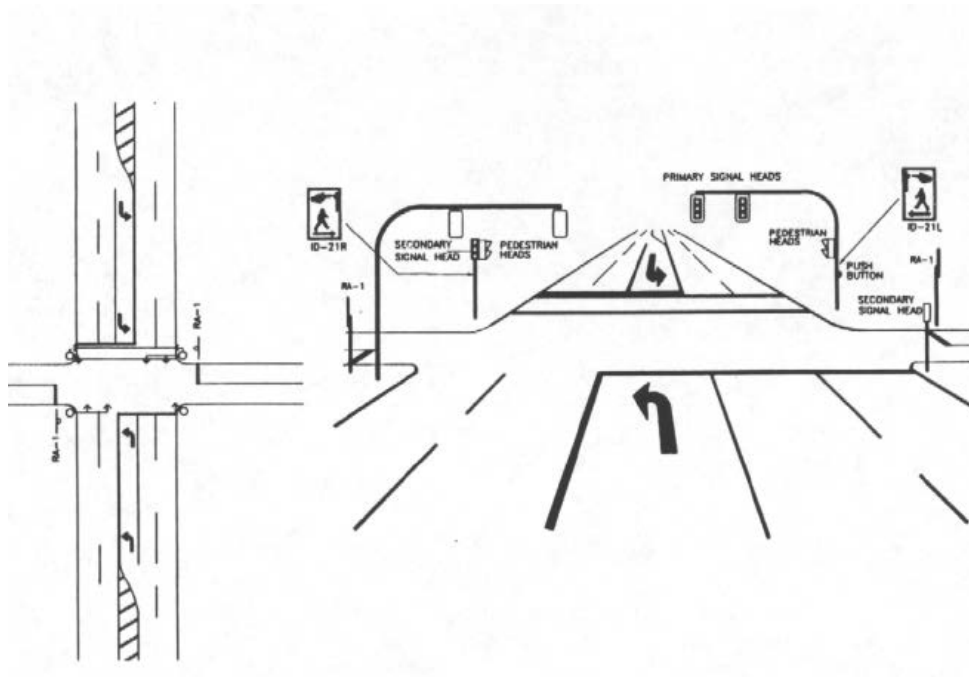
Figure 5: Typical Design of a Canadian Half-Signal (13)

The design of Canada's half-signals are controlled by their Pedestrian Crossing Control Manual (12). While this design still uses two signals poles, this design differs from Portland's in that typically only one pedestrian crossing is striped on the road. This design is shown below in Figure 5. One exception in the signal design across Canada is

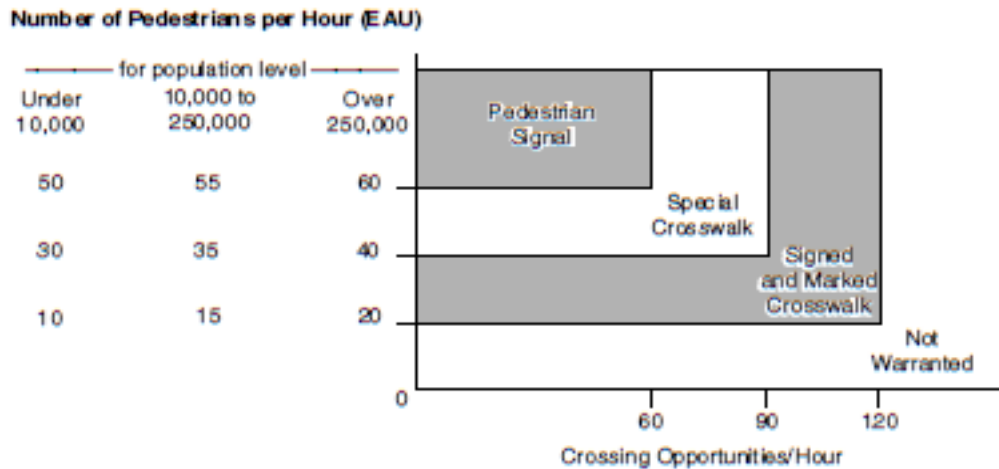
Figure 6: Pedestrian Crossing Control Warrant Chart (13)

As a contrast to Figure 6, the full-signal pedestrian volume warrant for the MUTCD in the USA is shown in Figure 7. The MUTCD warrant for installing pedestrian hybrid beacons at midblock locations is shown in Figure 8.

For a large city on a high-speed high-volume road, the half-signal warrant in Canada requires at least 60 pedestrians per hour. Under similar conditions in the United States, a full-signal needs 90 pedestrians per hour to meet the warrant and a pedestrian hybrid beacon needs 20 pedestrians per hour to meet the warrant. It is suspected that the pedestrian hybrid beacon warrant is comparatively low since these beacons are not currently placed at intersections and thus these devices are less desirable in most applications for pedestrians.

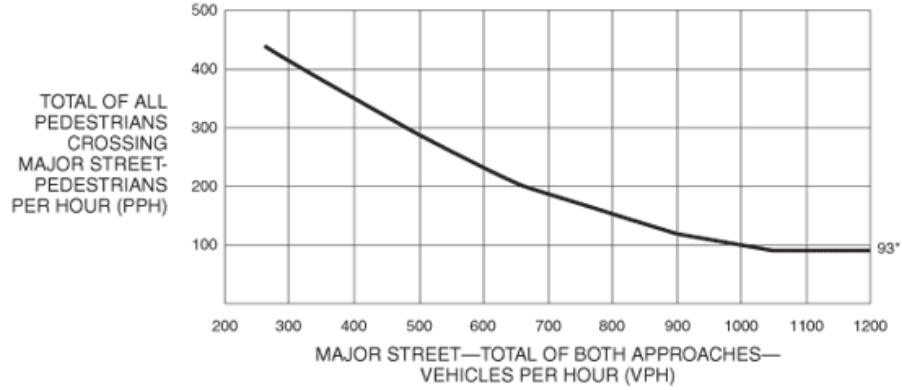
Figure 7: MUTCD Warrant 4 - 70% Pedestrian Peak Hour Volume

Figure 4C-8. Warrant 4, Pedestrian Peak Hour (70% Factor)

*Note: 93 pph applies as the lower threshold volume.

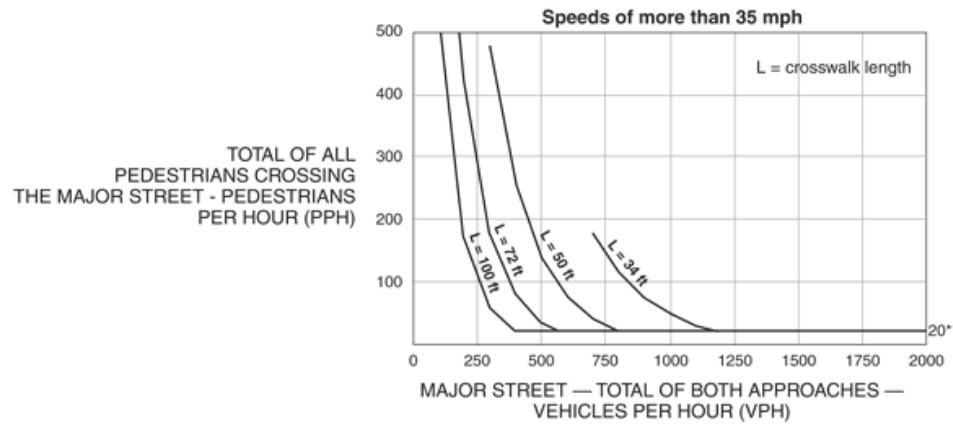
Figure 8: MUTCD Warrant - Pedestrian Hybrid Beacons High-Speed

Figure 4F-2. Guidelines for the Installation of Pedestrian Hybrid Beacons on High-Speed Roadways

* Note: 20 pph applies as the lower threshold volume

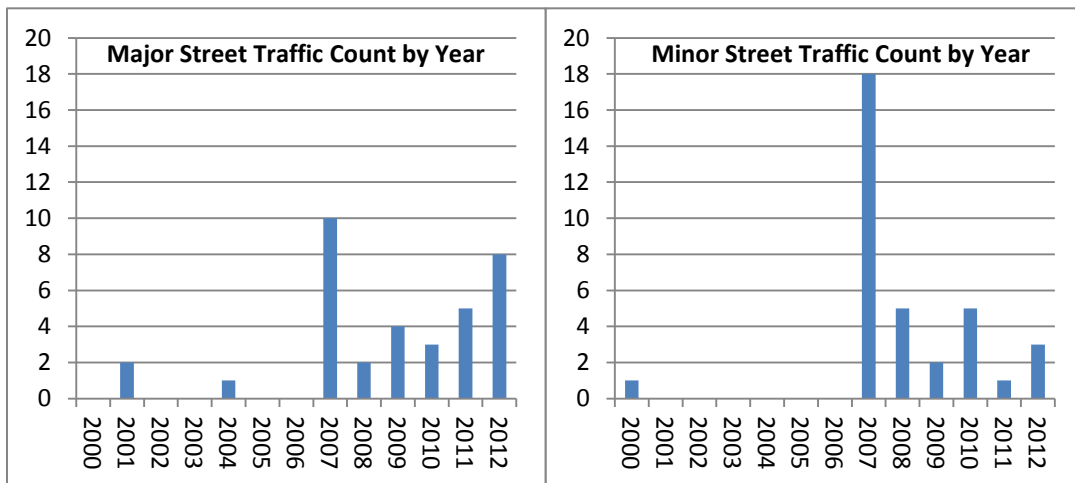
Figure 12: Traffic Count Distribution by Year

Traffic volume counts on major and minor roads were not available for all intersections. Of the 47 half-signalized intersections, 35 had traffic volumes for all approaching streets. Traffic counts were often not available at the specific intersection so nearby traffic volumes were used provided that they were on the shared street within ten blocks of the intersection and that there was not a collector or arterial road in between the traffic count and the intersection in question. Sources used to obtain traffic volumes included the City of Portland through the web-based portlandmaps.com and their GIS layer, ODOT, and Google search queries. Due to the variety of sources, traffic counts varied in the year that the count was performed. Traffic counts collected varied from 2000 to 2012 and the distribution of years for major and minor streets are shown in Figure 12. A majority of traffic counts on the minor street were obtained from a Portland Bureau of Transportation (PBOT) GIS layer with counts from 2007.

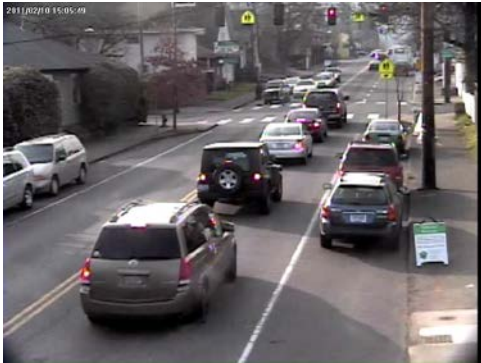
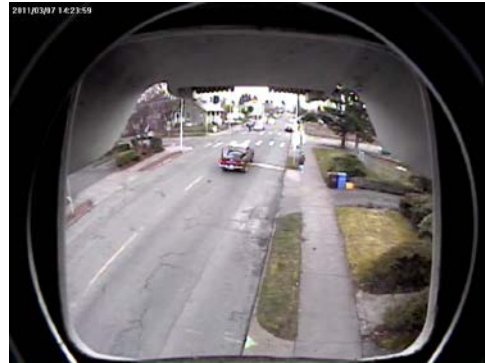
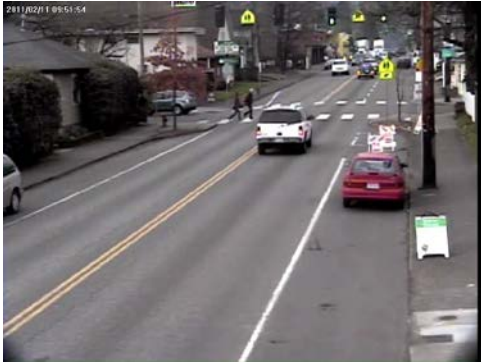
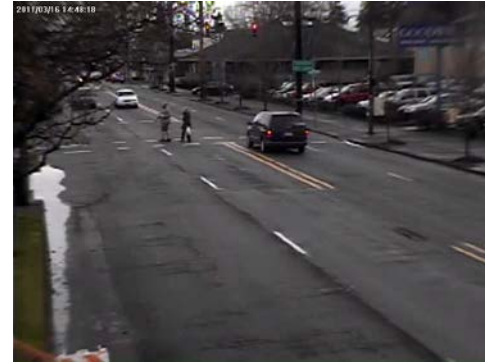
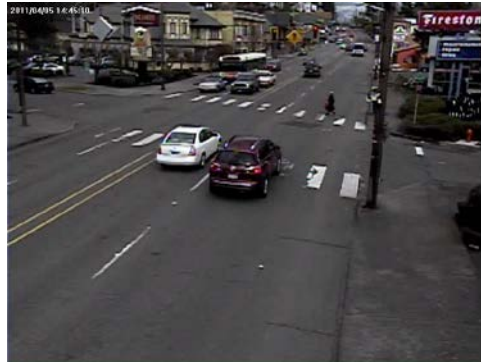
Figure 13: Sample Screen Captures from Half-Signals

Video cameras were pole mounted close to each of the five half-signal intersections along the major street. It was requested that the signal head, pedestrian

movements, and vehicles from major and minor roads be visible. A screen capture from each half-signal intersection is shown in Figure 13.

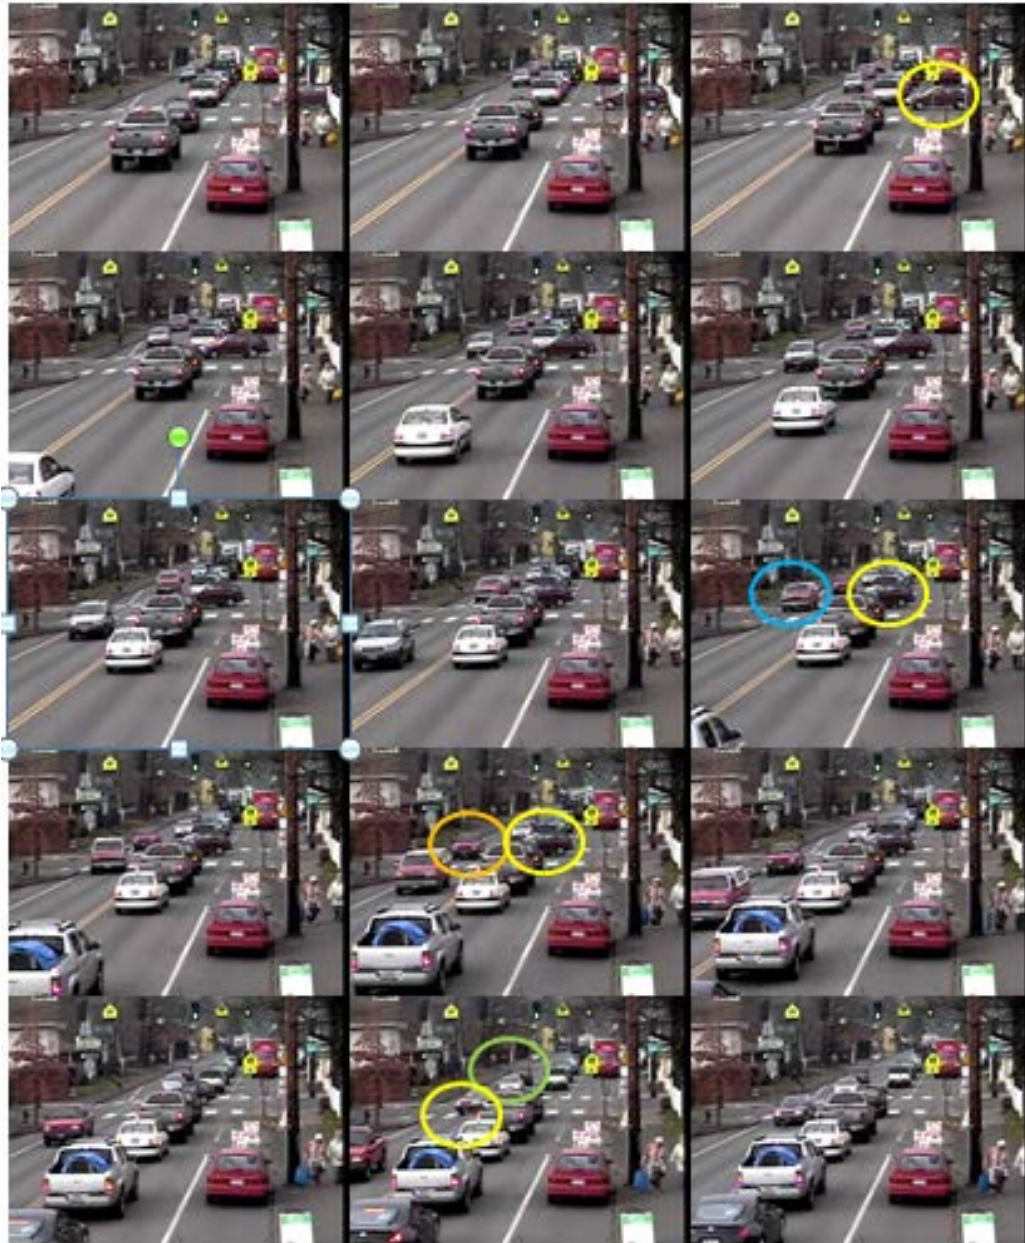
Figure 14: Left-Turning Conflict due to queuing at SE 15th and Tacoma Portland, OR

To illustrate this conflict type, a series of still images are shown in Figure 14 from SE Tacoma St and SE 15th Ave.

The vehicle causing a conflict is a red Subaru (circled in yellow) and enters the picture from the minor street on the right side of the photographs. The ninth frame shows an orange and white truck (circled in blue) and the eleventh frame shows a red SUV (circled in orange) both altering their course in response to the red Subaru. The silver car (circled in green) behind these two vehicles stops on the green allowing the red Subaru to complete the left turn. This type of conflict in places where queuing backups are a problem could be eliminated by prohibiting left and through movements at that intersection.

The vehicle on the minor street in many instances decided to proceed after stopping at the stop sign without being able to see traffic in the far lane. After proceeding halfway into the intersection, the vehicle nosed into the far lane and caused conflicts with motorists proceeding through the intersection on a green signal. It is unclear to what extent this is unique with half-signal intersections when compared with minor stop controlled intersections. It was not possible to determine if motorists on the major street were expecting to see a vehicle turning left from the minor road in front of them while having a green signal, however all of these motorists on the major street did avoid this conflict by changing course. These conflicts due to queuing happened to five vehicles and two bicycles at two intersections.

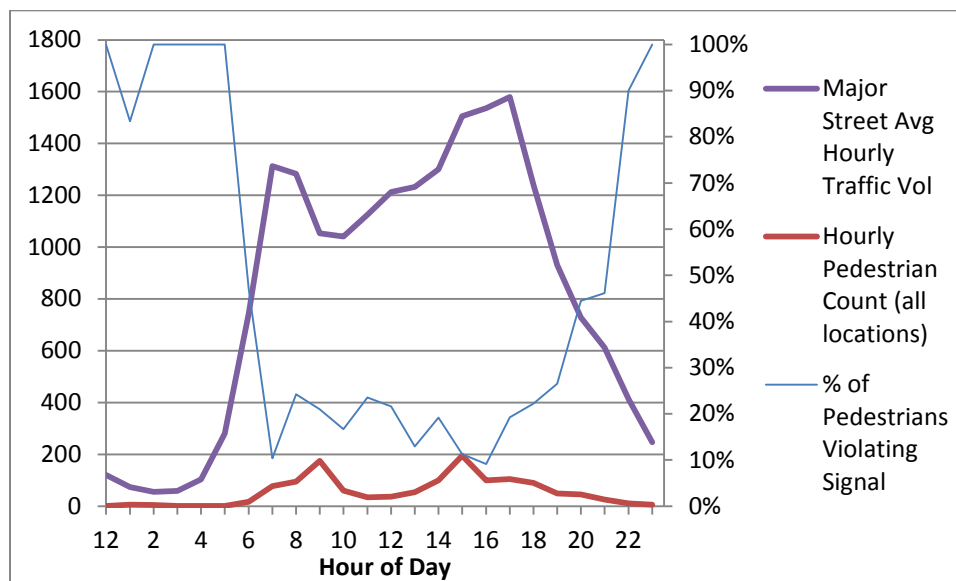
Figure 15: Pedestrian Signal Violation Rate by Hour of Day

Violation rates are typically associated with the delay that pedestrians experience waiting for a signal to change. Other studies have observed similar violation rates at fully signalized intersection with 6-21% of pedestrians violating the “Do Not Walk” phase (41). The Petzold and Nawrocki study (8) measured 10.3%- 22.0% pedestrian violations at half-signals and 25.7%-32.8% violation rates at reference semi-actuated fully signalized control sites. Violation rates are averaged across all five locations and plotted throughout the day with major street traffic and this is shown in Figure 15.

From Figure 15, on average, there were not particular peak times during daylight hours such as peak pedestrian times when pedestrian signal violation rates were higher. During the nighttime when there are lower traffic volumes, violation rates were high but pedestrian volumes were also low.

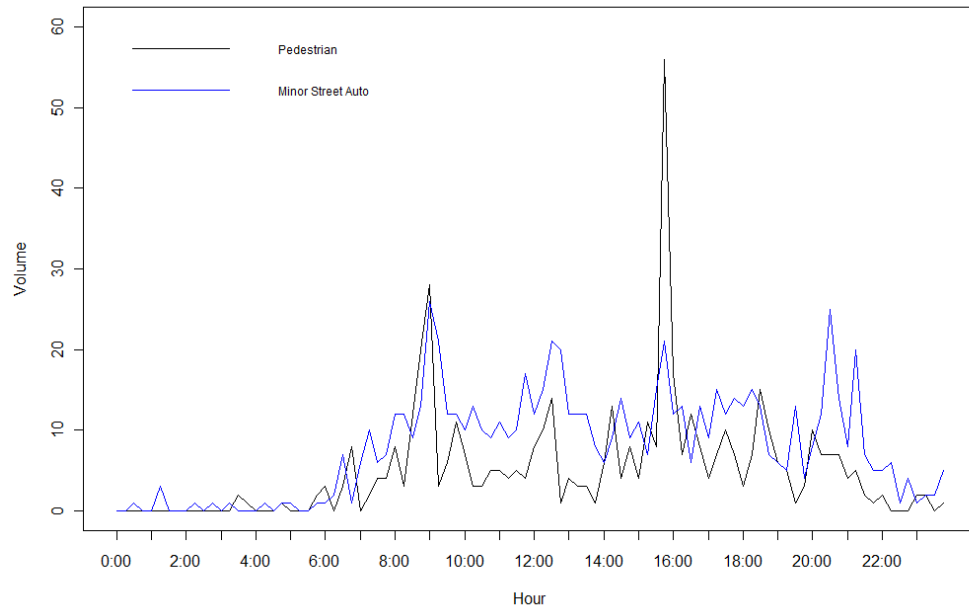
Figure 16: SE Tacoma and SE 15th February 11, 2011 Peak Hours 8:00-9:00 and 14:30-15:30

Independent variables included vehicle arrival and departure times, queue position, vehicle movement, pedestrian presence crossing the minor and major streets, if a vehicle was stopped at the signal on the major road, and if there was a vehicle across the intersection on the minor road. Since it was noticed that around school times there is a definite peak for pedestrian activities at the half-signal, an independent variable was included that indicates whether it is one of the two peak school hours. This variable may have colinearity with other independent variables. An example of peak hours associated with school activity is shown below in Figure 16.
