City of Boulder

Pedestrian Crossing Treatment Installation Guidelines

November 2011

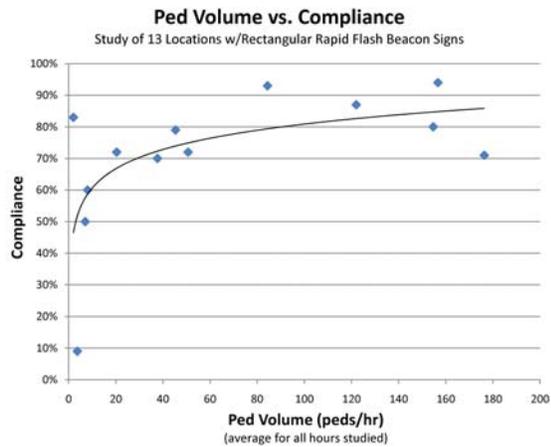
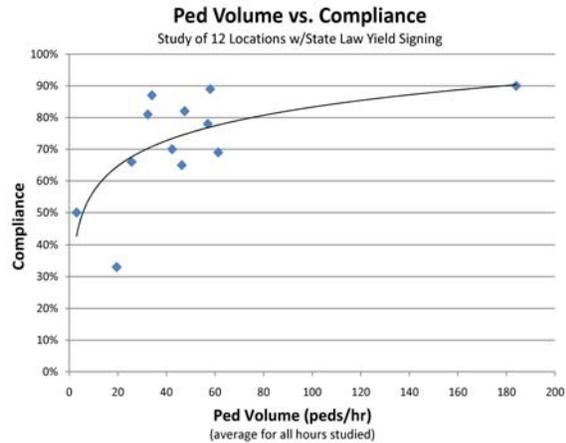
The City of Boulder has evaluated crosswalk enhancements at uncontrolled crossing locations over the years and has determined that there is a clear relationship between driver compliance (yielding) and the pedestrian and/or bicycle crossing volume. Data collected at Boulder crosswalks where rectangular rapid flash beacon signs (RRFB) or State Law-Yield signs were installed shows that driver compliance typically increases with higher crossing volumes. It is theorized that the primary reason for this relationship is that drivers tend to ignore enhanced crossing treatments over time at locations where they infrequently see pedestrians crossing. The following graphs illustrate this relationship:

The above data also illustrates that, below roughly 20 pedestrians per hour, driver compliance decreases significantly. Thus, the base threshold for consideration of an enhanced crossing treatment at an uncontrolled location is 20 pedestrians per hour. This threshold is consistent with recent national guidance and policies adopted by other states and cities, as determined through literature research.

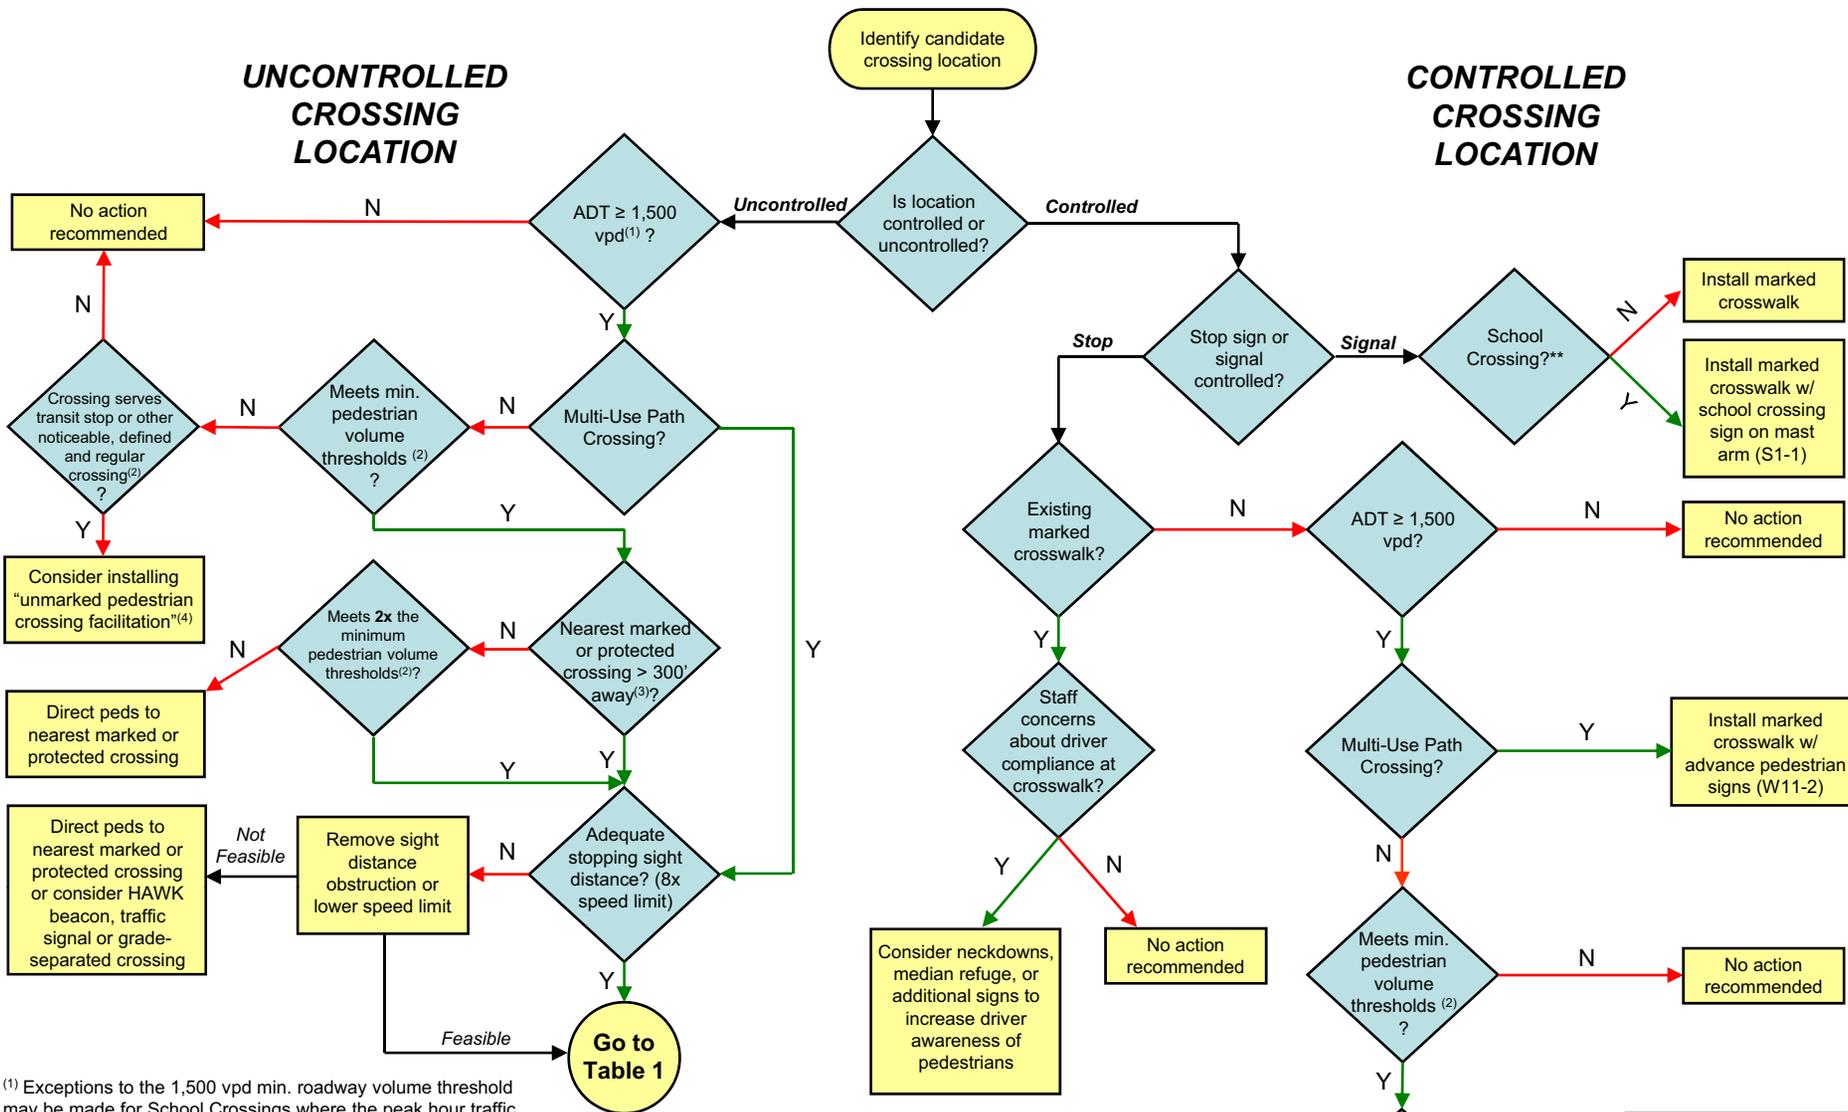
(1) Exceptions to the 1,500 vpd min. roadway volume threshold may be made for School Crossings where the peak hour traffic exceeds 10% of the daily traffic

(3) Distance to nearest marked or protected crossing may be reduced to 200' in urban conditions, subject to engineering judgment, where 1) the crosswalk does cross any auxiliary lanes, and 2) crossing treatments and crossing activity would not create undue restriction to vehicular traffic operations.

(4) An "unmarked pedestrian crossing facilitation" is any treatment that improves a pedestrian's ability to cross a roadway, short of the marked, signed and enhanced crossings detailed in Table 1. Installation of this type of pedestrian facilitation is subject to engineering judgment and may include curb ramps and/or a raised median refuge. However, no effort is made to attract pedestrians or recommend that pedestrians cross at this location. The treatments simply provide an improvement for a low volume pedestrian crossing where pedestrians are already crossing and will like continue to cross.

- a) Using the available data, utilize *Figure 1 – Pedestrian Crossing Treatment Flowchart* and *Table 1 – Criteria for Crossing Treatments at Uncontrolled Locations* (if applicable) to determine appropriate treatment(s) for signalized, stop-controlled, or uncontrolled locations. Also consider and incorporate the information in Section 2.2 and in Figure 2 as appropriate.

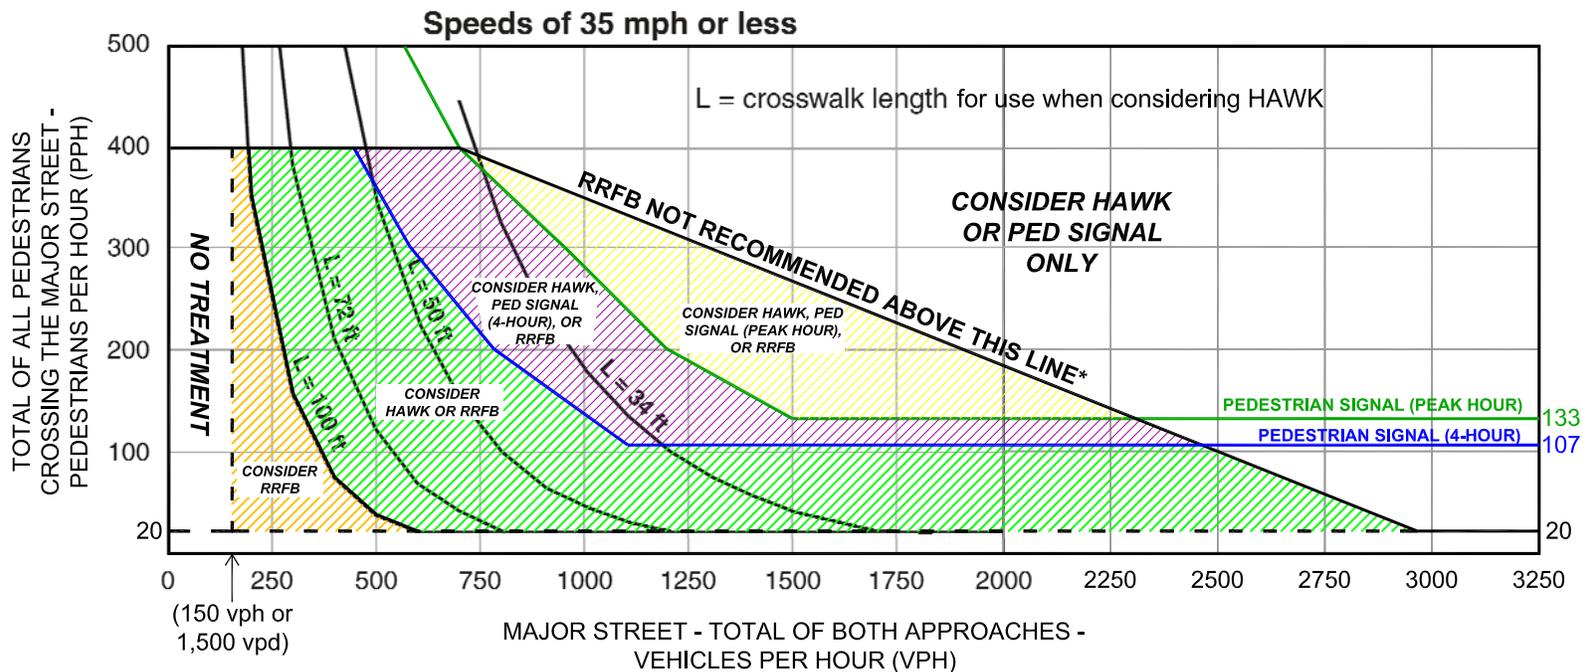
Figure 2a. City of Boulder Guidelines for the Installation of Pedestrian Hybrid (HAWK) Beacons, Pedestrian Signals, or Rectangular Rapid Flash Beacon (RRFB) Signs on Low-Speed Roadways

* RECOMMENDATION BASED ON CITY OF BOULDER SAFETY EVALUATIONS AT EXISTING RRFB SITES AND OBSERVED IMPACTS TO VEHICULAR TRAFFIC OPERATIONS

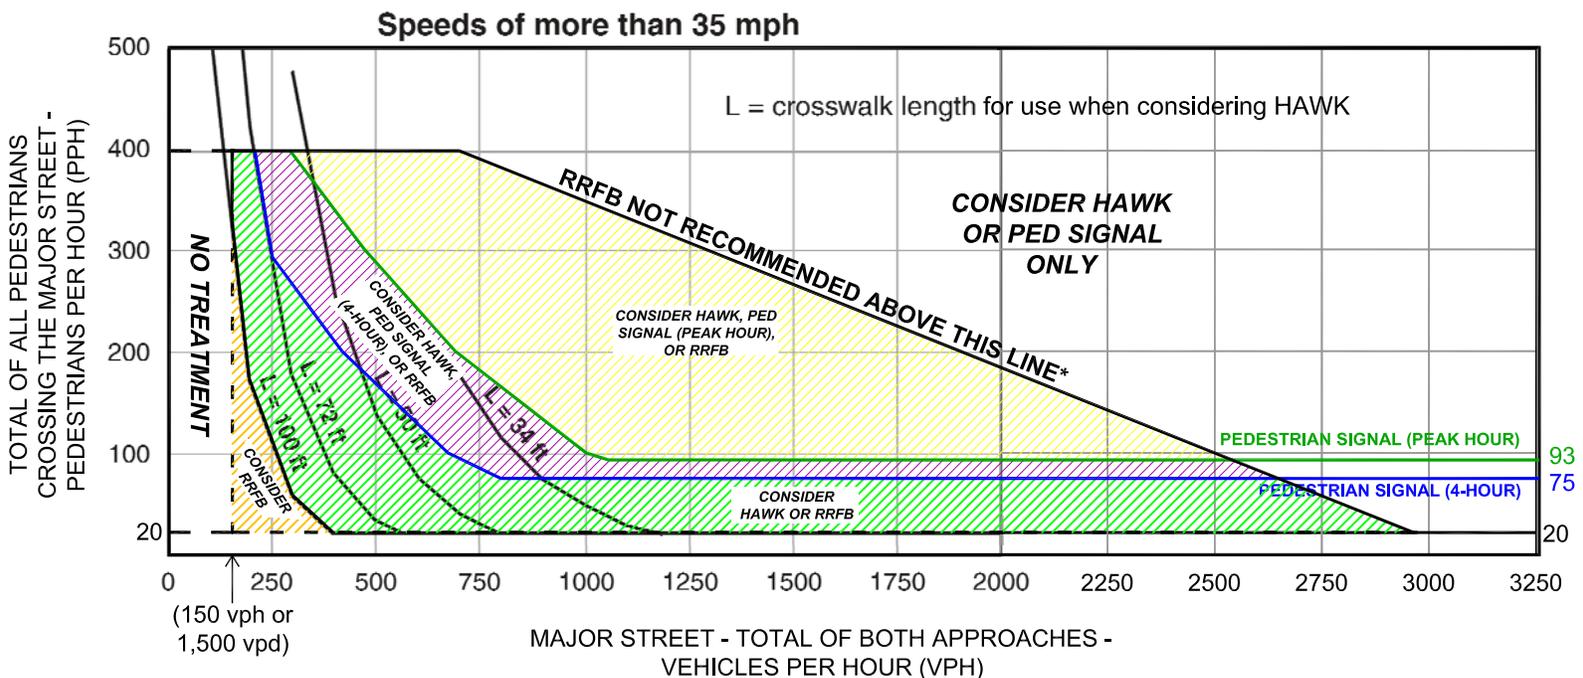
Figure 2b. City of Boulder Guidelines for the Installation of Pedestrian Hybrid (HAWK) Beacons, Pedestrian Signals, or Rectangular Rapid Flash Beacon (RRFB) Signs on High-Speed Roadways

* RECOMMENDATION BASED ON CITY OF BOULDER SAFETY EVALUATIONS AT EXISTING RRFB SITES AND OBSERVED IMPACTS TO VEHICULAR TRAFFIC OPERATIONS
