Pedestrian and Bicycle Information Center

# An Overview and Recommendations of High-Visibility Crosswalk Marking Styles

August 2013

**For:**  
Federal Highway Administration  
DTFHGI-11-H-00024

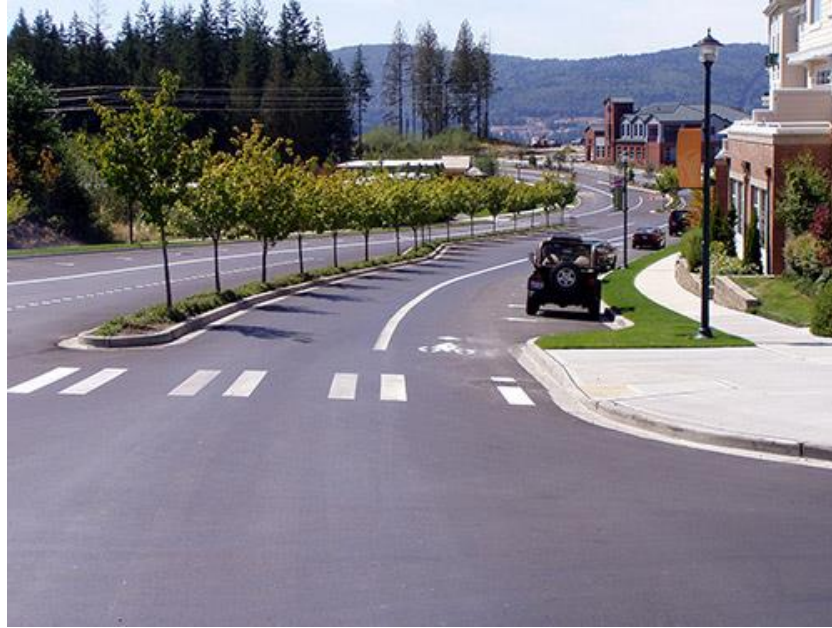
Figure 4 – A bar pair crosswalk that is spaced so as to avoid the wheel path of automobiles. (Source: Dan Burden, 2006. [www.pedbikeimages.org](http://www.pedbikeimages.org))

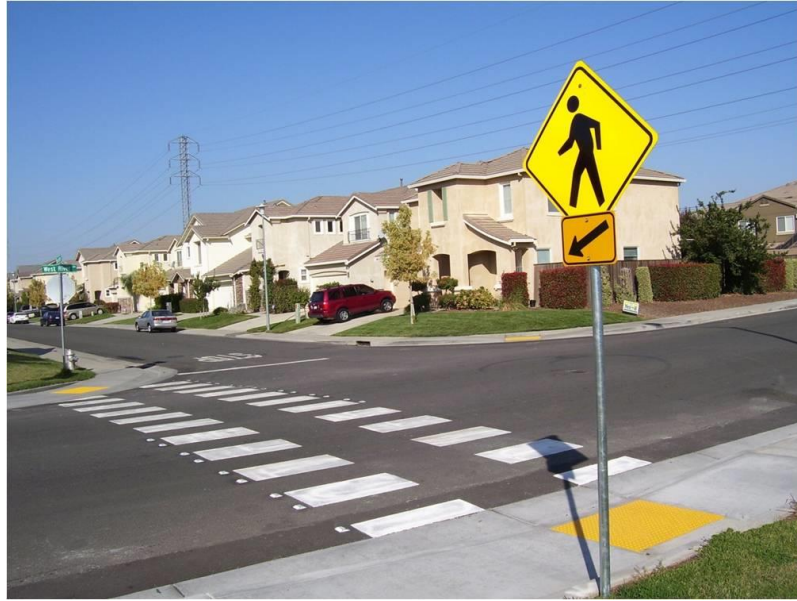
**Figure 5** – A triple-four crosswalk pattern, which is the standard crosswalk style in Sacramento, CA. This pattern is high-visibility, has a center channel that is less slippery, and has bars spaced so as to reduce maintenance costs. (Source: City of Sacramento, [http://www.cityofsacramento.org/transportation/dot\\_media/engineer\\_media/traffictriplefourcrosswalk.jpg](http://www.cityofsacramento.org/transportation/dot_media/engineer_media/traffictriplefourcrosswalk.jpg))

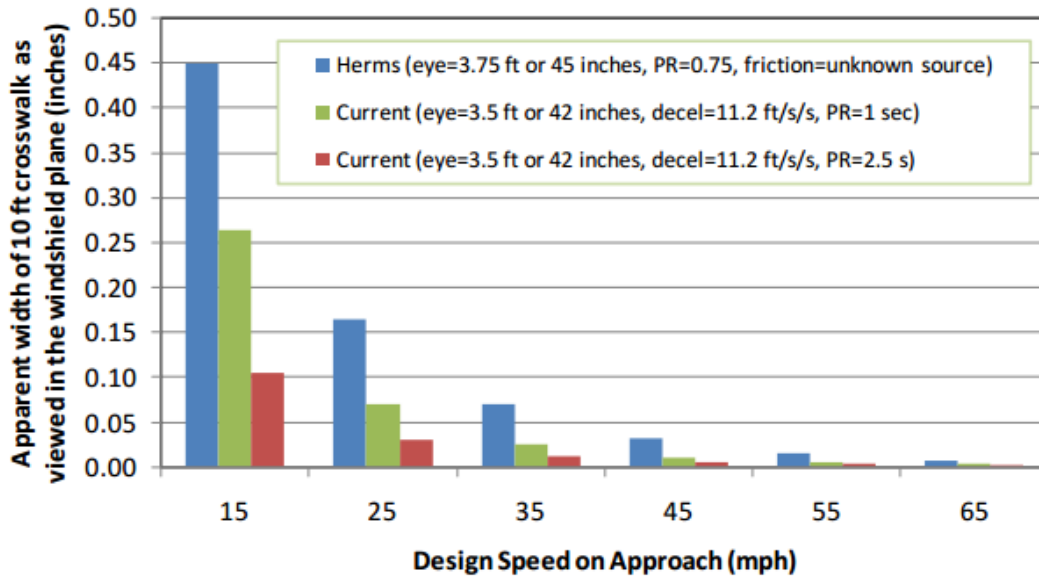
**Comparison of Apparent Width Values Using Different Assumptions.**

Figure 7 (Source: ITE TENC Technical Committee 109-01. Pavement Marking Patterns Used at Uncontrolled Pedestrian Crossings, Publication No. IR-131. Institute of Traffic Engineers, Washington, DC, 2010)

that transverse crosswalks were “essentially not visible” because the apparent width of a 10 foot crosswalk was often below a quarter inch when viewed in the windshield pane (see Figure 7) (14).
