Effects of Traffic Calming Measures on Pedestrian and Motorist Behavior

Herman F. Huang and Michael J. Cynecki

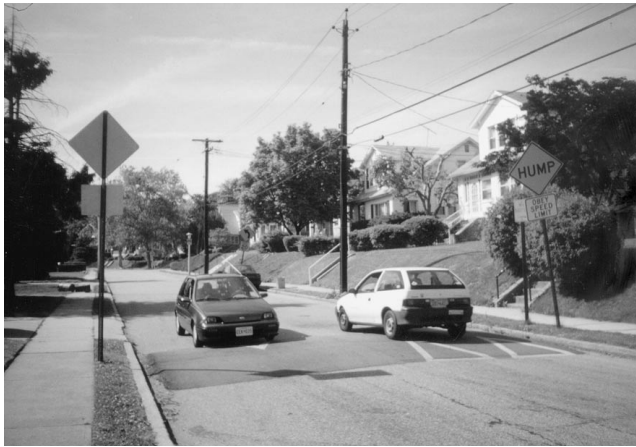
FIGURE 1 Two vehicles slow down as they pass over speed hump.

Also known as road humps, undulations, or "sleeping policemen," speed humps have the purpose of promoting the smooth flow of traffic at speeds of about 32 to 40 km/h (20 to 25 mph). The speed hump is an elongated bump with a circular arc cross-section (round top) or flat top, rising to a height of 76 mm (3 in) above the normal pavement surface and having a length of 3.7 m to 6.7 m (12 ft to 22 ft) in the direction of vehicular travel (Figure 1). Speed humps usually extend the full width of the road, excluding the gutter to allow for drainage (1).

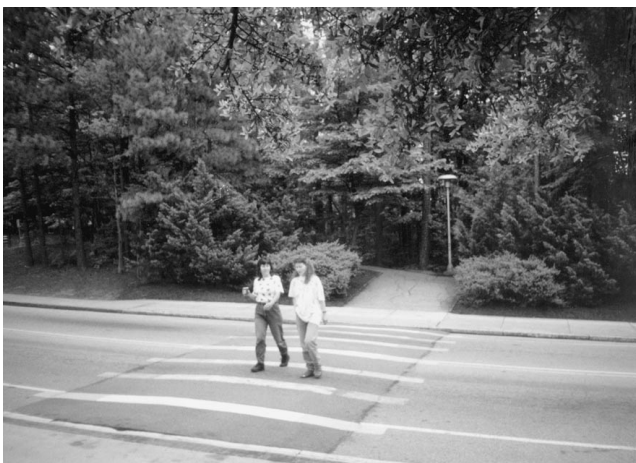
FIGURE 2 Two pedestrians using raised crosswalk.

Raised crosswalks are flat-top speed humps with crosswalk markings painted on the top (Figure 2). Raised crosswalks elevate pedestrians above the surface of the roadway and can make them more visible to motorists. Raised crosswalks cause motorists to slow at the most critical location, where pedestrians cross, and they are generally designed to keep pedestrians at one level so that there is no need for curb ramps. Drainage is accommodated by pipes along the gutter or other design features. Speed humps have been evaluated in many cities. The following paragraphs summarize some of those studies.

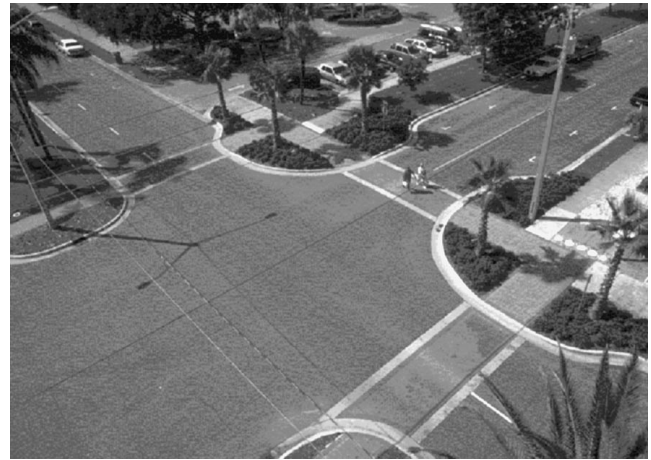
FIGURE 3 Bulbouts shorten crossing distances for pedestrians, improve sight distances, and may slow vehicle speeds.

The purpose of a bulbout (also known as a choker, curb bulb, neck-down, nub, or gateway) is reduction of the width of vehicle travel way at an intersection or a mid-block pedestrian crossing. Bulbouts shorten the street crossing distance for pedestrians, may slow vehicle speeds, and provide pedestrians and motorists with an improved view of one another, thereby reducing the risk of a motor vehicle–pedestrian collision (Figure 3).

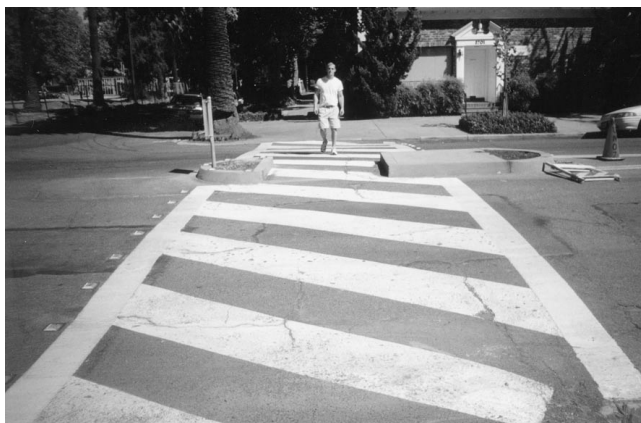
FIGURE 4 Pedestrian in crosswalk with refuge island, Sacramento, California.

The chi-square statistic was used to compare the percentages of pedestrians who crossed in the crosswalk (Figure 4) in the before and after periods. As Table 3 shows, the raised intersection in Cambridge and the refuge islands in Sacramento had statistically significant effects: that is, more pedestrians crossed in the crosswalk in the after period than in the before period. The effects of the Cambridge bulbouts and the refuge island in Corvallis were in the desired direction but were not statistically significant, not even at the 0.10 level. The results for the bulbouts in Seattle were statistically significant, but in the undesired direction—more pedestrians crossed in the crosswalk before the bulbouts were installed than after they were installed.
