NCHRP

REPORT 612

Safe and Aesthetic Design of Urban Roadside Treatments

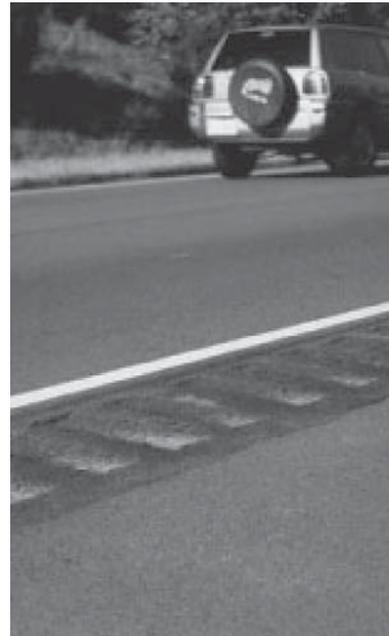
Figure 1. Rumble strips.

Physical rumble strips are grooves placed into the roadway or paved shoulder and are aimed at alerting the driver of potentially hazardous conditions (see Figure 1). A similar alert can also be achieved using thermoplastic rumble strips which are generally placed on the surface of the road in conjunction with lane edge delineation. While transverse rumble strips are often used for purposes such as alerting the driver of a downstream stop condition such as a toll booth or a stop-controlled intersection, longitudinal rumble strips are also effective for alerting the driver that he or she is leaving the travelway. Although rumble strips do not have speed-reducing capabilities (23), they cause a vehicle to vibrate and make noise when it crosses over them, thereby signaling to the driver that greater attention to the traveling environment is warranted. The sound made by a vehicle crossing rumble strips typically does not exceed that of the ambient sound experienced by the driver (24); thus, the ability of rumble strips to alert drivers

to hazardous conditions is largely restricted to the vibration the rumble strips produce. This vibration is nevertheless a substantial cue for increasing the driver's awareness of the roadway environment. Several studies of the effectiveness of rumble strips have determined that placement of rumble strips can decrease the number of run-off-road crashes between 30 and 85 percent (25, 26).

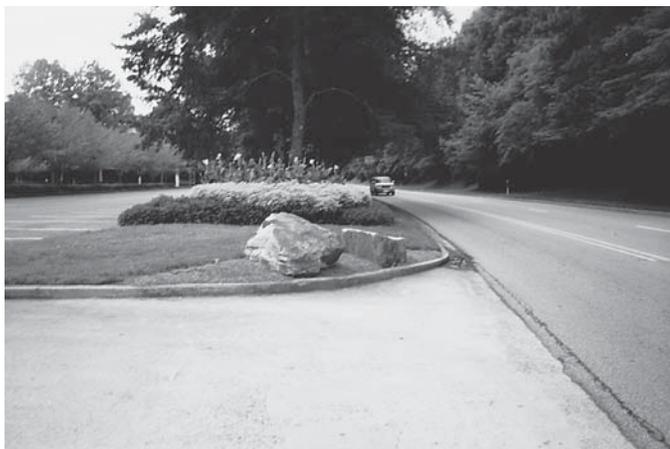
Figure 4. Landscaping in sight triangle for driveway.

Many landscape policies do not directly stipulate tree placement near driveways, but use an approach similar to the New South Wales guidelines, which simply state that drivers exiting driveways should be able to see approaching traffic and pedestrians (61). As an example, the attractive landscaping depicted in Figure 4 seems reasonable upon

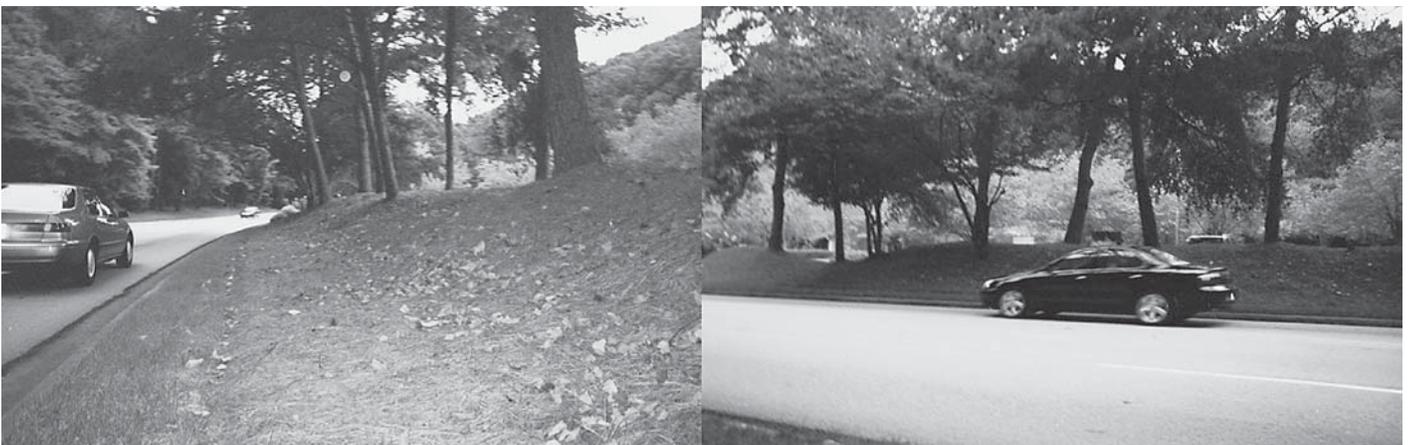
Figure 6. Landscape berm that blocks horizontal sight distance.

Figure 6 depicts another type of encroachment into the vertical clear vision space. Often landscape berms are used to screen adjacent parking from the roadway. The photo on the left shows a longitudinal landscape berm and the effect it has on horizontal sight distance. At the location shown, the road has a horizontal curve to the right (in the direction the vehicle shown is traveling) and has numerous driveways that are not easily visible due to the berm height. The photo on the right depicts the same location but more clearly shows that the height of the berm exceeds the height of a typical passenger car. This type of landscape treatment is a common roadside treatment in many urban areas.

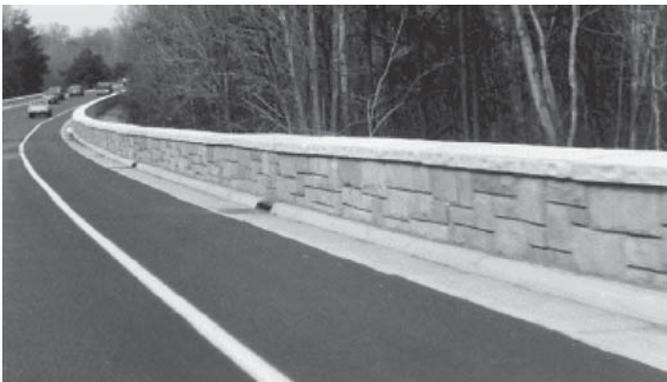
Figure 12. Stone masonry barrier.

In locations where aesthetics are important and a barrier is required, jurisdictions may develop crash-tested options such as the Vermont-approved stone masonry system shown in Figure 12 (in addition to the various aesthetic barriers identified in the California report previously indicated [90]).

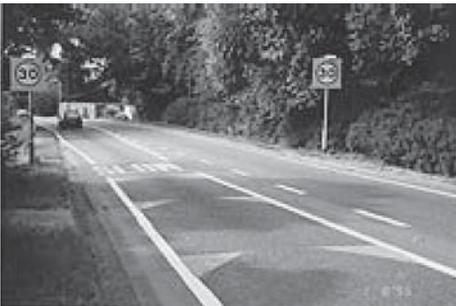
Figure 14. Dragon-teeth marking.

In a 1997 study in the United Kingdom, researchers at the Transport Research Laboratory performed a before-after evaluation of a series of traffic calming strategies on major roads (112). The traffic volume on candidate roads was greater than 8,000 vehicles per day, and at least 10 percent of the traffic was composed of heavy vehicles. Speeds at inbound gateways were reduced at eight out of nine locations tested. Mean speed reductions ranged from 5 to 21 km/hr (3 to 13 mph). The study evaluated a variety of treatments, including speed reduction signage, narrowings, dragon teeth marking, speed cushions, colored pavement, and advanced signing. The researchers determined that the signing provided a high visual impact and resulted in large speed reductions. Physical devices such as the speed cushions resulted in a greater level of speed reduction than signing alone. The use of colored bands placed laterally across the road and placed in a series seemed to result in some speed reduction, but did not result in large decreases in speed. The researchers did not test the speed reduction signs and so could not comment on the effectiveness of these devices. Dragon-teeth marking, identified as one of the strategies, is depicted as a schematic and a photograph in Figure 14.

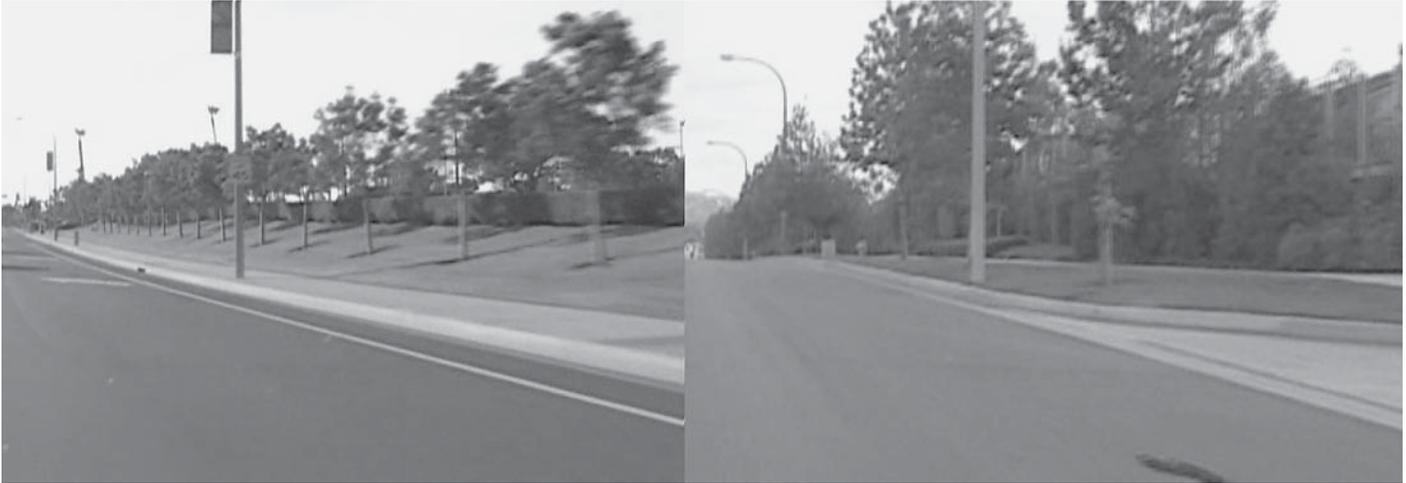
Figure 18. Pole placed at lane merge.

Description. Often acceleration lanes, lane merges, and bus bay exit points transition to the through travel lane at a taper point. At this location, the driver of the vehicle needs to focus on merging into the active traffic stream. If the driver does not judge the merge correctly, he or she may run off the road at this location. As a result, lane merge locations should be free of roadside objects where possible.

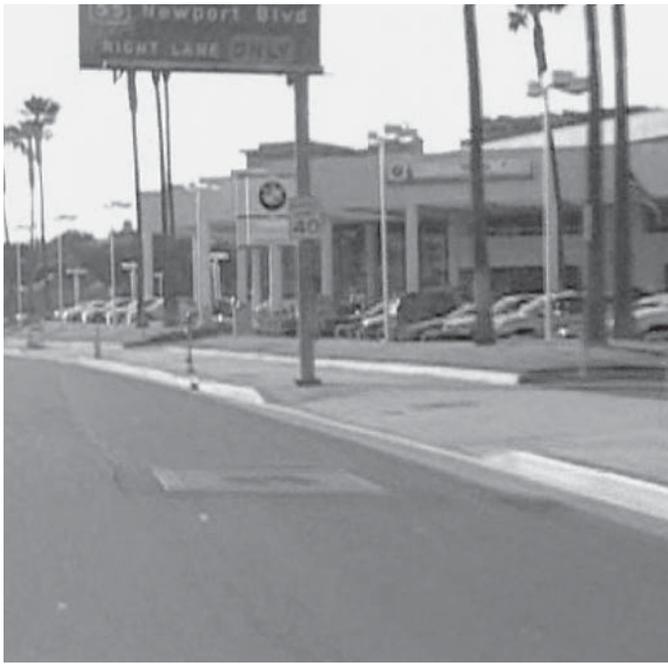
Figure 20. Lack of positive guidance at a driveway.

- Impacted small channelization islands (often these islands included signs, traffic signals, or poles). This intersection crash type occurred at six of the study corridors (see Table 14).
- Impacted objects positioned close to the lane edge. These objects often interfered with turning movements when vehicles veered from their turning path.
- Impacted objects where pedestrian ramps at intersection corners were oriented in such a way as to direct errant

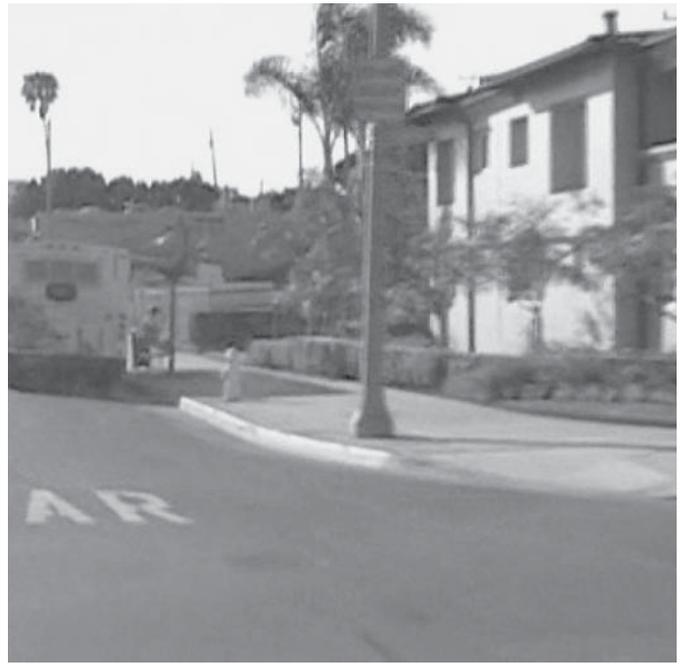
Figure 21. Object orientation with access ramp.

Several of the study corridors were characterized by high crash numbers at a specific location. Often this peak in crash statistics resulted from a physical road feature unique to the site. For example, at corridor UCZ-IL-1 a disproportionately large number of crashes involved an underpass structure. When members of the research team inspected the site, they determined that sometime in its past, a two-way road with one lane under each side of the underpass wall had been converted into a two-lane, one-way road. This modification occurred at two separate locations due to the creation of a one-way pair configuration. As a result, the approach to the underpass required vehicles to shift in an effort to avoid the wall now located between the lanes in the same direction of travel. The crashes occurred when a vehicle did not safely navigate this required lane shift. This crash cause was evident due to a scarred underpass wall.
