# Effects of Shared Lane Markings on Bicyclist and Motorist Behavior along Multi-Lane Facilities

The City of Austin Bicycle Team  
John Brady, Jeff Loskorn, Alison Mills, Jen Duthie, Randy Machemehl  
The Center for Transportation Research  
The University of Texas at Austin  
Phone: (512) 471-4541  
Fax: (512) 475-8744  
Email: [johnbrady.jb@gmail.com](mailto:johnbrady.jb@gmail.com)

Submitted July 15, 2010

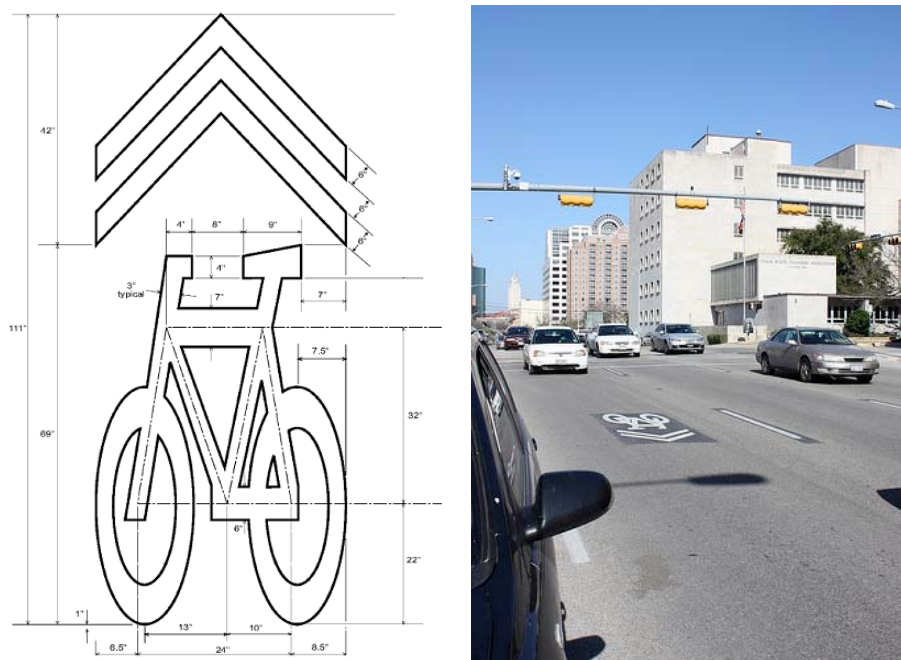
**Figure 1. A drawing and photograph of the Shared Lane Marking used in this study**

The design of the Shared Lane Marking used in this experiment is shown in Figure 1. This design was recommended by the National Committee on Uniform Traffic Control Devices' Bicycle Technical Committee and measures 3.25 feet wide by 9.25 feet tall and is unmistakably similar to the Shared Lane Marking described in the 2009 MUTCD. The Shared Lane Markings were always placed in a manner consistent with the applicable MUTCD standards and guidance. In this paper, Shared Lane Markings are referred to as sharrows—a common shortening of 'share the road arrow.'

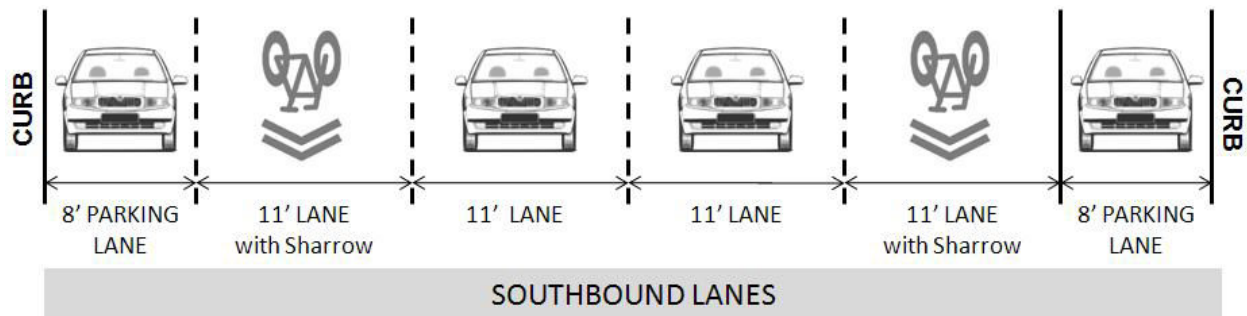
**Figure 2. A cross-section of Guadalupe Street approaching the intersection with 12<sup>th</sup> Street**

Between W 20<sup>th</sup> Street and W Cesar Chavez Street, Guadalupe Street is a four lane, one-way southbound street that extends from the southern edge of campus to the southern end of downtown. Before the study began, Guadalupe was a common corridor for bicyclists despite heavy traffic and narrow outside lanes. Sharrows were installed at the beginning of each block in the center of both the rightmost and leftmost vehicle lanes—since bicycling in the leftmost lane of a one-way facility is appropriate for left-turning bicyclists. An additional pair of sharrows was placed on the north side of the intersection of Guadalupe and 12<sup>th</sup> Street to assist with data collection. A cross-section of the street is shown in Figure 2. Typical AM peak traffic volumes ranged from 800 vehicles per hour to 1100 vehicles per hour, while PM peak traffic volumes were as high as 1650 vehicles per hour. The posted speed limit on the studied section of Guadalupe Street is 30 mph.

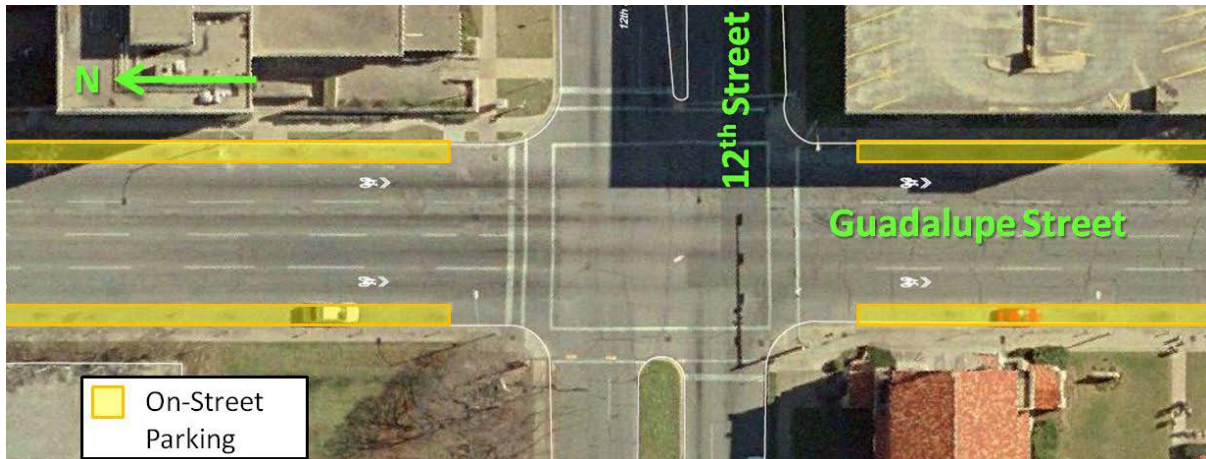
**Figure 3. A map of the intersection of Guadalupe and 12th Street**

Data was collected by a traffic camera mounted at the intersection of Guadalupe Street and 12<sup>th</sup> Streets in downtown Austin. The camera was positioned to record southbound traffic as it approached 12<sup>th</sup> Street. One unique feature of the Guadalupe site is that on-street parking is provided along both sides of the facility, represented by the shaded area in Figure 3. During peak commuting hours (when data was collected) the parking spaces were rarely full, allowing bicyclists to bypass queues by riding in the empty parking spaces.

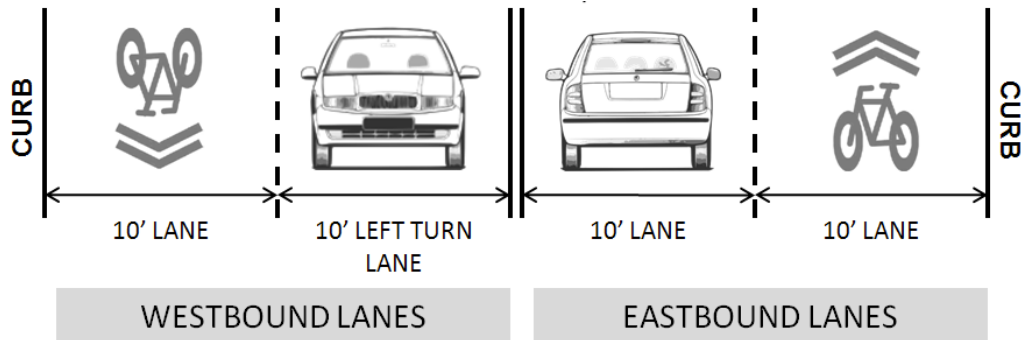
**Figure 4. Cross-section of Westbound 51st Street approaching the intersection with Airport Boulevard**

E 51<sup>st</sup> Street is a four-lane arterial that connects the suburban neighborhoods of north-central and north-east Austin. The facility has bicycle lanes west of Airport Boulevard and east of IH-35, but the lane width between Airport Boulevard and IH-35 is narrow, forcing bicyclists and motorists to share the road. In order to increase the bicycling appeal of this route, sharrow markings were placed in the rightmost lane along both the east- and westbound directions of this segment in the center of the lane. A cross-section of the site is shown in Figure 4.

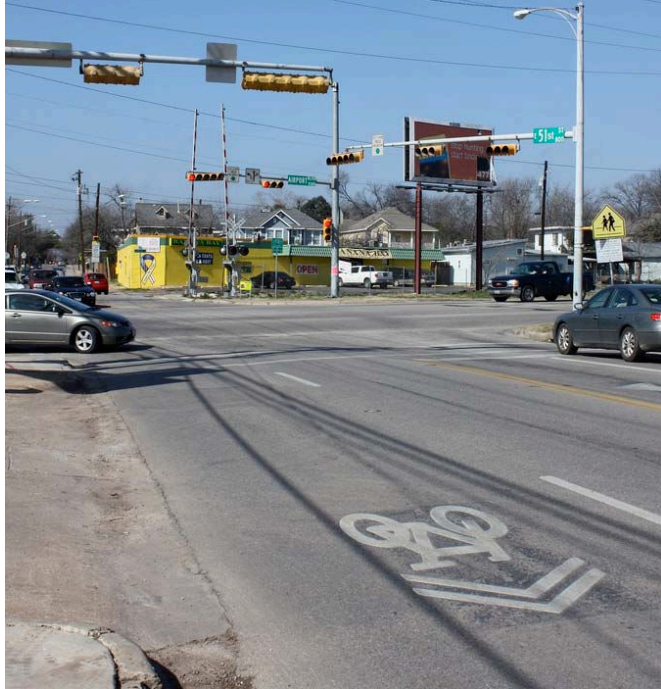
**Figure 5. Shared Lane Marking installed on E 51st Street**

A traffic camera located at the intersection of Airport Street and E 51<sup>st</sup> Street captured traffic moving in both directions along the eastern leg of the E 51<sup>st</sup> Street and Airport Boulevard intersection. Traffic volumes were typically around 400 vehicles per hour in both the AM and PM peak periods and the speed limit is 30 mph. Bicyclists approaching the intersection (traveling west) were presented with different traffic conditions than bicyclists departing the intersection (traveling east). In order to account for these differences, each direction was considered separately. Figure 5 shows a sharrow installed at the study location on E 51<sup>st</sup> Street.

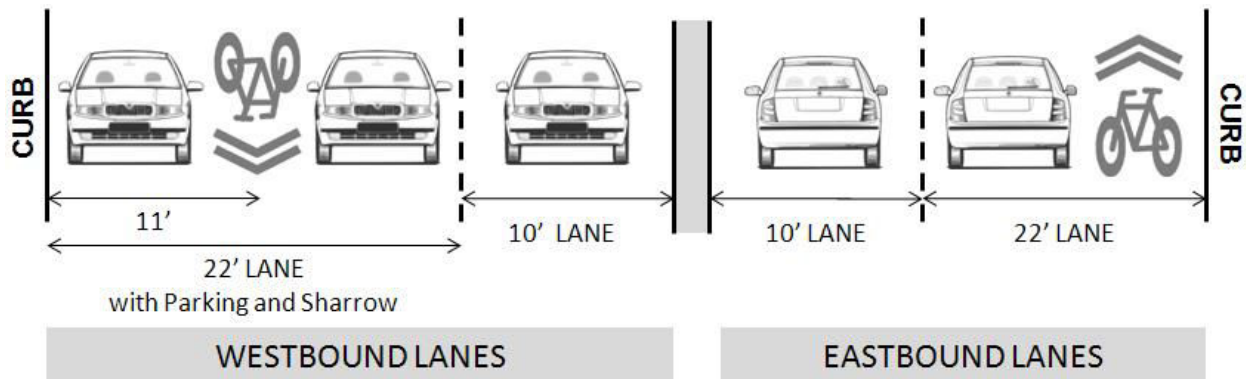
**Figure 6. Cross-section of Westbound Dean Keeton Street departing the intersection with San Jacinto Boulevard**

Dean Keeton Street is an east-west arterial that runs along the north side of The University of Texas at Austin campus. In Summer 2009, bicycle lanes were installed for the segment of Dean Keeton Street east of San Jacinto Boulevard as well as where space permitted on segments of Dean Keeton Street west of San Jacinto Boulevard. Where space did not permit the installation of bicycle lanes in accordance with City of Austin standards, sharrows were installed in August 2009. A cross-section of the roadway is shown in Figure 6. This paper compares the data collected after the installation of the bicycle lanes (but before the addition of the sharrows to the gaps) to the data collected after the installation of the sharrows.

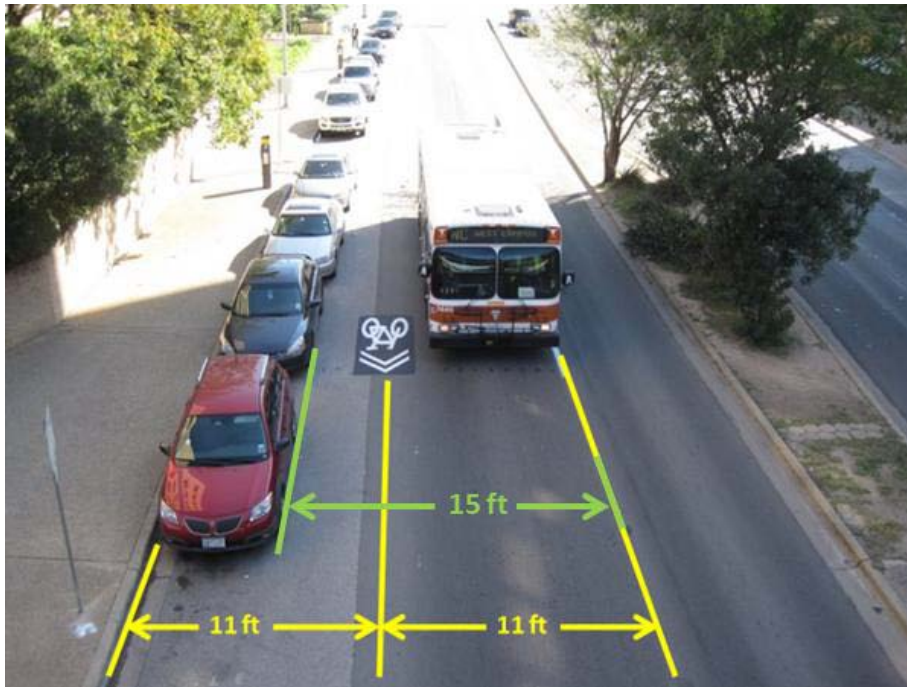
**Figure 7. Shared Lane Marking position near the study site on Dean Keeton Street**

Data for this site was collected from a vantage point above the west leg of the intersection of Dean Keeton Street and San Jacinto Boulevard. Traffic volume along Dean Keeton Street was typically around 500 vehicles per hour and the speed limit is 35 mph. From this location, bicyclists were recorded traveling westbound just after departing the intersection. Sharrow's were not installed in the center of the lane, but rather off to one side. In accordance with MUTCD standards, sharrow's were centered 11 feet from the curb, leaving 11 feet between the sharrow's center and the next full lane. Figure 7 shows the studied segment of Dean Keeton Street near San Jacinto Boulevard.

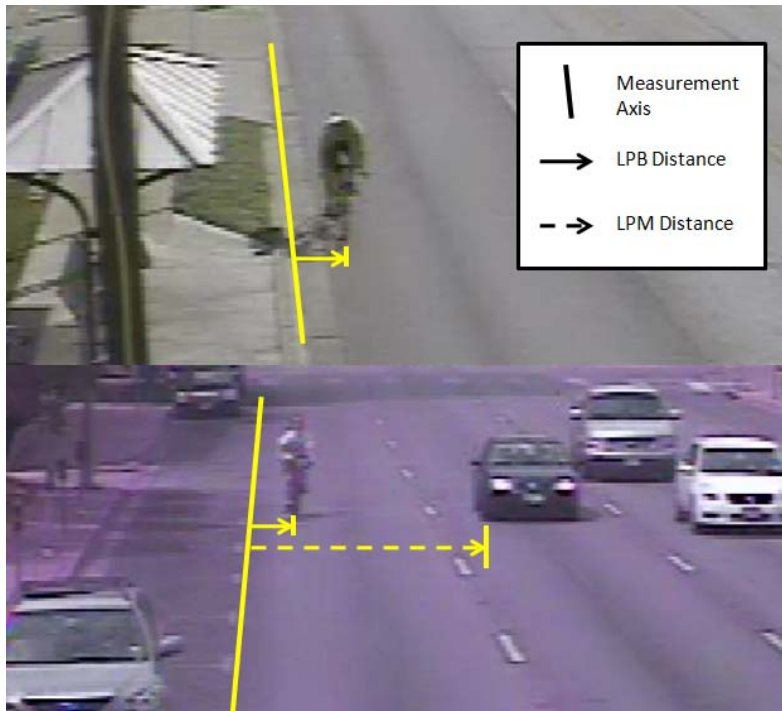
**Figure 8. Method for taking BLP and MLP measurements using different measurement axes**

To evaluate safety as defined above, several elements of the environment, bicyclist behavior, and bicyclist-motorist interaction were recorded. Although no single measurement can comprehensively measure bicyclist and motorist safety, the improvement of several safety indicators can contribute to the conclusion that safety is indeed improved. Among the measurements taken were: traffic volume, position of motor vehicles and bicycles during passing and non-passing events, percent of motor vehicles that change lane to pass or make an incomplete passing maneuver, percent of bicyclists traveling with traffic (as opposed to against traffic or on sidewalks), and percent of bicyclists who bypassed a queue of stopped vehicles. Figure 8 illustrates how measurements of the bicyclist lateral position (BLP) and motorist (MLP) were recorded.

- Bicyclist lateral position (BLP) – BLP is a measure of the bicyclist's position within the lane. Due to geometric differences, BLP was measured in a manner most consistent with each site's unique configuration. On 51<sup>st</sup> Street, BLP was measured as the lateral distance between the bicyclist's front wheel and the curb. On Guadalupe Street, BLP was measured as the lateral distance between the bicyclist's front wheel and the on-street parking space delineation marking. On Dean Keeton, no parking space delineation marking existed, so BLP was measured as the lateral distance between the bicyclist's front wheel and the parked motor vehicle's outer edge.

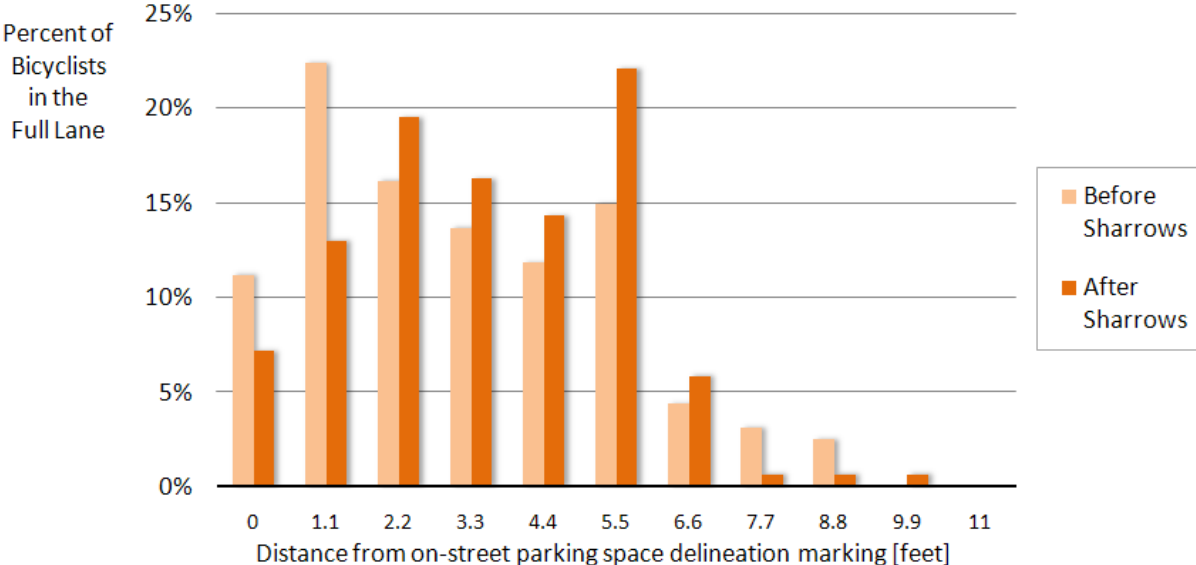
**Figure 9. Distribution of bicyclist lateral position along Guadalupe Street during non-passing events**

Figure 9 shows the distribution of BLP during mid-block travel on Guadalupe Street. Note that the center of the sharrow was placed 5.5 feet from the parking space delineation markings. After the sharrows were installed, the average BLP increased by 4.4 inches from 3.14 feet to 3.51 feet. More importantly, the mode<sup>1</sup> increased from 1.1 feet to 5.5 feet. Figure 6 shows that the percentage of bicyclists riding in the center of the lane (defined as BLP between 4.4 and 6.6 feet) increased significantly from 31% to 42% after the installation of the sharrows. Overall, the lateral position data suggests that the sharrow encouraged bicyclists to ride with a stronger lateral position and more predictably than before. This trend is also evident in the substantial decrease of bicyclists observed riding further than 7 feet from the lane edge. A significant change in BLP during passing events was not observed at this site.

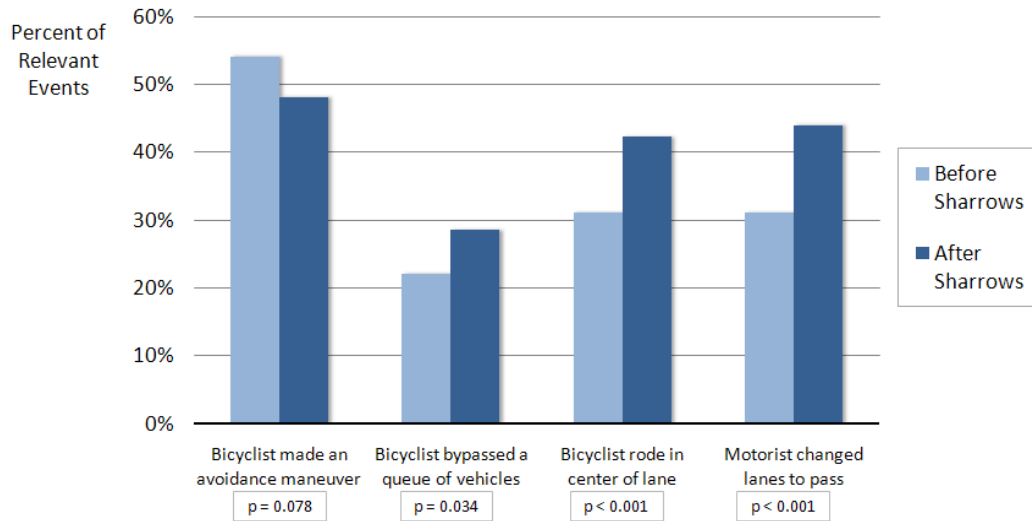
**Figure 10. Notable comparisons on Guadalupe Street**

The histogram in Figure 10 shows four statistically significant results that suggest sharrows have a substantial influence on both motorist and bicyclist behavior. First, bicyclists were less likely to make an avoidance maneuver after the implementation of the sharrow and motorists were more likely to change lanes while passing after the implementation of the sharrow. Another interesting comparison shows that while bicyclists were less likely to make an avoidance maneuver, they were more likely to bypass a queue of stopped vehicles after the sharrows were in place. This may suggest that the sharrow encouraged bicyclists to assert themselves more when sharing the roadway with motorists.

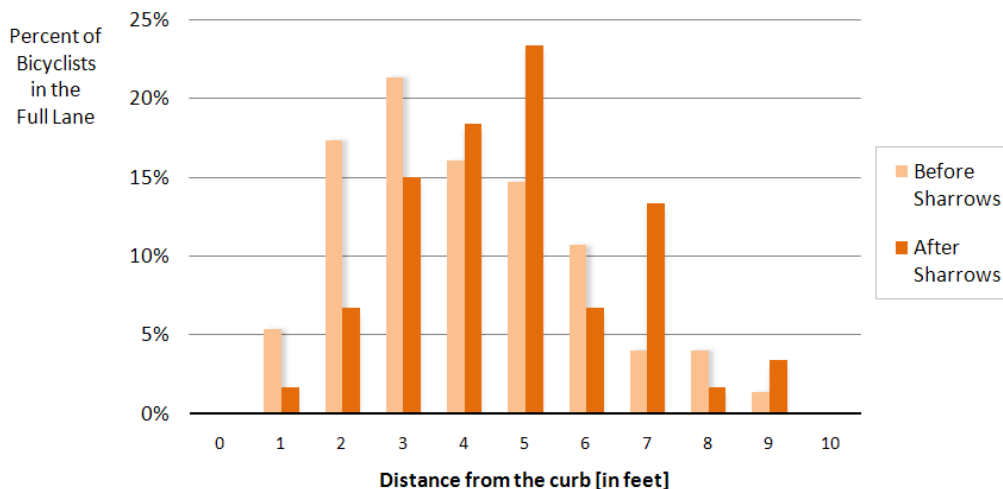
**Figure 11. Distribution of bicyclist lateral position on 51<sup>st</sup> Street approaching Airport Boulevard during non-passing events**

In general, the improvements in safety observed on 51<sup>st</sup> Street are similar to those seen on Guadalupe Street. As Figure 11 illustrates, bicyclists approaching the intersection of E 51<sup>st</sup> Street and Airport Boulevard were observed riding between one and ten feet from the curb face at mid-block. After the sharrows were installed, bicyclists tended to take a stronger position in the lane as evidenced by the increase in average BLP by 8 inches from 4.0 feet to 4.75 feet. As was the case on Guadalupe Street, the most significant result may be the increase in mode from 3 feet to 5 feet. Figure 12 shows that the proportion of on-street bicyclists who rode in the center of the lane (defined as an BLP between 4 and 6 feet) increased from 44% to 54%. The results for BLP or MLP during passing events are not presented because so few passing events were recorded in this direction—see Table 1. Since bicyclists approaching the intersection with Airport Boulevard often faced a queue of vehicles at low speeds, there were fewer opportunities for a passing event to occur.

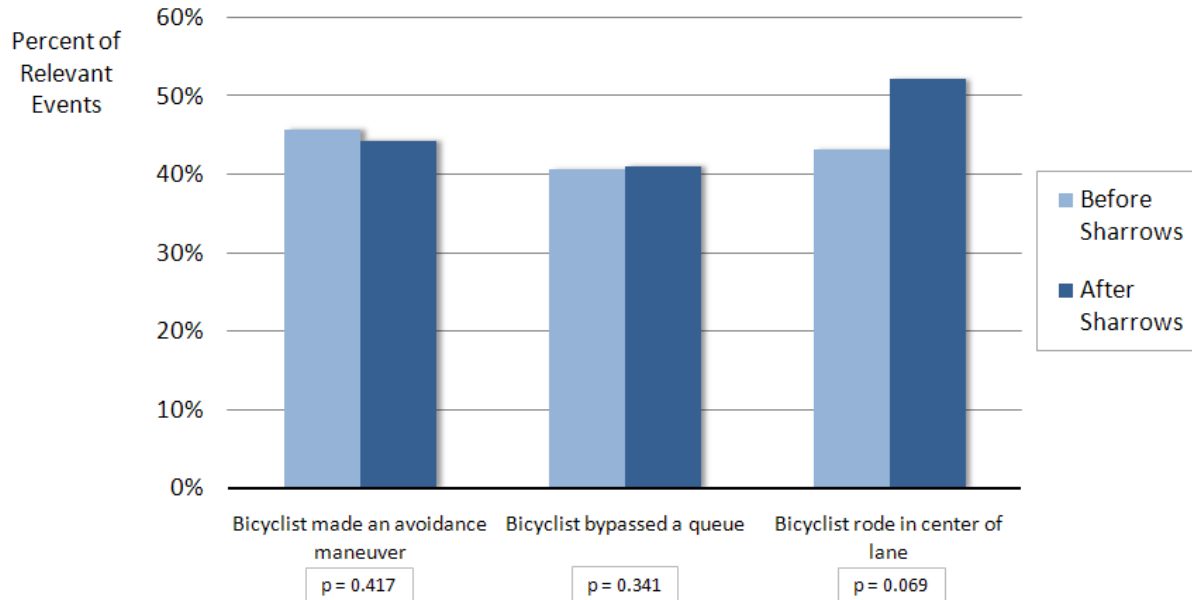
**Figure 12. Notable comparisons on E 51st Street westbound approaching Airport Boulevard**

Figure 12 compares notable bicyclist behaviors before and after the implementation of the sharrows. Both the percentage of bicyclists who bypassed a queue or who made an avoidance maneuver remained unchanged after the installation of the sharrows. This may suggest that bicyclists on E 51<sup>st</sup> Street choose to ride on the sidewalk or ride around a queue of stopped vehicles for convenience, not for perceived lack of safety. The presence of the Shared Lane Marking led to a significant decrease—from 12% to 4%--of bicyclists riding against traffic on the sidewalk. As mentioned previously, the proportion of bicyclists riding in the center of the lane did increase substantially; indicating sharrows can be effective at encouraging bicyclists to take a strong position in the full lane.

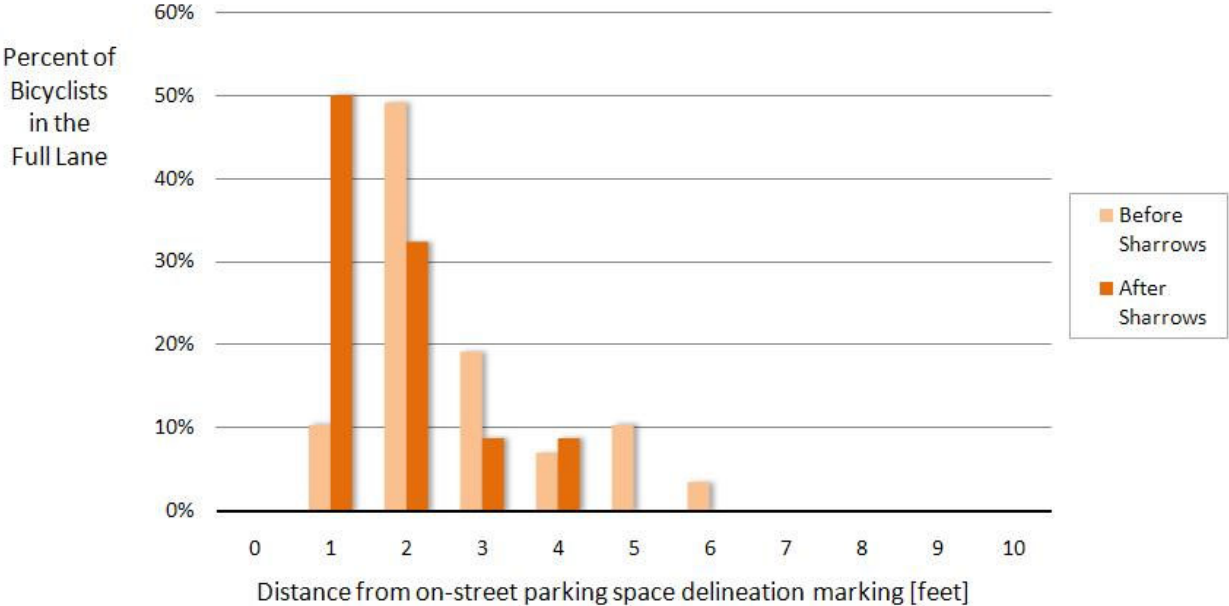
**Figure 13. Distribution of bicyclist lateral position on E 51st Street departing Airport Boulevard during passing events**

Bicyclists departing the intersection of E 51<sup>st</sup> Street and Airport Boulevard were frequently passed by motorists. Relative to the BLP measured on other sites, bicyclists on E 51<sup>st</sup> Street took a very weak position in the lane during passing events. Figure 13 compares the BLP before and after the implementation of the sharrows. After the sharrow installation, the mode increased from 1 foot to 2 feet and the percent of bicyclists riding in the middle of the lane increased significantly. This shift suggests that when a sharrow is present, bicyclists are willing to take a stronger position in the lane, even when being passed.

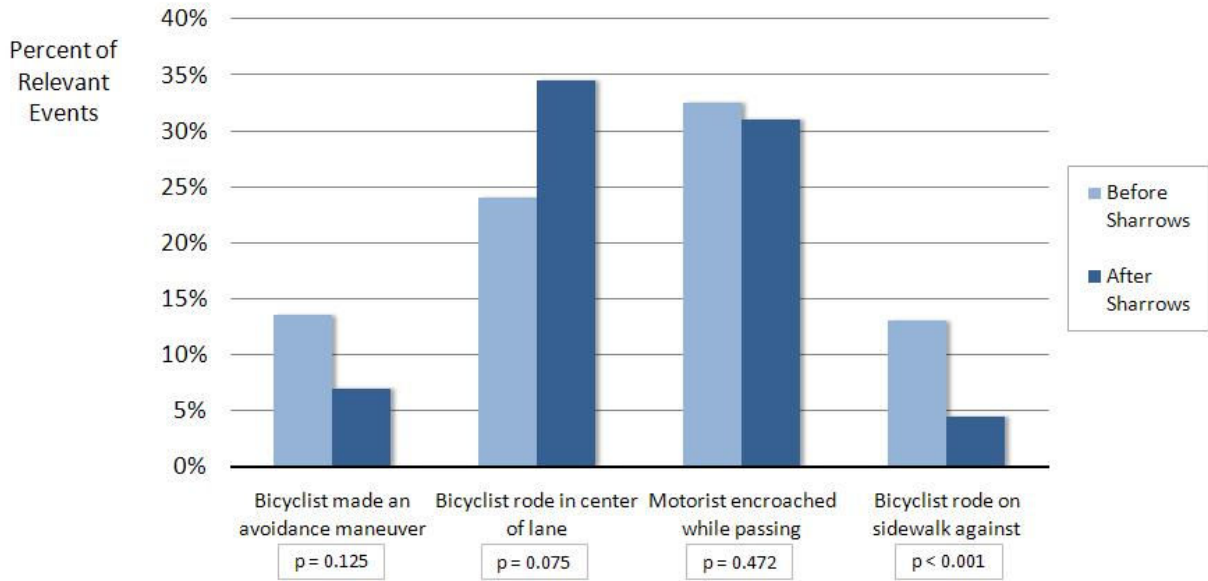
**Figure 14. Notable comparisons on E 51st Street Eastbound departing Airport Blvd**

Avoidance maneuvers were relatively rare at this site and after the installation of the Shared Lane Markings the proportion of avoiding bicyclists decreased further as illustrated in Figure 14. The percentage of bicyclists occupying the center of the lane (defined as BLP between 4 feet and 6 feet) during non-passing events increased significantly. This change, along with the substantial increase in bicyclists riding in the center of the lane during passing events suggests that the sharrow markings encouraged bicyclists to properly share the road with vehicles, even when faced with a high number of passing events. Although not shown in Figure 14, the presence of the sharrow marking led to a significant decrease—from 12% to 4%—of bicyclists riding against traffic on the sidewalk along E 51<sup>st</sup> Street.

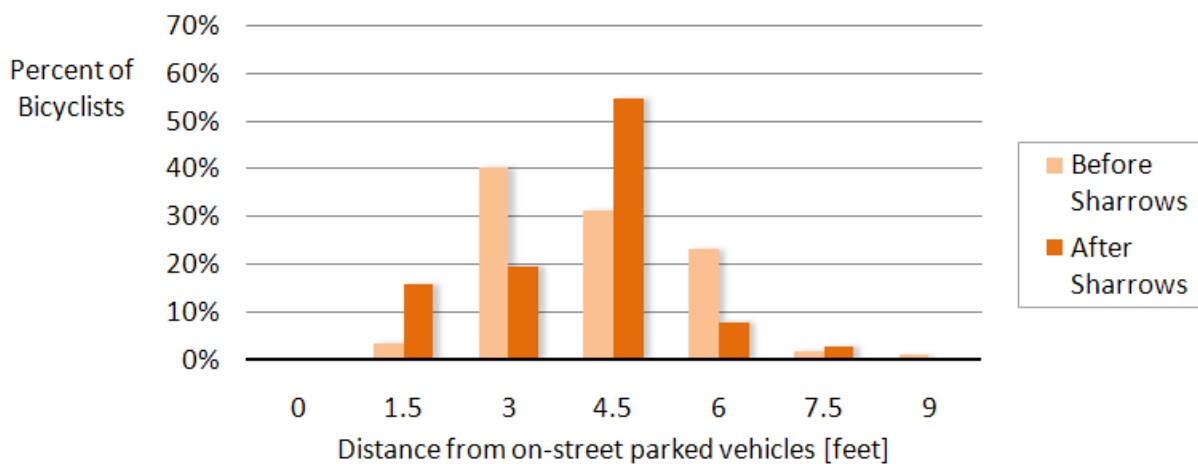
**Figure 15. Distribution of bicyclist lateral position on Dean Keeton Street during non-passing events**

As mentioned in site description, the unique site geometry and the fact that bicyclists departing an intersection are frequently passed by motorists made bicyclist safety during passing events a key concern for this site. Figure 15 and Figure 16 compare bicyclist lateral position before and after the sharrow installation for both passing and non-passing events, respectively. The most significant trend suggests that after the sharrow installation, bicyclists tend to behave more predictably. In the before conditions, bicyclist position during passing events varied between 1.5 feet and 4.5 feet, while after the installation, nearly 70% of bicyclists rode at 3 feet. A similar but less pronounced trend can be observed for non-passing events. Although the decrease in standard deviation of BLP during passing events is noticeable, tests show that the change is not statistically significant ( $p=0.363$ ). Together, this information suggests that the sharrow can substantially influence the consistency of bicyclist lateral position.

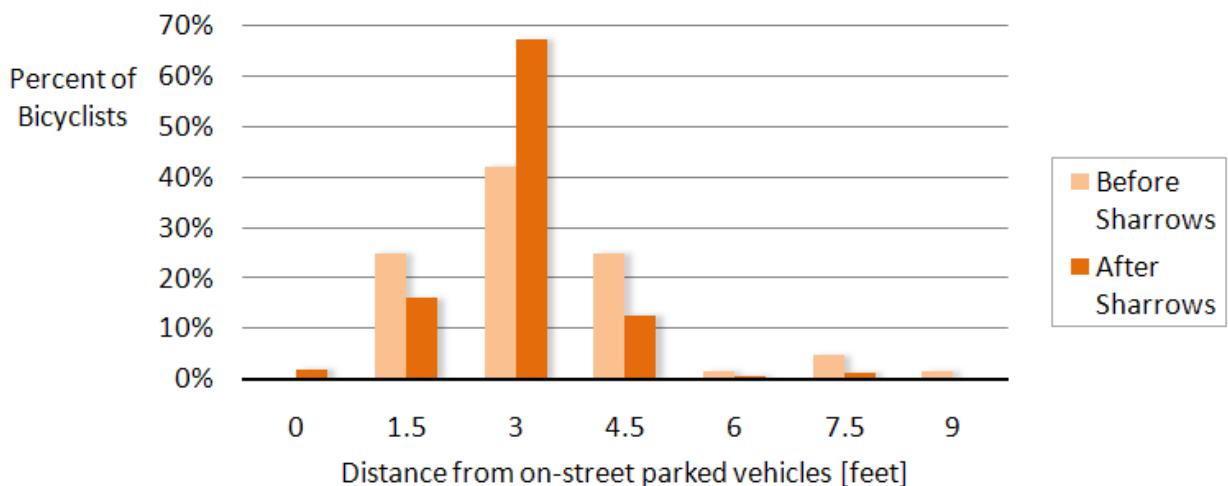
**Figure 16. Distribution of bicyclist lateral position on Dean Keeton Street during passing events**

*Note: Although BLP could be measured up to 15 feet from the edge of the on-street parked vehicles, no bicyclists were observed riding at a position greater than 9 feet from the edge of on-street parked vehicles.*

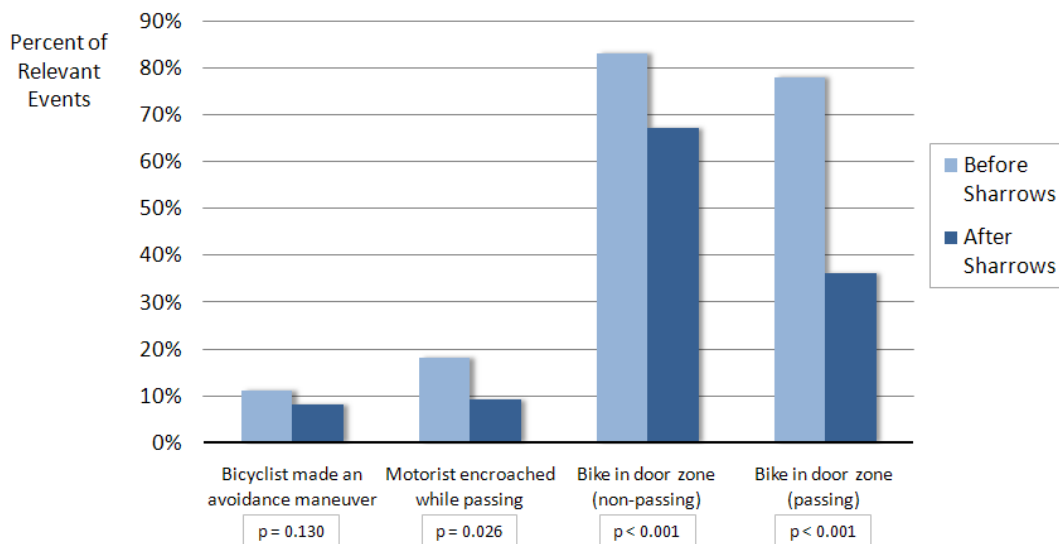
**Figure 17. Notable comparisons on Dean Keeton Street**

As illustrated in Figure 17, instances of bicyclist avoidance decreased substantially after the sharrows were installed and the proportion of passing motorists who encroached on the adjacent lane decreased as well. This change, coupled with the increased predictability of bicyclist position during passing events, suggests that motorists feel more comfortable passing bicyclists when the sharrow is present and are therefore less likely to encroach on the adjacent lane when passing. (Note that the dimensions of Dean Keeton Street do not require motorists to change lanes to pass.) Taken together, these results suggest that sharrows can be effective as a tool to connect areas where bicycle lanes are not continuous.

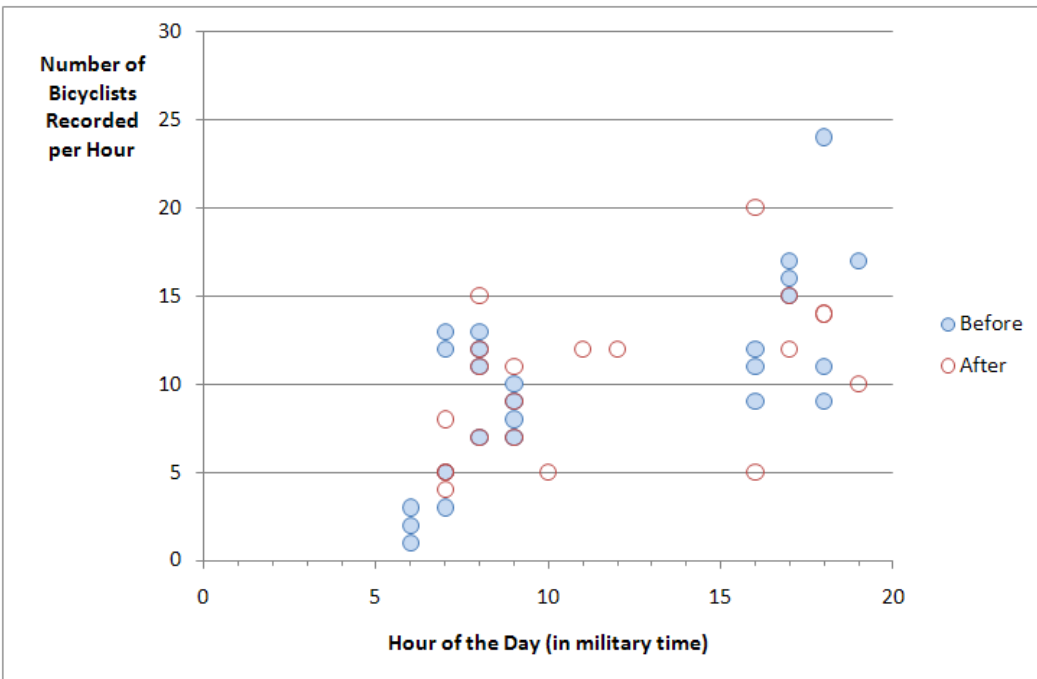
**Figure A1: Number of bicycles recorded each hour of the day on E 51st Street**  
*Note: These data points include bicyclists traveling in both directions along 51st Street*

The following figures illustrate the level of bicycle traffic that E 51st Street, Guadalupe Street, and Dean Keeton Street received before and during the course of this study. Figures A1, A2, and A3 show the number of bicyclists recorded at each site for each hour of the day, expressed in military time (where 15 represents 1500 hours, or 3:00pm). At both Airport Boulevard and Guadalupe Street the number of bicyclists per hour was generally higher in the afternoon peak. Also, the number of bicyclists per hour at E 51st Street, and Guadalupe Street increased with time during the morning peak hours and decreased with time during the afternoon peak hours. These trends are similar to ridership trends observed on Lamar Boulevard, which was observed during a “Bicycles May Use Full Lane” sign study. There is a high, but variable number of bicycles per hour along Dean Keeton Street, so few conclusions can be drawn about bicyclist patterns at this location. The variability in bicyclist volume is most likely due to site’s close proximity to the University of Texas. The before data was collected while summer classes were in session at the University, while the after data was collected during the fall semester. The increase in bicycle volume on Dean Keeton street would be due in large part to the increase in student population during the fall semester.

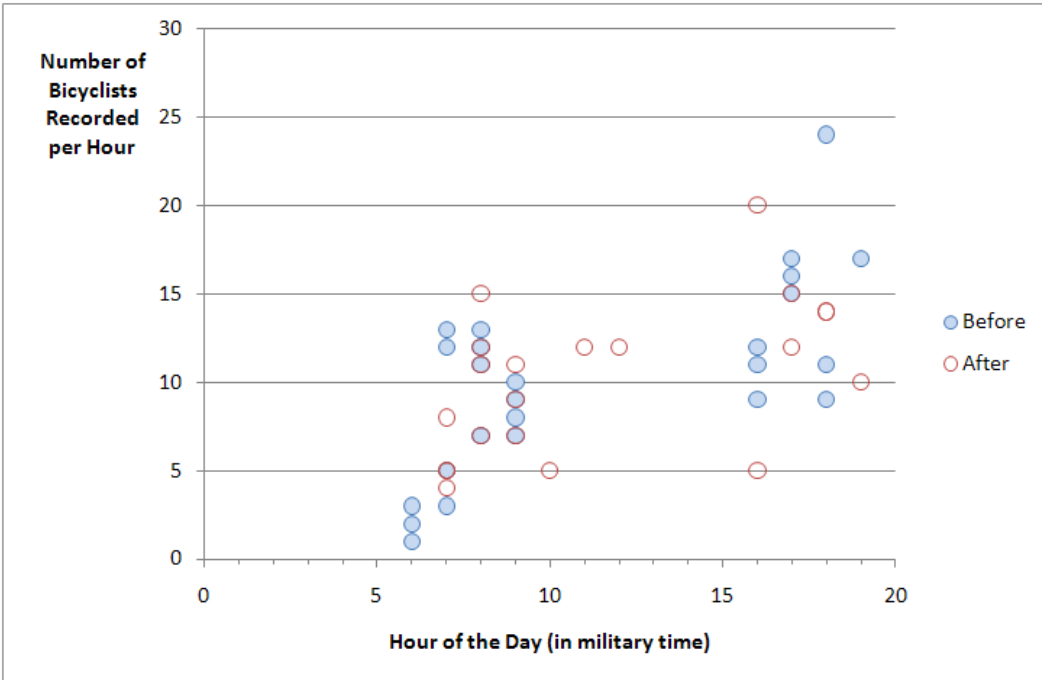
Figure A2: Number of bicycles recorded each hour of the day on Guadalupe Street

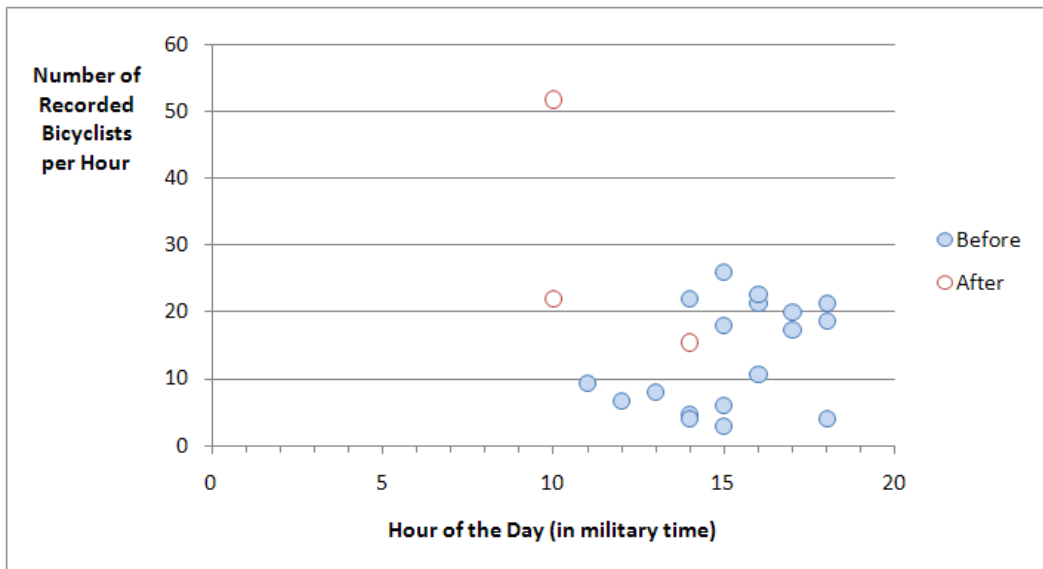
Figure A3: Number of bicycles recorded each hour of the day on Dean Keeton Street

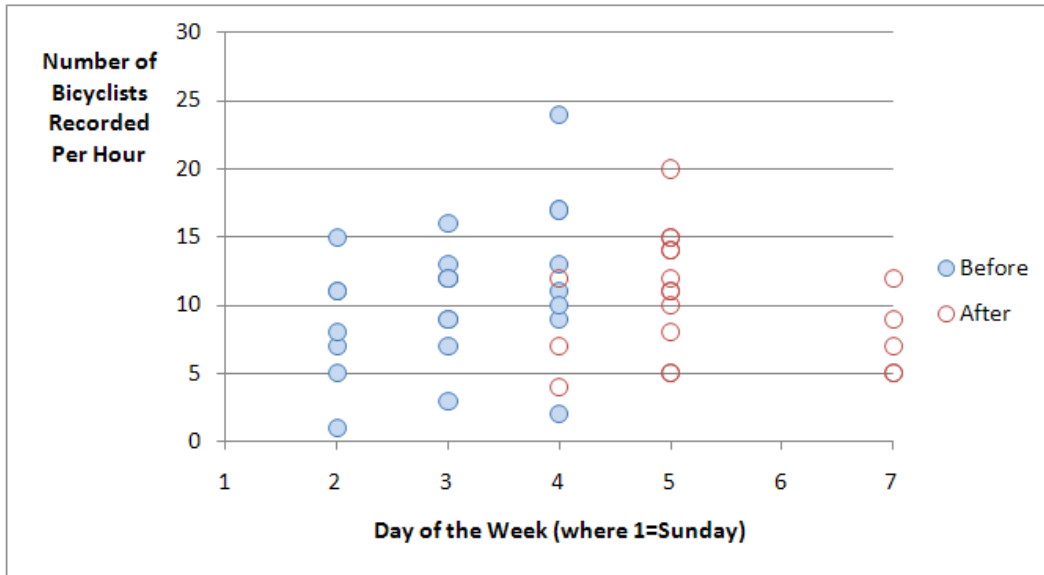
**Figure A4: Number of bicycles recorded each day of the week on E 51st Street**  
*Note: These data points include bicyclists traveling in both directions along 51st Street*

Figures A4, A5, and A6 show the number of bicyclists recorded per hour for each day of the week along E 51st Street, Guadalupe Street, and Dean Keeton Street, respectively. E 51st Street, experienced a higher hourly volume of bicyclists (9.9 bicyclists per hour) than Guadalupe Street (8.0 bicyclists per hour), but both volumes were relatively constant for each weekday. This trend contributes to the hypothesis that E 51st Street and Guadalupe Street are primarily used as commuter routes. The average volume along Dean Keeton was 16.1 bicyclists per hour and was relatively constant for each day of the week as well. This indicates that despite bicyclist volume varying each hour of a day, Dean Keeton Street experiences consistently high ridership each day of the week.

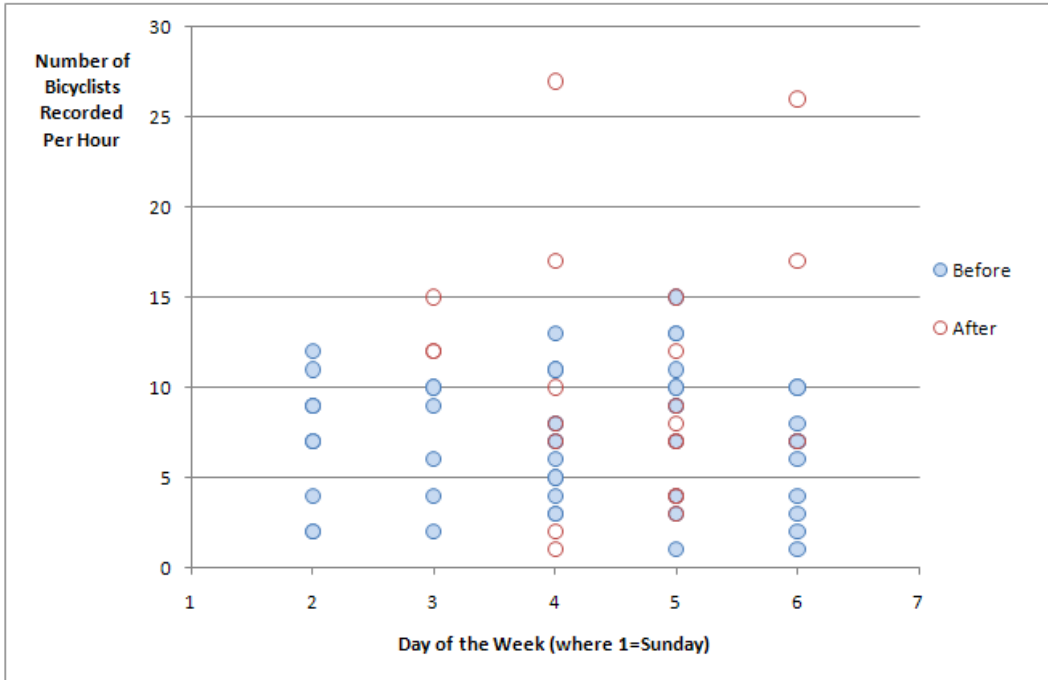
**Figure A5: Number of bicycles recorded each day of the week on Guadalupe Street**

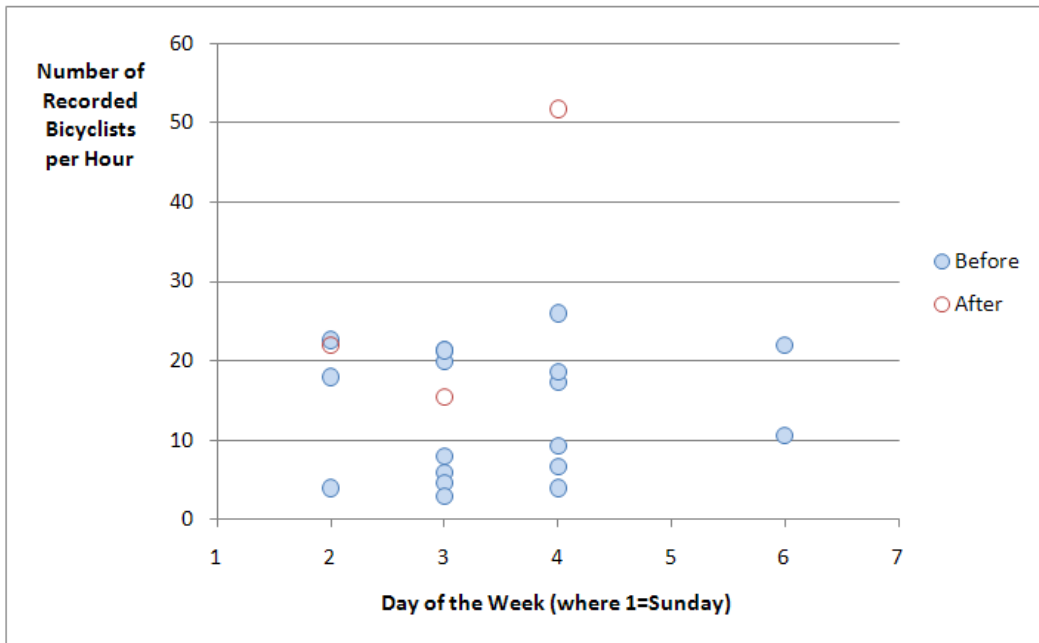
**Figure A6: Number of bicycles recorded each day of the week on Dean Keeton Street**

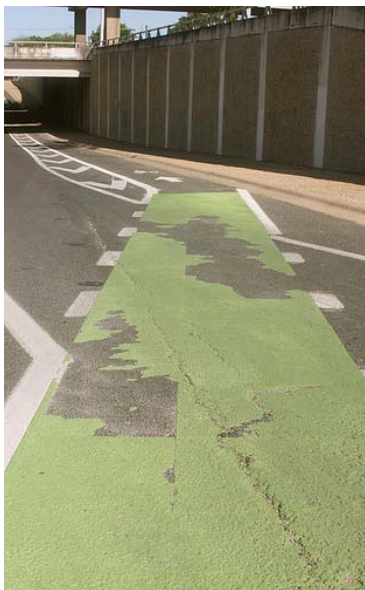
**Figure B1. Deteriorating thermoplastic on one of the I-35 exit ramps (breaking up in sheets)**

An installation error of the colored thermoplastic on Dean Keaton at the IH-35 exit ramp led to its quick deterioration. While waiting for the oil layer to dry one of the crew members spilled a large amount of water onto the oil. This water eventually led to inadequate bonding between the pavement and the thermoplastic, which resulted in the thermoplastic breaking up (illustrated in Figure B1).

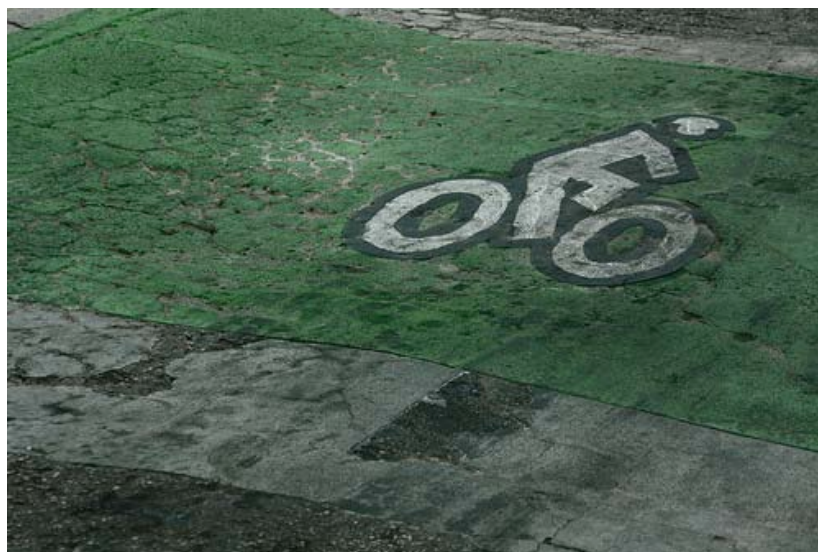
**Figure B2. Poor quality of road lead to the deterioration of the thermoplastic bike boxes on Speedway Boulevard**

The quality of pavement was a contributing factor to the quick deterioration of the colored thermoplastic, illustrated in Figure XX. In particular, the pavement on Speedway at 38th Street is cracked and uneven from the high volume of bus traffic. (The street is scheduled for

reconstruction in the next few years.) Clearing debris from the deep cracks of the application surface was nearly impossible; applying the oil-layer to these same cracks and the other surface flaws was also troublesome. The resultant colored thermoplastic was only tenuously bonded to the street surface at best.

Additionally, the colored thermoplastic on Speedway was discolored very quickly (see Figure B2). This discoloration is likely due to the heavy bus traffic on Speedway, where there is a peak hourly volume of over 15 buses/hour. This discoloration may have been compounded by the buses, wider than personal cars, driving in the colored lane. Another concern with the thermoplastic is shown in Figure B7. It is unclear whether the uneven application of thermoplastic shown in the photograph is the result of a misapplication, the rough nature of the street surface, or a deterioration problem.

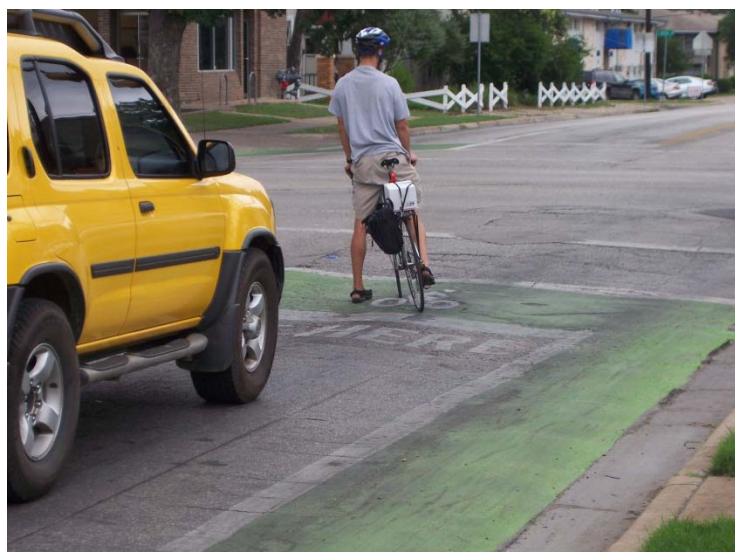
**Figure B3. Poor quality of road lead to the deterioration of the thermoplastic bike boxes on Speedway Boulevard**

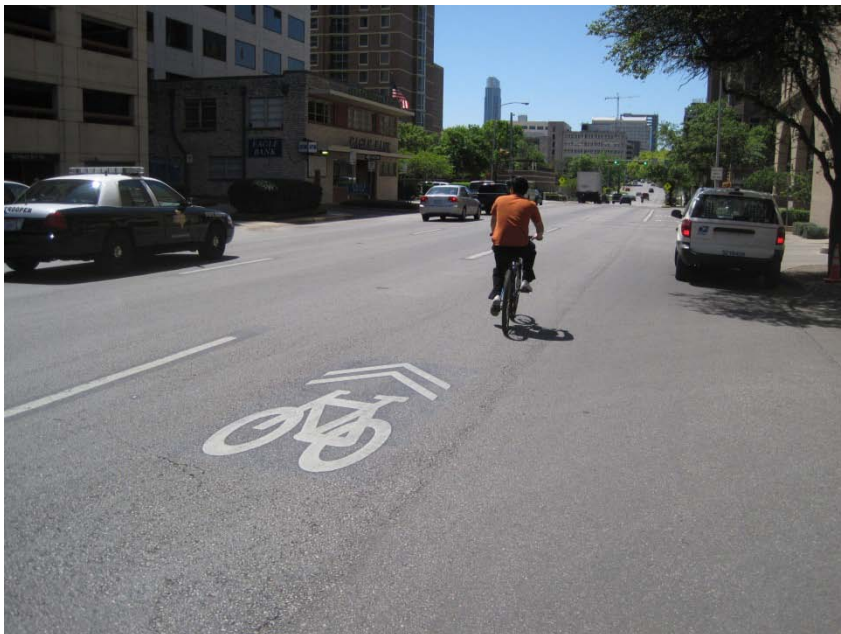
**Figure B4. Central placement of sharrow resulted in thriving thermoplastic five months after installation.**

All sharrows were installed on top of a painted black box in order to provide visual contrast. Additionally, all sharrows were installed in the outside travel lanes. The sharrows on Guadalupe, Lavaca, and 51st Sts were installed in the center of the outside travel lanes as described by Figure B4. Each sharrow was individually placed in order to keep the sharrow out of the typical wheel paths and to avoid driveways where entering and exiting vehicles would have more variable wheel paths. By placing the sharrows outside of wheel paths the integrity of the thermoplastic was maintained.

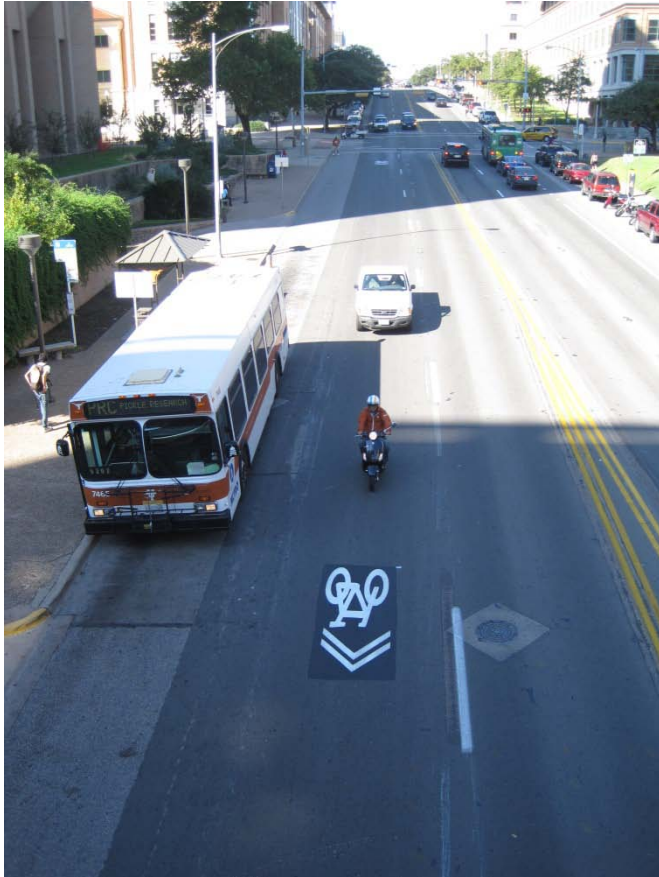
**Figure B5. Central placement of sharrows on east-bound, downhill Dean Keeton St.**

The east-bound sharrows on Dean Keeton St were installed in the center of the outside travel lanes (see Figure B5) in the same manner as the sharrows on Guadalupe, Lavaca, and 51st Sts. Like these other streets, centralizing the east-bound Dean Keeton sharrows helped to preserve the thermoplastic. Another reason these sharrows were installed in the center of the travel lane was to keep them out of the path of buses. Dean Keeton St has an extremely high volume of bus traffic (peak hourly volume of 40 buses/hour) and there a number of bus stops requiring buses to enter and exit the outer travel lane as shown in Figure B5. Finally east-bound bicyclists are also able to reach faster speeds because of the downhill allowing bicyclists and cars to travel at similar speeds.

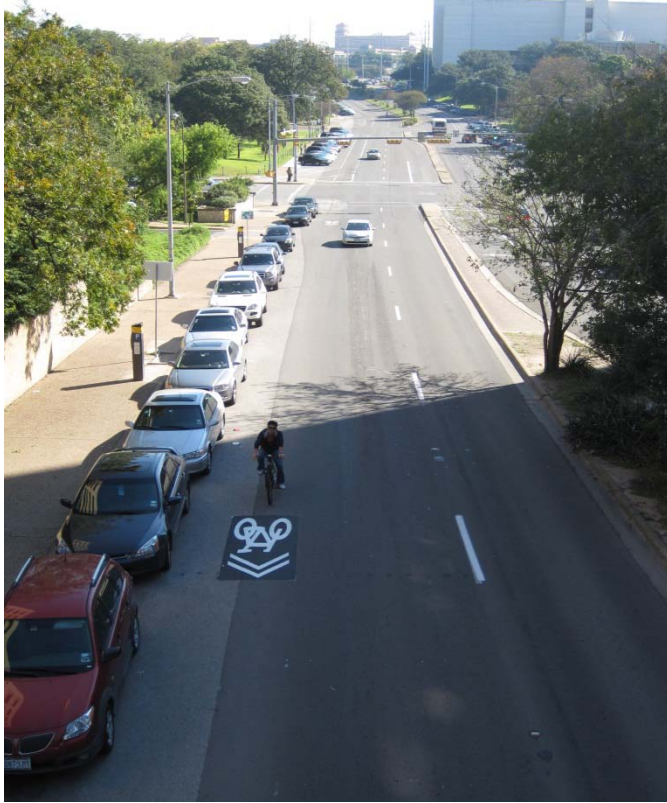
**Figure B6. Curb-justified placement of sharrows on west-bound, uphill Dean Keeton St.**

The west-bound sharrows on Dean Keeton differed from the other locations as these sharrows were aligned closer to the curb (see Figure B6). These sharrows were aligned closer to the curb for the following reasons: the outside travel lane on west-bound Dean Keeton was very large, there were no bus stops, the sharrows were only utilized to provide a bicycle facility to link two bicycle lanes, and west-bound bicyclists slow down to travel uphill.
