# Effects of Shared Lane Markings on Bicyclist and Motorist Behavior along Multi-Lane Facilities

The City of Austin Bicycle Team  
John Brady, Jeff Loskorn, Alison Mills, Jen Duthie, Randy Machemehl  
The Center for Transportation Research  
The University of Texas at Austin  
Phone: (512) 471-4541  
Fax: (512) 475-8744  
Email: [johnbrady.jb@gmail.com](mailto:johnbrady.jb@gmail.com)

Submitted July 15, 2010

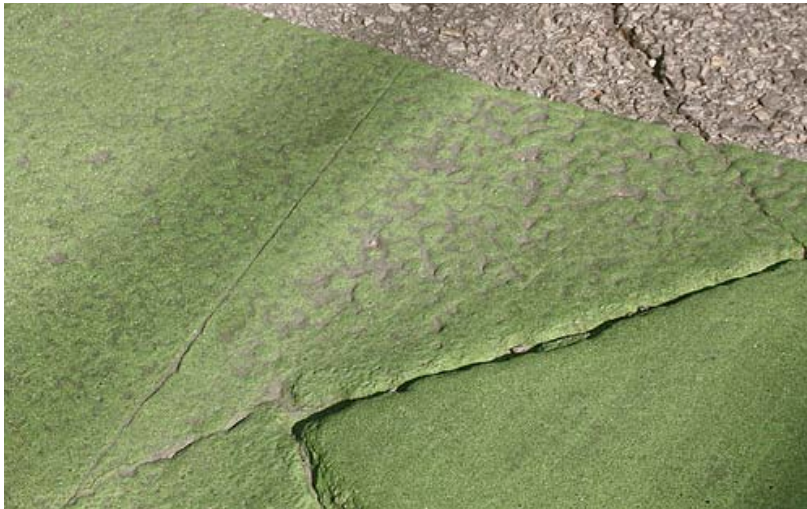
**Figure B7. Thermoplastic thinning on the colored lane on San Jacinto Boulevard**
